Client Address	Hampshire County Council PBRS Three Minsters House 76 High Street Winchester Hampshire SO23 8UL
Site Name	Bickerley Green NCU
Site Address	Kingsbury Lane Ringwood Hampshire BH24 1EL
Site contact	Jacquie Milford
Site telephone number	01425 473312
Last risk assessment carried out by	Freeston Water Treatment Limited
Date of risk assessment	April 2011
Date of previous review	4th April 2012
Date of new review	10th March 2014
Review carried out by	Mr Chris Wilson

This Review has been carried out in accordance with ACoP L8 'The control of Legionella bacteria in water systems' (APPROVED CODE OF PRACTICE & GUIDANCE) and BS 8580 (RISK ASSESSMENTS FOR LEGIONELLA CONTROL-CODE OF PRACTICE).

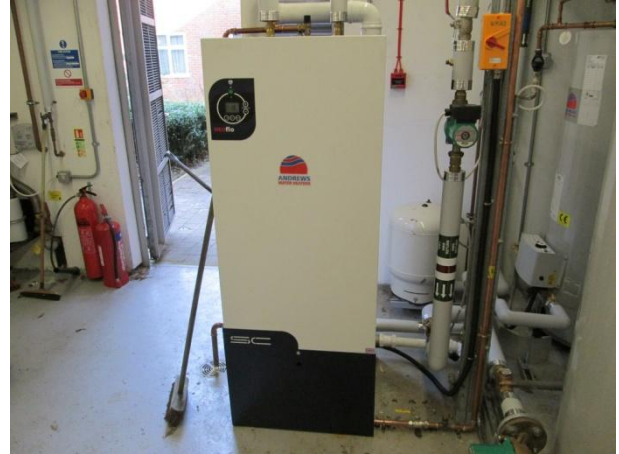
Calorifier No. 1	Storage	63.0°C	Satisfactory
Calorifier No. 1	Return	55.8°C	Satisfactory
Calorifier No. 2	Storage	18.0°C	Not Satisfactory
Calorifier No. 2	Return	55.8°C	Satisfactory
Hot Water Storage Vessel	Storage	62.0°C	Satisfactory
Hot Water Storage Vessel	Return	55.8°C	Satisfactory

The new Calorifier (No. 2).

I would recommend adjustment of Calorifier No. 2 as soon as is practicable to achieve these temperatures.

- Adjust Calorifier No. 2 to achieve a minimum storage temperature of 60°C at all times and a minimum of 50°C on the return at all times.
- If the self contained water feature in the rear garden is re-instated then I would recommend that it is dosed with an animal safe biocide to the manufacturers recommendations.
- Ensure that all Arjo / Malibu etc. type baths are serviced and maintained in line with the manufacturers recommendations e.g. seals and hoses changed, filters cleaned and disinfected etc. This should all be recorded within a logbook when carried out. No records were seen within the logbook relating to this being carried out.
- A Written Scheme should be prepared to ensure that all necessary controls are maintained, monitored and remain effective.

Calorifier No. 2 should be adjusted as soon as is practicable to achieve a minimum flow temperature of **60°C** at all times and a minimum return temperature of **50°C** at all times.

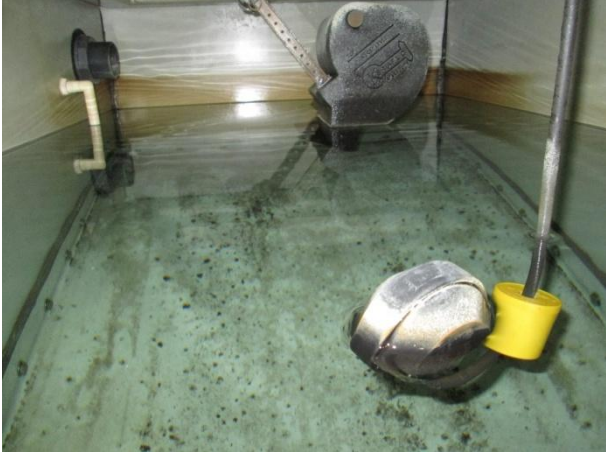
The inside of the tank no. 1 (nearest to the roof space access hatch) showed a medium deposit of sediment on the base and a heavy amount of biofilm on the sides.

Sediment, corrosion and biofilm act as nutrients and an ideal environment for the proliferation of bacteria including legionella.

Internal view of cold water storage tank no.
1.

The vessels were last cleaned and disinfected on the 12th July 2012 and I would recommend that this be carried out again within the near future.

- Clean and disinfect the domestic cold water storage tanks as soon as is practicable.
- Ensure Deputy Responsible Persons are appointed and are competent and adequately trained.

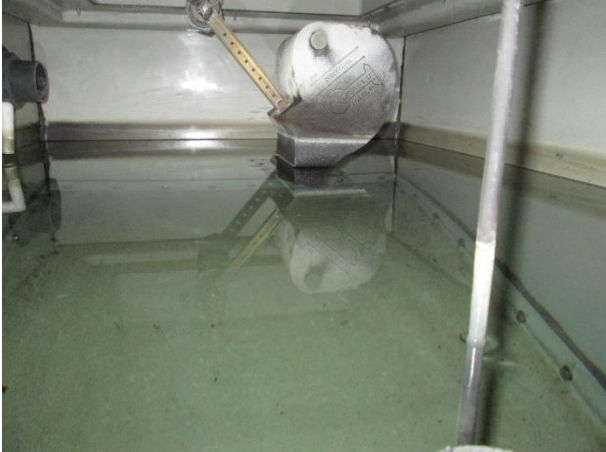
The inside of the tank no. 2 showed a medium deposit of sediment on the base and a medium to heavy amount of biofilm on the sides.

Internal view of cold water storage tank no
2.

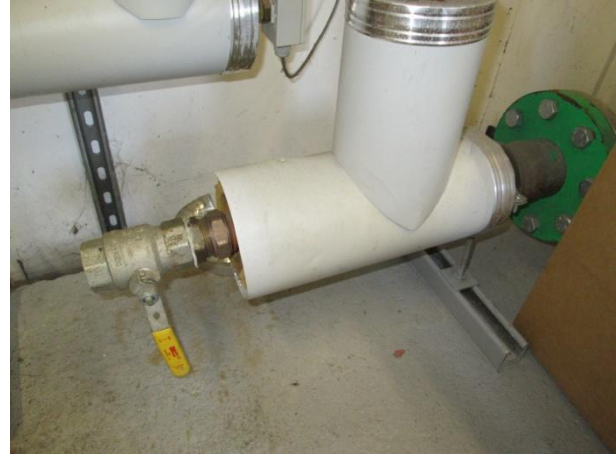
DL1 Boiler Room

The drain on the pipe from the domestic cold water storage tanks to the booster pump set is too long creating a dead leg.

- DL 1 - Boiler Room - The drain on the pipe from the tanks to the booster pump set is too long and creating a dead leg.

- Dead leg pipework is an ideal area for the proliferation of bacteria and should be removed or put on a weekly flushing regime (without creating an aerosol) and recorded.
Dead legs were found in the following areas:-

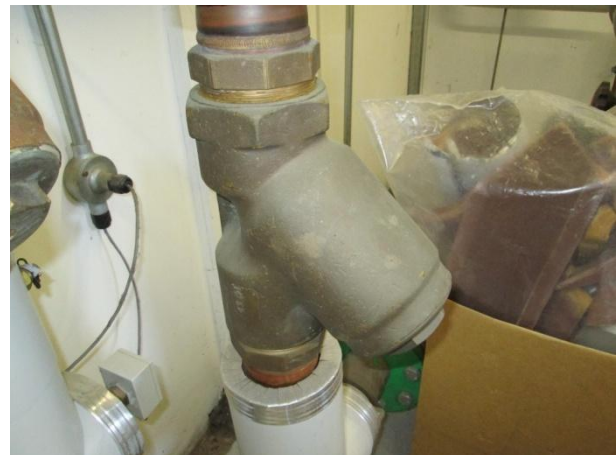
Boiler Room

The strainer on the pipe from the domestic cold water storage tanks to the booster pump set should be cleaned and disinfected regularly.

- There is a strainer on the inlet of the cold water booster pump set in the Boiler Room. This should be cleaned / maintained in line with the manufacturer's recommendations. It is not thought that this is being carried out.

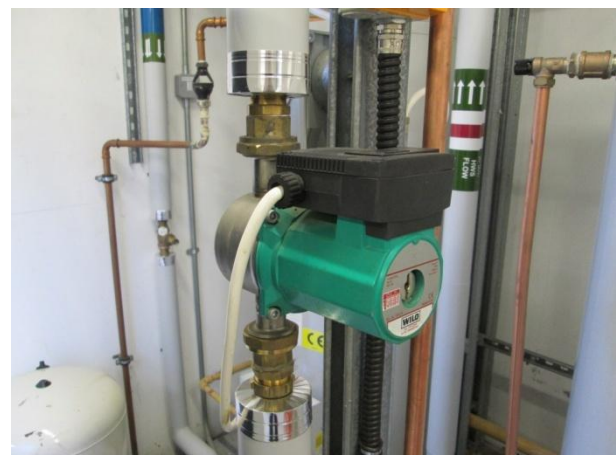
Boiler Room

The first of two return circulation pumps to the calorifiers and the hot water storage vessel.

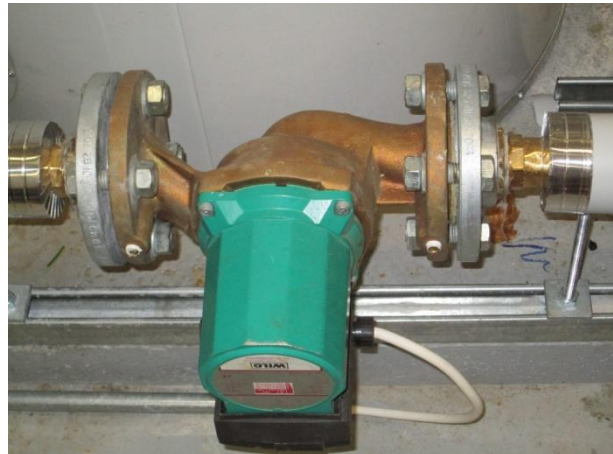
Boiler Room

The second of two return circulation pumps to the calorifiers and the hot water storage vessel.
