INTRODUCTION

Client Address	Hampshire County Council PBRS Three Minsters House 76 High Street Winchester Hampshire SO23 8UL
Site Name	Fleming House NCU
Site Address	Heron Square Eastleigh Hampshire SO50 9JD
Site contact	Wendy Burrett
Site telephone number	02380 626640
Last risk assessment carried out by	Freeston Water Treatment Limited
Date of risk assessment	April 2011
Date of previous review	22nd March 2012
Date of new review	4th March 2014
Review carried out by	Mr Chris Wilson

This Review has been carried out in accordance with ACoP L8 'The control of Legionella bacteria in water systems' (APPROVED CODE OF PRACTICE & GUIDANCE) and BS 8580 (RISK ASSESSMENTS FOR LEGIONELLA CONTROL-CODE OF PRACTICE).

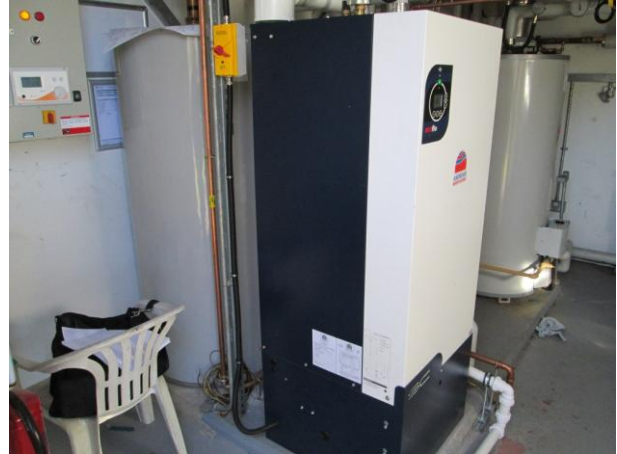
HOT WATER STORAGE PHOTOGRAPHS

Calorifier No. 1	Storage	58.0°C	Not Satisfactory
Calorifier No. 1	Return	47.0°C	Not Satisfactory
Calorifier No. 2	Storage	65.0°C	Satisfactory
Calorifier No. 2	Return	47.0°C	Not Satisfactory
Hot Water Storage Vessel	Storage	63.0°C	Satisfactory
Hot Water Storage Vessel	Return	47.0°C	Not Satisfactory

The hot water storage vessel is on the left, the existing Calorifier (no.1) is on the right and the new Calorifier (no.2) is in the middle of the picture.

I would recommend adjustment of the calorifiers as soon as is practicable to achieve these temperatures.

- Adjust the calorifiers where needed to achieve a minimum flow temperature of 60°C at all times and a minimum return temperature of 50°C at all times.

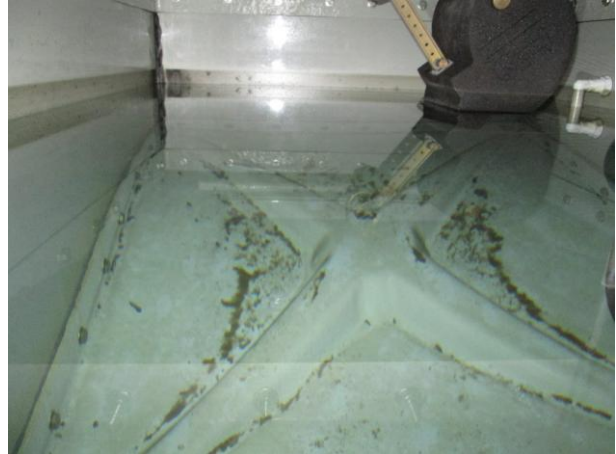
1.

The inside of the tank no. 1 (nearest to the roof space access hatch) showed a light to medium deposit of sediment on the base and a medium amount of biofilm on the sides.

Sediment, corrosion and biofilm act as nutrients and an ideal environment for the proliferation of bacteria including legionella.

Internal view of cold water storage tank no.

The vessels were last cleaned and disinfected on the 25th May 2011 and I would recommend that this be carried out again as soon as is practicable.

- Clean and disinfect the domestic cold water storage tanks as soon as is practicable. Inspect the tanks annually and repeat if required.
- There is an inline scale reducing device on the outlet pipe of the cold water booster pump set in the Boiler Room. This should be cleaned / maintained in line with the manufacturer's recommendations. It is not thought that this is being carried out.

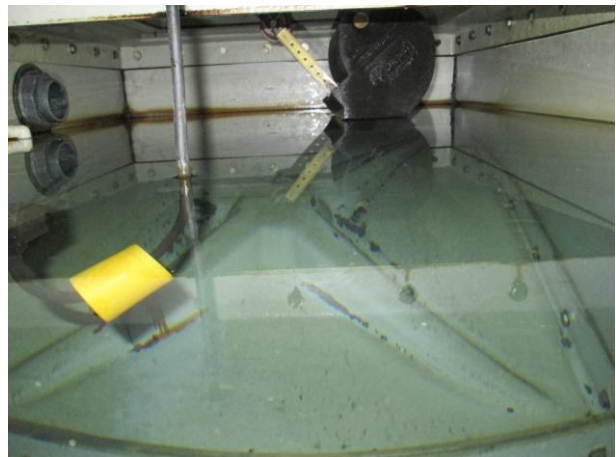
2.

The inside of the tank no. 2 showed a medium deposit of sediment on the base and a heavy amount of biofilm on the sides.

Internal view of cold water storage tank no

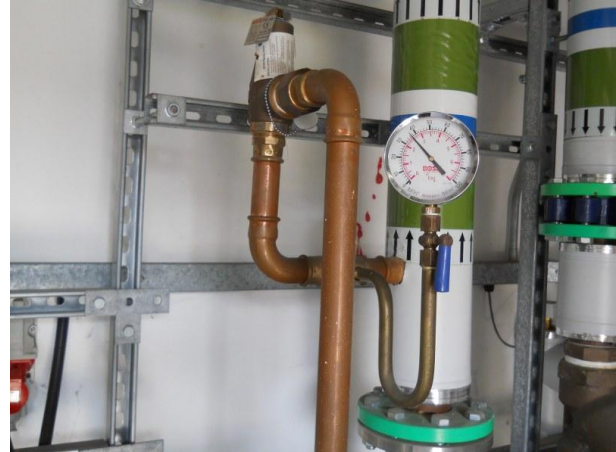
DL1 Boiler Room

Swan neck dead leg type pipe and also the pipe to the pressure relief valve is too long creating a dead leg. These are on the outlet of the cold water booster pump set.

- Dead leg pipework are ideal areas for the proliferation of bacteria and should be removed or put on a weekly flushing regime (without creating an aerosol) and recorded.
Dead legs were found in the following areas:-

- DL1 - Boiler Room - There is a swan neck type dead leg pipe to the pressure gauge on the outlet pipe of the booster pump set. The pipe that it is on is to the pressure relief valve; this pipe is too long and also creating a dead leg and should be shortened as far as possible.

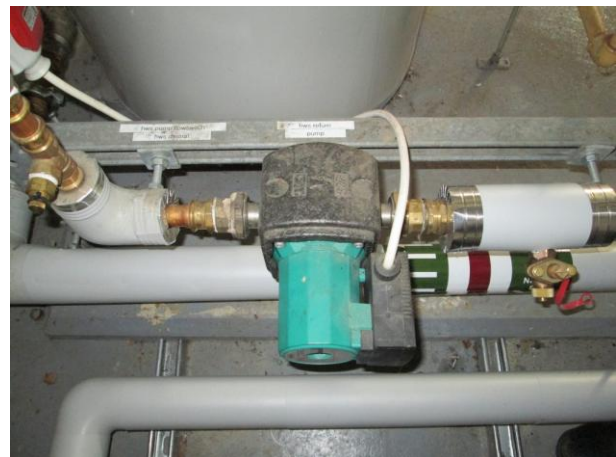
Boiler Room

The first of two return circulation pumps to the calorifiers and the hot water storage vessel.

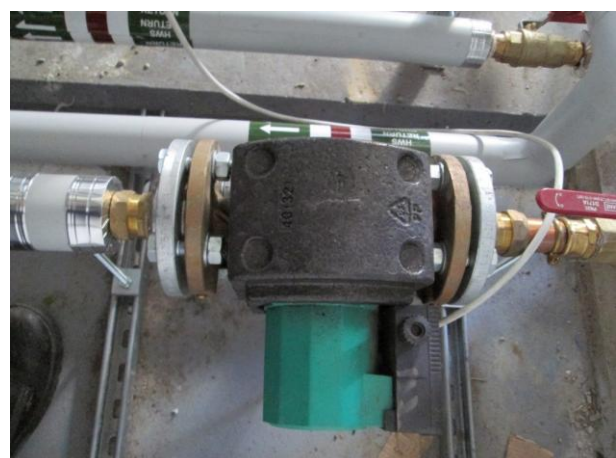
Boiler Room

The second of two return circulation pumps to the calorifiers and the hot water storage vessel.
