Client Address	Hampshire County Council PBRS Three Minsters House 76 High Street Winchester Hampshire SO23 8UL
Site Name	Forest Court NCU
Site Address	Forest Way Tatchbury Mount Calmore Hampshire SO40 2PZ
Site Contact	Glenn Dinsdale
Site Telephone Number	02380 664770
Last Risk Assessment Carried Out By	Freeston Water Treatment Limited
Date of Risk Assessment	May 2011
Date of Previous Review	14th March 2012
Date of New Review	14th February 2014
Review Carried Out By	Mr Chris Wilson

ACoP L8 DOCUMENTATION/LOGBOOK AND RISK ASSESSMENT / REVIEW AUDIT

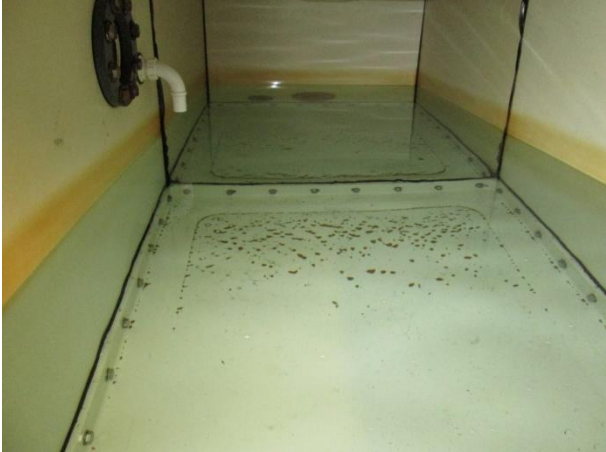
The inside of the tank no. 1 (nearest to the roof space access hatch) showed a medium deposit of sediment on the base and a medium amount of biofilm on the sides.

Sediment, corrosion and biofilm act as nutrients and an ideal environment for the proliferation of bacteria including Legionella.

Internal view of cold water storage tank no.
1.

The vessels were cleaned and disinfected on the 15th July 2013 and I would therefore recommend that it be carried out again.

- Clean and disinfect the domestic cold water storage tanks. Inspect annually and repeat if required.
- Fit extra insulation to the cold water storage tank inlet valve housing lids if needed in hotter months.

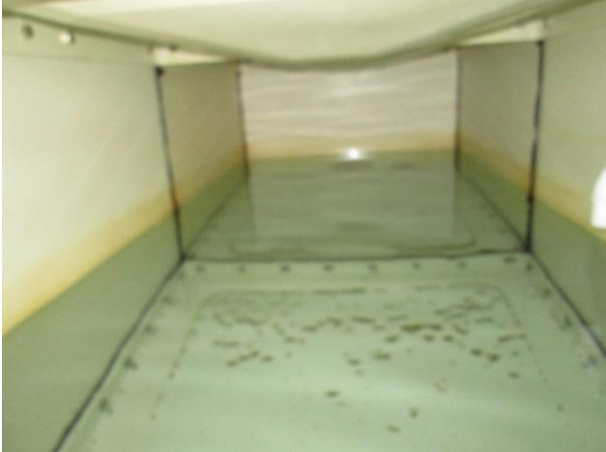
The inside of the tank no. 2 (furthest from the roof space access hatch) also showed a medium deposit of sediment on the base and a medium to heavy amount of biofilm on the sides

Internal view of cold water storage tank no.
2.

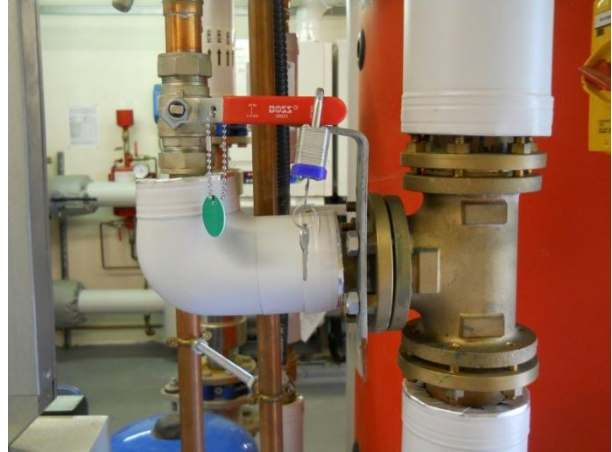
DL1 Boiler Room

The fill pipe from the booster pumps to the calorifiers has a small dead leg on the supply pipe to the standby calorifier as it is too long and should be shortened as much as possible.

- DL1 - Boiler Room – The fill pipe from the booster pumps to the calorifiers has a small dead leg on the supply pipe to the standby calorifier as it is too long and should be shortened as much as possible.

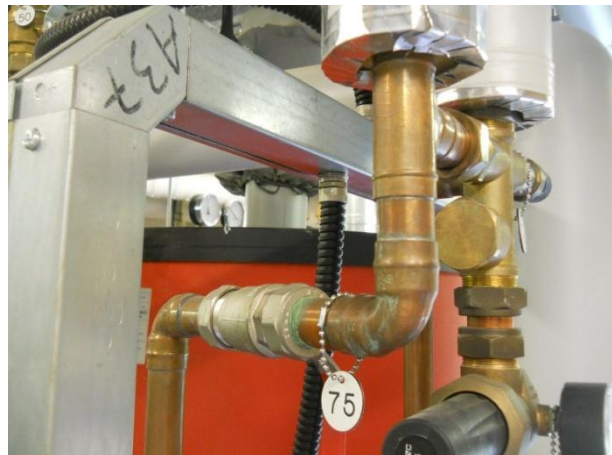
DL2 Boiler Room

The fill pipe from the booster pumps to the standby calorifiers has a small dead leg on the drain valve as the pipe is too long and should be shortened as much as possible. **This only applies when the standby calorifier is in service and the pipe is charged, it is currently empty.**

- DL2 - Boiler Room - The fill pipe from the booster pumps to the standby calorifiers has a small dead leg on the drain valve as the pipe is too long and should be shortened as much as possible. **This only applies when the standby calorifier is in service and the pipe is charged, it is currently empty.**

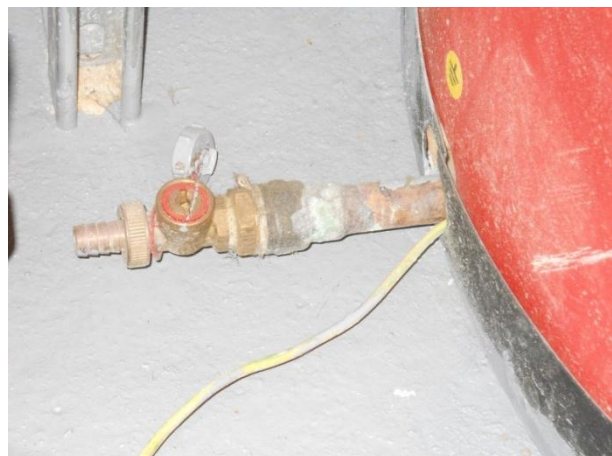
DL4 Boiler Room

There is a small dead leg on the hot water storage vessel drain as it is too long and should be shortened as much as possible.

- DL4 - Boiler Room - There is a small dead leg on the hot water storage vessel drain as it is too long and should be shortened as much as possible.
- IF STANDBY CALORIFIER IS TO BE USED.
