Client Address	Hampshire County Council PBRS Three Minsters House 76 High Street Winchester Hampshire SO23 8UL
Site Name	Hawthorne Court NCU
Site Address	Coldeast Way Sarisbury Green Southampton Hampshire SO31 7LX
Site contact	Kerry Bean
Site telephone number	01489 556720
Last risk assessment carried out by	Freeston Water Treatment Limited
Date of risk assessment	April 2011
Date of previous review	30th March 2012
Date of new review	20th March 2014
Review carried out by	Mr Chris Wilson

This Review has been carried out in accordance with ACoP L8 'The control of Legionella bacteria in water systems' (APPROVED CODE OF PRACTICE & GUIDANCE) and BS 8580 (RISK ASSESSMENTS FOR LEGIONELLA CONTROL-CODE OF PRACTICE).

SITE REVIEW

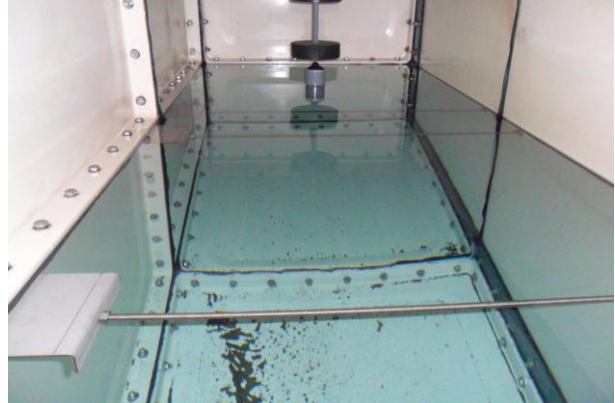
Internal view of cold water storage tank no.

The inside of the tank no. 1 (left side) showed a light deposit of sediment on the base and a light amount of biofilm on the sides.

Sediment, corrosion and biofilm act as nutrients and an ideal environment for the proliferation of bacteria including legionella.

The vessels were last cleaned and disinfected on the 5th July 2012 and I would recommend that they be cleaned and disinfected again within the near future.

- Clean and disinfect the domestic cold water storage tanks within the near future. Inspect the tanks annually and repeat if required.
- There is an inline scale reducing device on the inlet pipe of the cold water booster pump set in the boiler room. This should be cleaned / maintained in line with the manufacturer's recommendations. It is not thought that this is being carried out.

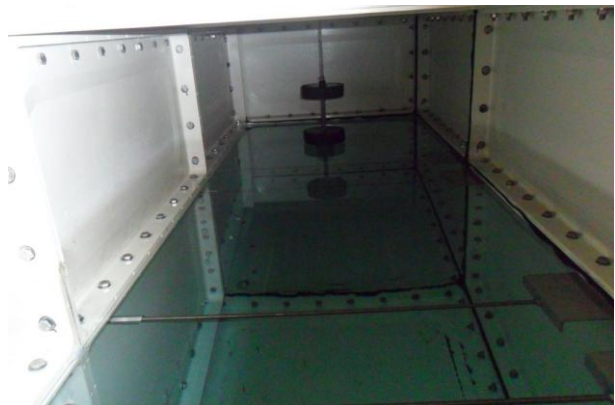
Internal view of cold water storage tank no.

The inside of the tank no. 2 (right side) showed a light deposit of sediment on the base and a light amount of biofilm on the sides.

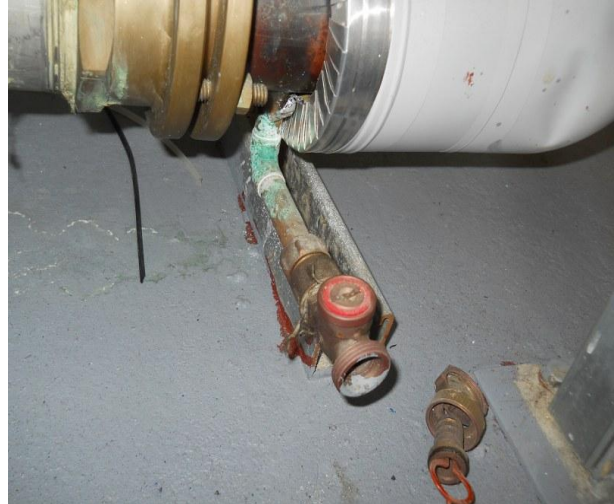
DL1 Boiler Room

Boiler Room – The drain on the outlet pipe of the booster pump set is too long and creating a dead leg.

- Dead leg pipework is an ideal area for the proliferation of bacteria and should be removed or put on a weekly flushing regime (without creating an aerosol) and recorded.
Dead legs were found in the following areas:-

- DL1-Boiler Room – The drain on the outlet pipe of the booster pump set is too long and creating a dead leg.
 - DL2 - Boiler Room – The drain on the bottom of the hot water storage vessel is too long and creating a dead leg.

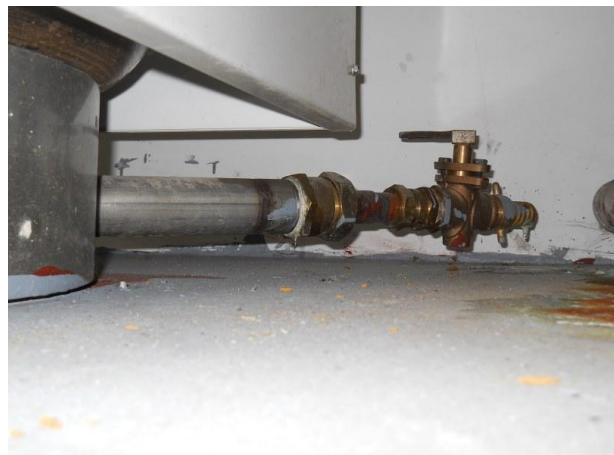
DL2 Boiler Room

The drain on the bottom of the hot water storage vessel is too long and creating a dead leg.

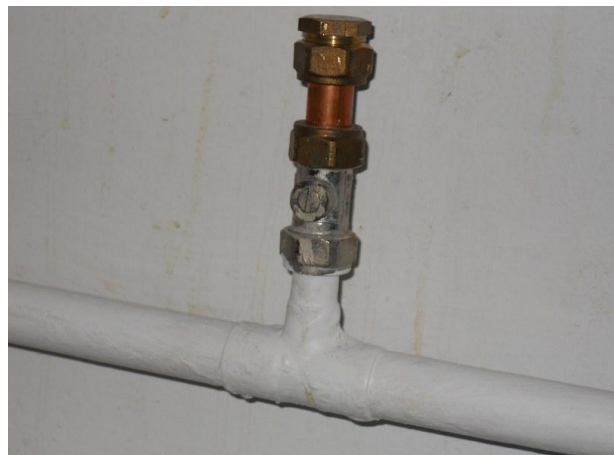
DL3 Main Kitchen

Small dead leg behind the dishwasher.

- DL3 - Main Kitchen – There is a small dead leg behind the dishwasher.
 - DL4 - Boiler Room - The vent pipe on the hot flow pipe of calorifier no. 1 should be as short as possible or put on a weekly flushing regime.

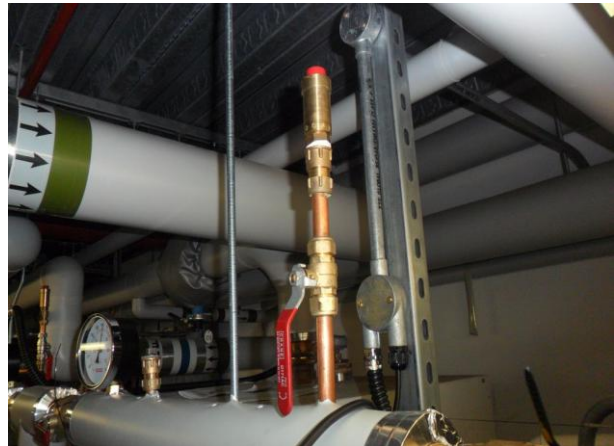
DL4 Boiler Room

The vent pipe on the hot flow pipe of calorifier no. 1 should be as short as possible or put on a weekly flushing regime.

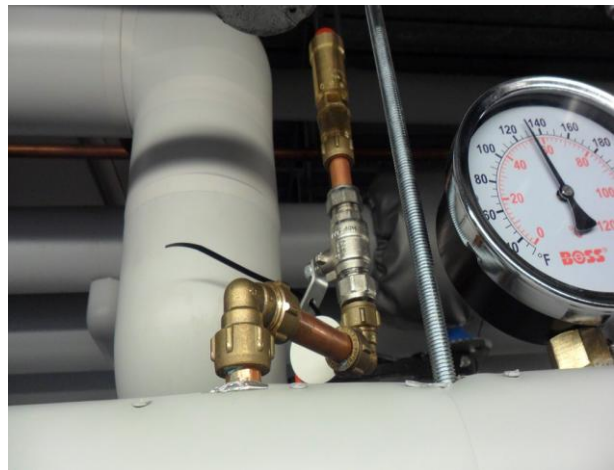
DL5 Boiler Room

The vent pipe on the hot flow pipe of calorifier no. 2 should be as short as possible or put on a weekly flushing regime.

- DL5 - Boiler Room - The vent pipe on the hot flow pipe of calorifier no. 2 should be as short as possible or put on a weekly flushing regime.
- Purge the calorifiers and hot water storage vessel to drain on at least an annual basis and record when carried out.

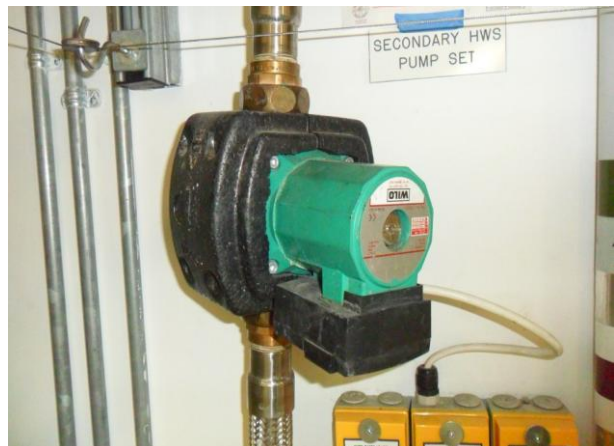
Boiler Room

The first of the two new hot return circulation pumps.

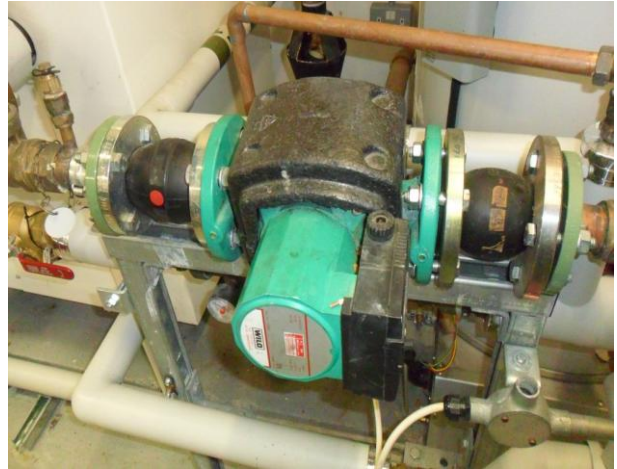
Boiler Room

The second of the two new hot return circulation pumps.
