Client Address	Hampshire County Council PBRS Three Minsters House 76 High Street Winchester Hampshire SO23 8UL
Site Name	Westholme NCU
Site Address	55 Harestock Road Winchester Hampshire SO22 6NT
Site contact	Christine Chirimumimba
Site Telephone Number	01962 881481
Last Risk Assessment Carried Out By	Freeston Water Treatment Limited
Date of Risk Assessment	June 2011
Date of Previous Review	10th April 2012
Date of New Review	12th March 2014
Review Carried Out By	Mr Chris Wilson

This Review has been carried out in accordance with ACoP L8 'The control of Legionella bacteria in water systems' (APPROVED CODE OF PRACTICE & GUIDANCE) and BS 8580 (RISK ASSESSMENTS FOR LEGIONELLA CONTROL-CODE OF PRACTICE).

SITE REVIEW

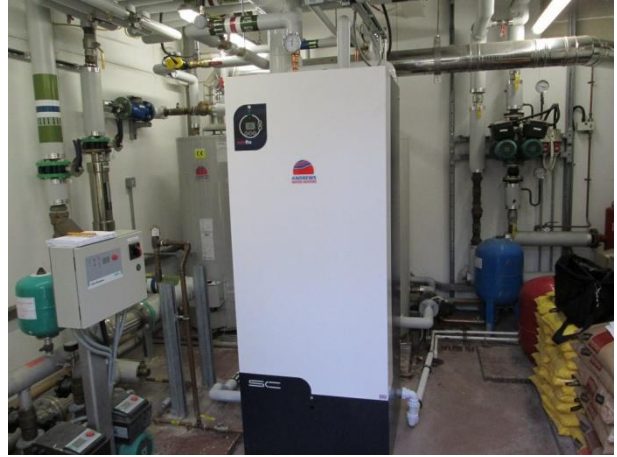
The newly installed calorifier (Calorifier no. 2) was manufactured by Andrews Water Heaters and is a NEOflo SC 25/200 model. The calorifier is supplied by the domestic cold water storage tanks within the loft via a pressure reducer and booster pump set. The calorifier has insulation under the factory fitted metal outer casings, is of a stainless steel construction and is directly heated by gas.

The new Calorifier (no. 2).

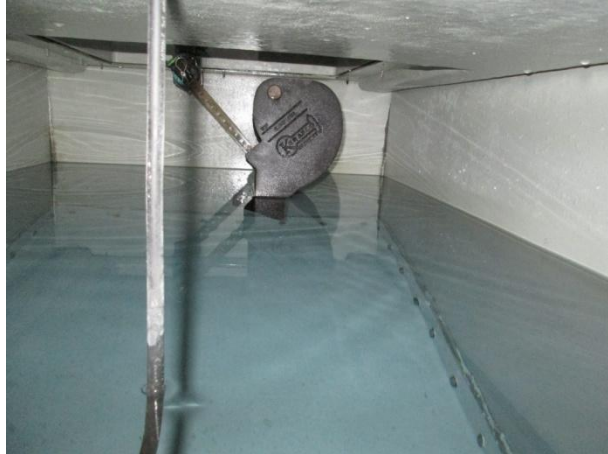
The inside of the tank showed a light deposit of sediment on the base and a medium amount of biofilm on the sides. Sediment and biofilm act as nutrients and an ideal environment for the proliferation of bacteria including legionella.

An internal view of domestic cold water storage tank no 1.

It is unknown when this vessel was last cleaned and disinfected and I would recommend that this be carried out within the near future.

- Clean and disinfect domestic cold water storage tank no. 1 as soon as is practicable and repeat annually if required.
- Clean and disinfect domestic cold water storage tank no. 2 if brought back into service.

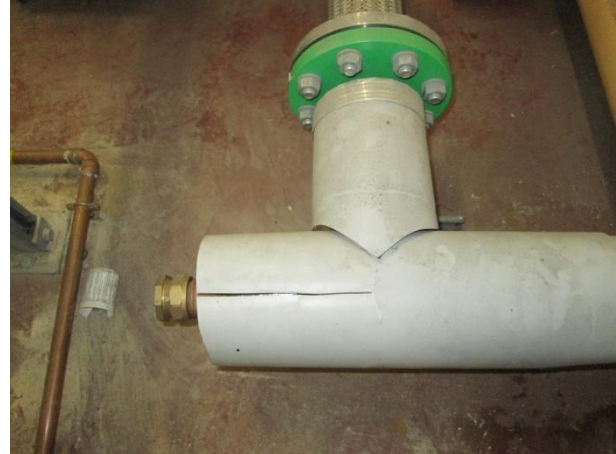
DL1 Boiler Room

The drain on the inlet pipe to the booster pumps from the tanks is too long and creating a dead leg.

- Dead leg pipework are ideal areas for the proliferation of bacteria and should be removed or put on a weekly flushing regime (without creating an aerosol) and recorded.
Dead legs were found in the following areas:-

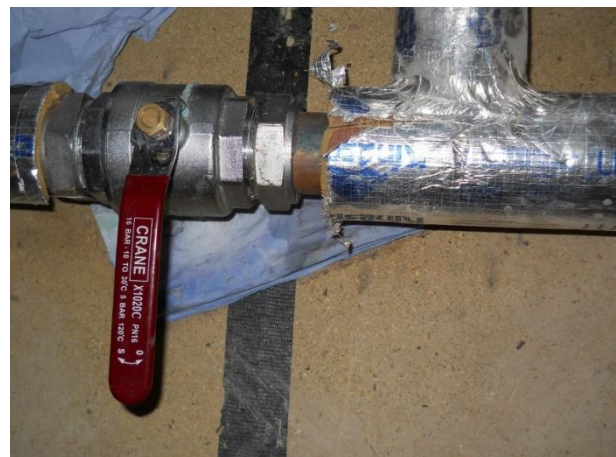
DL2 Roof Space above Jay Wing

The valve on the mains cold water pipe to the inlet of Tank no. 2 is shut and creating a dead leg.

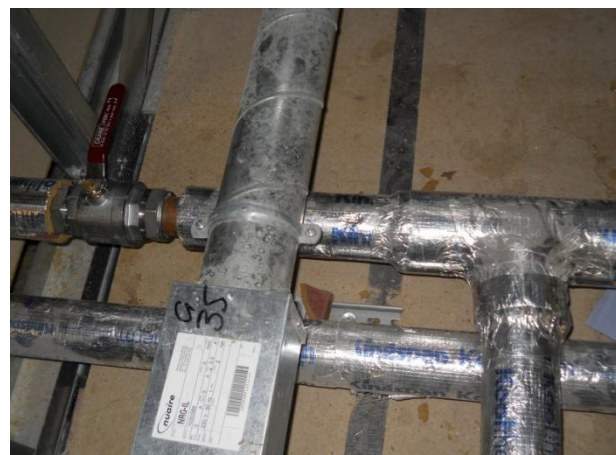
DL3 Roof Space above Jay Wing

The valve on the outlet pipe of Tank no. 2 is shut and creating a dead leg on the outlet header pipe.
