Client Address	Hampshire County Council PBRS Three Minsters House 76 High Street Winchester Hampshire SO23 8UL
Site Name	Cranleigh Paddock Resource Centre OPH
Site Address	Calpe Avenue Lyndhurst Hampshire SO43 7AT
Site contact	Jenny Parsons
Site telephone number	02380 283602
Last risk assessment carried out by	Freeston Water Treatment Limited
Date of risk assessment	April 2011
Date of previous review	29th March 2012
Date of new review	6th March 2014
Review carried out by	Mr Chris Wilson

This Review has been carried out in accordance with ACoP L8 'The control of Legionella bacteria in water systems' (APPROVED CODE OF PRACTICE & GUIDANCE) and BS 8580 (RISK ASSESSMENTS FOR LEGIONELLA CONTROL-CODE OF PRACTICE).

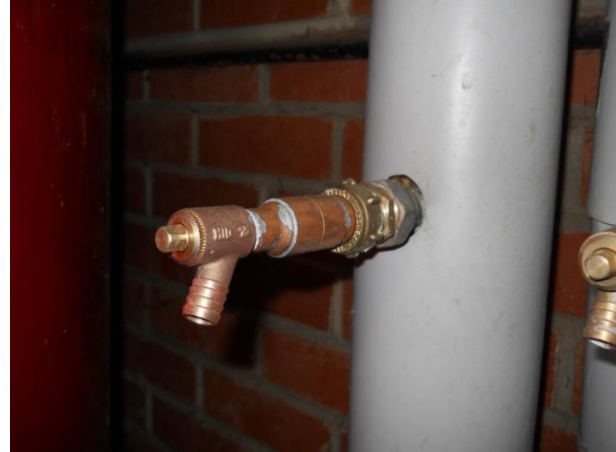
DL1 Boiler Room

Dead leg on the mains cold water riser. This has replaced the un-operable valve dead leg as a temporary measure (as the water could not be shut off for long) and requires weekly flushing.

- DL1 - Boiler Room - There is a drain pipe on the mains cold water rising main. The pipe is too long and is therefore a dead leg. This has replaced the un-operable valve dead leg as a temporary measure (as the water could not be shut off for long) and requires weekly flushing.

- Dead leg pipework are ideal areas for the proliferation of bacteria and should be removed or put on a weekly flushing regime (without creating an aerosol) and recorded.
Dead legs were found in the following areas:-

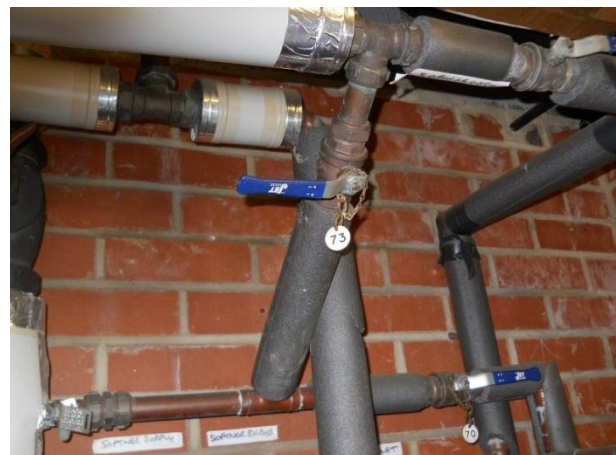
DL2 Boiler Room

Dead leg on the water softener bypass pipe.

- DL2 - Boiler Room - There is a valve on the mains cold water, water softener bypass pipe that is closed and this is creating a dead leg either side of it.

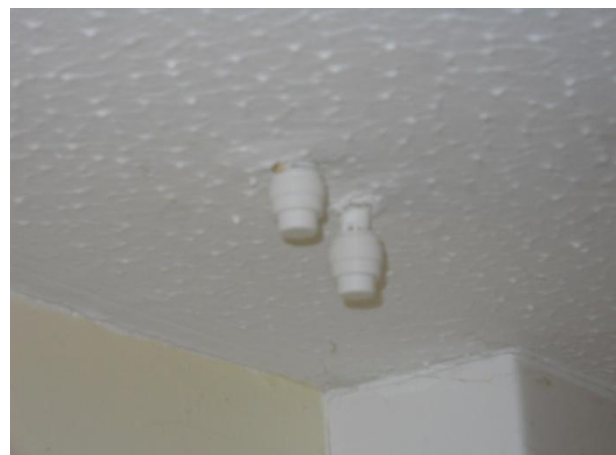
DL3 Oakwood Wing

Toilet next to Room 57

Dead legs in ceiling.

- DL3 - Oakwood Wing Toilet next to Room 57 - There are two capped dead leg pipes protruding through the ceiling.
 - DL4 - Main Kitchen - There are two dead legs behind the water softener.

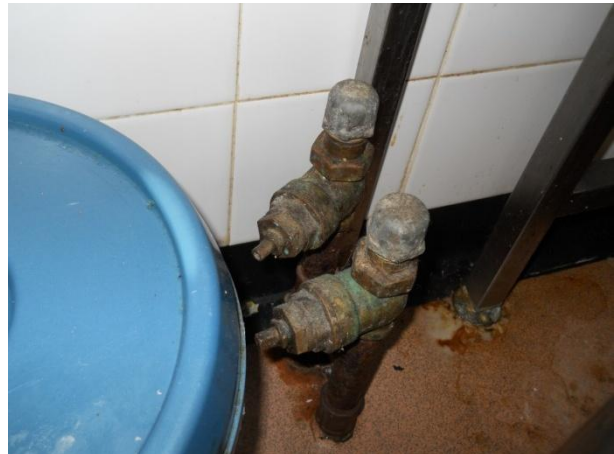
DL4 Main Kitchen

Dead legs behind the water softener.

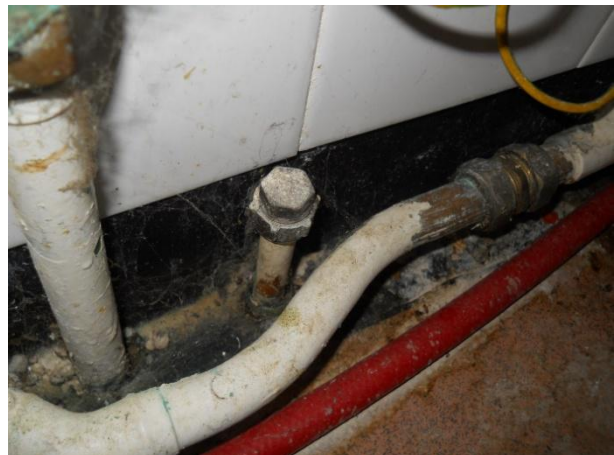
DL5 Main Kitchen

Dead leg behind the sinks.

- DL5 - Main Kitchen - There is a dead leg behind the sinks.
 - DL6 - Laundry - There is a dead leg on the wall between the washing machines and the sinks.

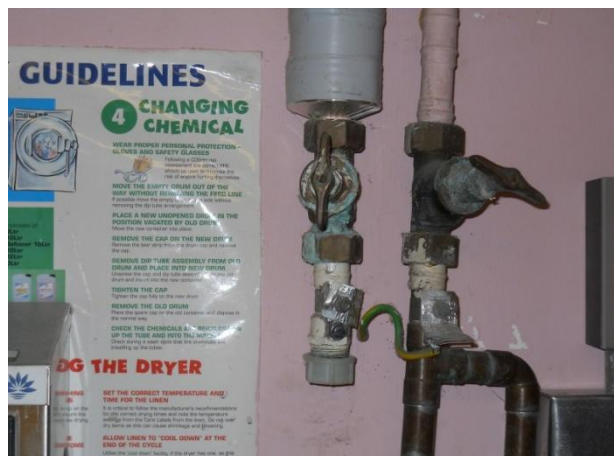
DL6 Laundry

Dead leg.

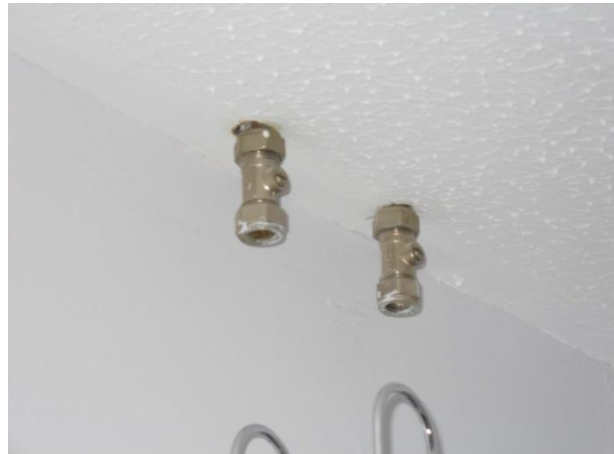
DL7 Medical Room

Dead legs in ceiling.

- DL7 - Medical Room - There are two dead legs protruding through the ceiling on the left side of the room.
 - DL8 - Medical Room - There is a dead leg protruding through the ceiling on the right side of the room.

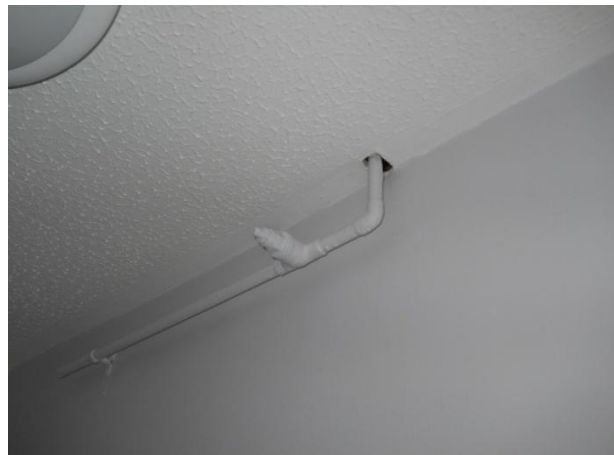
DL8 Medical Room

Dead leg in ceiling.

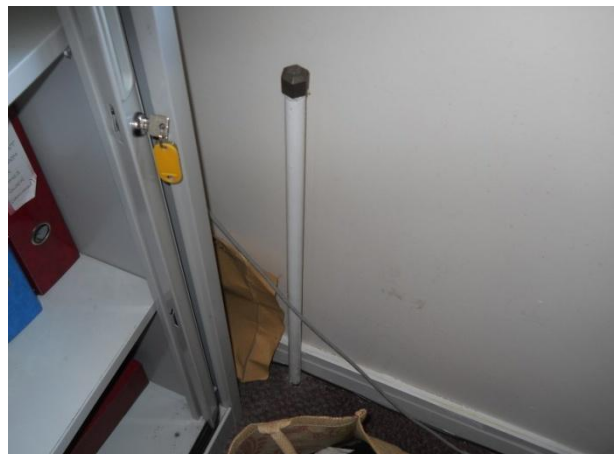
DL9 Receptionists Room

Dead leg,

- DL9 - Receptionists Room - There is a dead leg from the floor.
 - DL10 - Boiler Room - There is a dead leg on the common return pipe to the right side of calorifier no. 1.

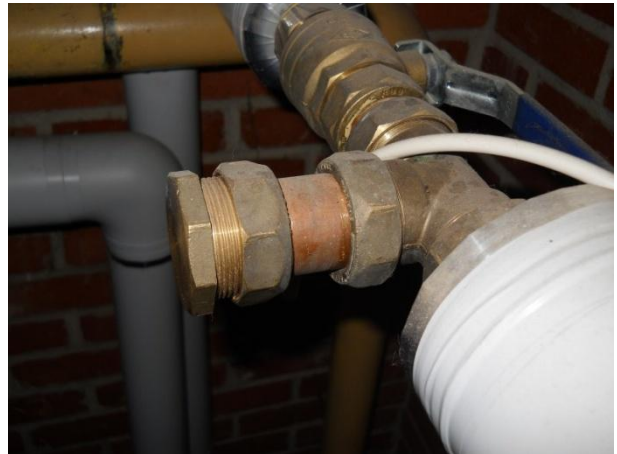
DL10 Boiler Room

Dead leg on the common return pipe.
