Client Address	Hampshire County Council PBRS Three Minsters House 76 High Street Winchester Hampshire SO23 8UL
Site Name	Fleming House OPH
Site Address	Heron Square Eastleigh Hampshire SO50 9JD
Site contact	Wendy Burrett
Site telephone number	02380 626640
Last risk assessment carried out by	Freeston Water Treatment Limited
Date of risk assessment	April 2011
Date of previous review	22nd March 2012
Date of new review	4th March 2014
Review carried out by	Mr Chris Wilson

This Review has been carried out in accordance with ACoP L8 'The control of Legionella bacteria in water systems' (APPROVED CODE OF PRACTICE & GUIDANCE) and BS 8580 (RISK ASSESSMENTS FOR LEGIONELLA CONTROL-CODE OF PRACTICE).

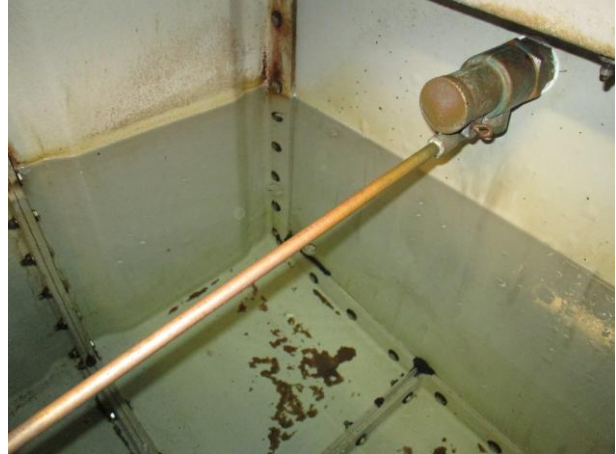
1.

The domestic cold water storage tank is of a double skinned GRP construction and is in good condition.

The inside of the tank showed a light to medium deposit of sediment on the base, a medium amount of biofilm on the sides and heavy staining from a sealant on the stainless steel bolts. Sediment, corrosion and biofilm act as nutrients and an ideal environment for the proliferation of bacteria including legionella.

Internal view of cold water storage tank no.

This tank was last cleaned and disinfected on the 18th July 2012 and I would recommend that this be carried out again as soon as is practicable.

- Clean and disinfect the domestic cold water storage tank as soon as is practicable. Inspect the tank annually and repeat if required.
- Ensure that the sentinel tap temperatures are taken on a monthly basis and recorded.

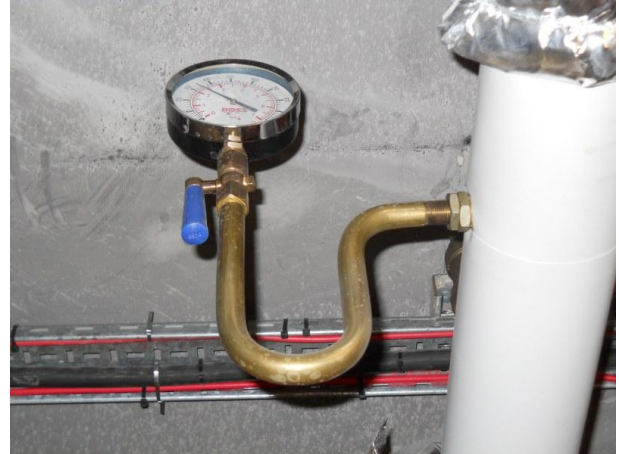
DL1 Boiler Room

Dead leg on the boosted cold water supply to the calorifiers.

- Dead leg pipework are ideal areas for the proliferation of bacteria and should be removed or put on a weekly flushing regime (without creating an aerosol) and recorded.
Dead legs were found in the following areas:-

- DL1 - Boiler Room - There is a pig tail type dead leg pipe to the gauge on the boosted cold water supply pipe to the calorifiers.
- Purge the calorifier to drain on at least an annual basis and record when carried out.
