INTRODUCTION

Client Address	Hampshire County Council PBRS Three Minsters House 76 High Street Winchester Hampshire SO23 8UL
Site Name	Malmesbury Lawn OPH
Site Address	Woolston Road Leigh Park Havant Hampshire PO9 4JY
Site contact	Filip Baginski
Site telephone number	02392 244900
Last risk assessment carried out by	Jasun Envirocare PLC
Date of risk assessment	28th June 2011
Date of previous review	N/A
Date of new review	1st April 2014
Review carried out by	Mr Chris Wilson

SITE REVIEW

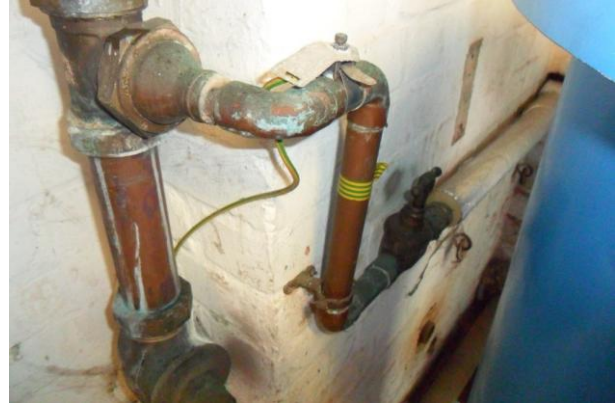
DL1 Boiler Room

There is a bib tap on the mains cold water pipe which is never used and has therefore been rendered a dead leg.

- Dead leg pipework are ideal areas for the proliferation of bacteria and should be removed or put on a weekly flushing regime (without creating an aerosol) and recorded.
Dead legs were found in the following areas:-

- DL1 - Boiler Room - There is a bib tap on the mains cold water pipe which is never used and has therefore been rendered a dead leg.
 - DL2 - Boiler Room - There is dead leg at height on the mains cold water pipe.

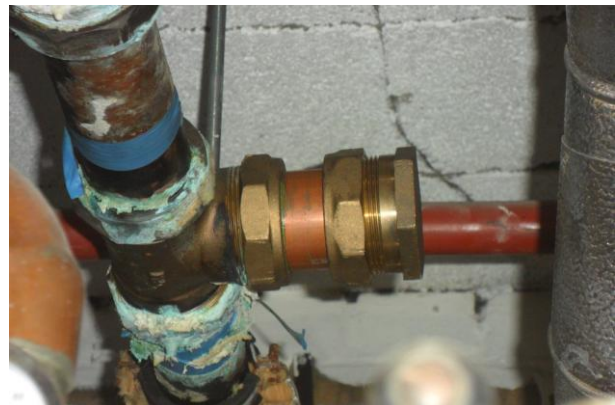
DL2 Boiler Room

There is dead leg at height on the mains cold water pipe.

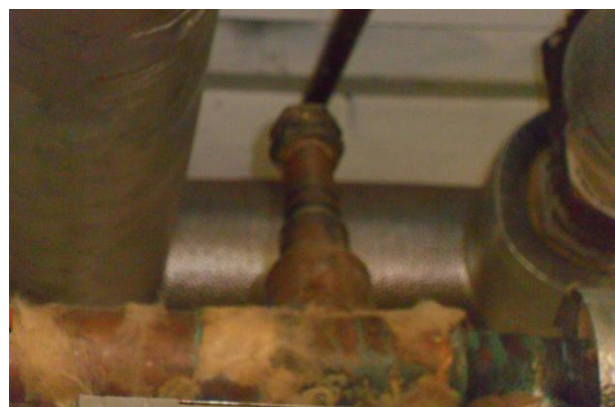
DL3 Boiler Room

There is a dead leg on the hot flow pipe behind calorifier no. 2.

- DL3 - Boiler Room - There is a dead leg on the hot flow pipe behind calorifier no. 2.
 - DL4 - Boiler Room - On the hot return pipe to the calorifier there is a vent pipe arrangement that consists of a large pipe. This should be replaced with a smaller conventional auto vent.

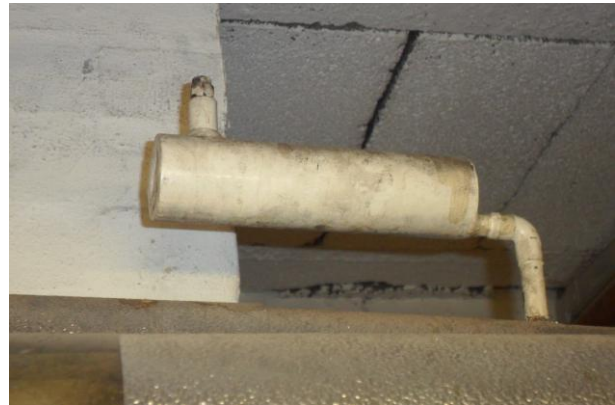
DL4 Boiler Room

On the hot return pipe to the calorifier there is a vent pipe arrangement that consists of a large pipe. This should be replaced with a smaller conventional auto vent.

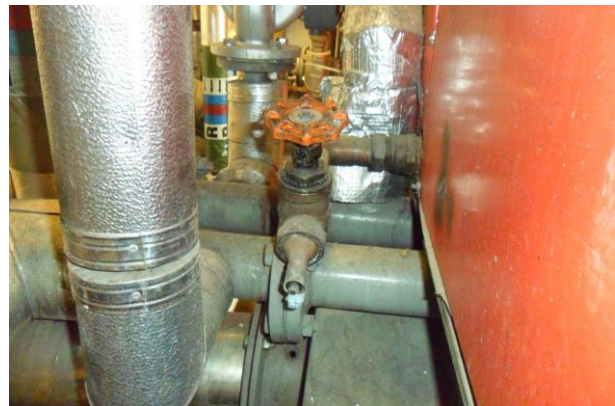
DL5 Boiler Room

The drain valves on both calorifiers are too long and creating dead legs and should be shortened back as far as possible.

- DL5 - Boiler Room - The drain valves on both calorifiers are too long and creating dead legs and should be shortened back as far as possible.
 - DL6 - Boiler Room - The drain on the water softener is too long and creating a dead leg and should be shortened back as far as possible.

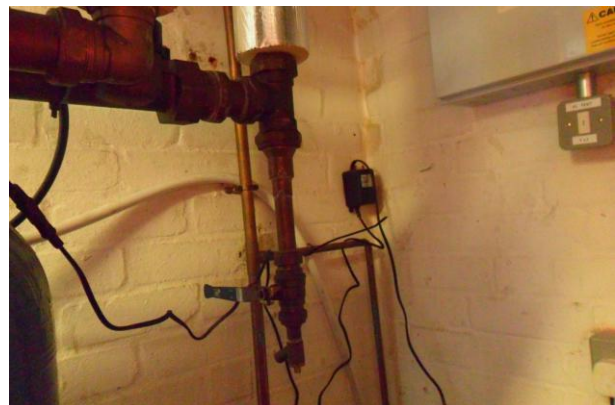
DL6 Boiler Room

The drain on the water softener is too long and creating a dead leg and should be shortened back as far as possible.

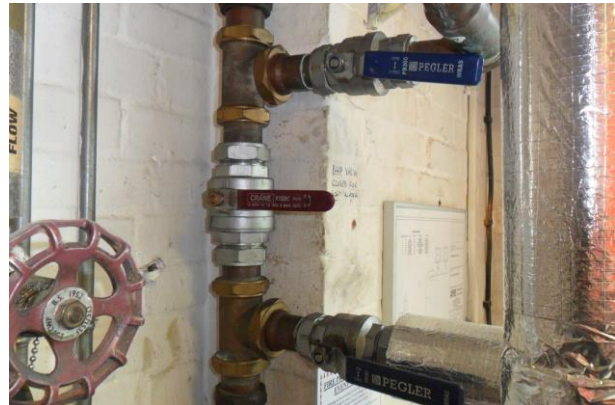
DL7 Boiler Room

There is a water softener bypass pipe with a valve on it that is in the shut position and creating small dead legs either side of it.

- DL7 - Boiler Room - There is a water softener bypass pipe with a valve on it that is in the shut position and creating small dead legs either side of it.

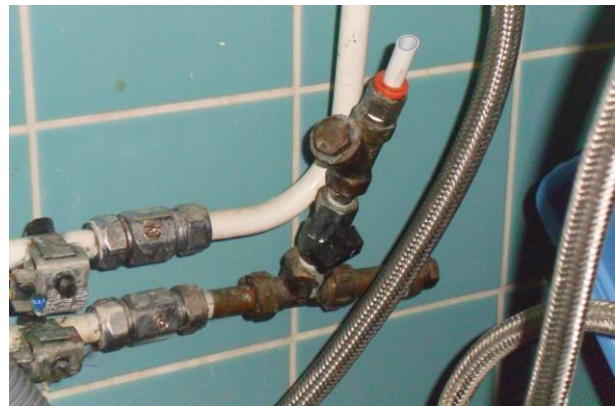
DL8 Kitchen

There is a dead leg pipe at low level by the dishwasher.

- DL8 – Kitchen - There is a dead leg pipe at low level by the dishwasher.
- Purge the calorifiers to drain on at least an annual basis and record when carried out.

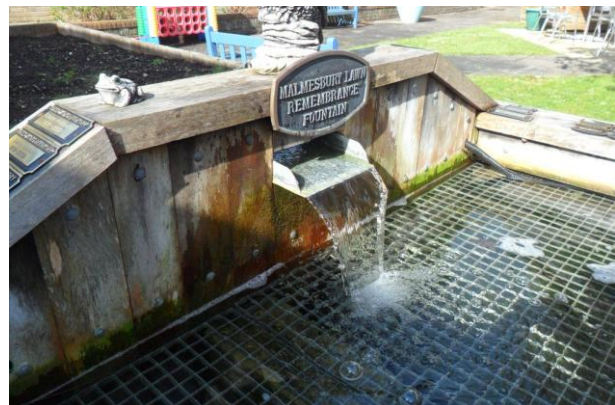
Rear Garden

The water feature / pond is creating an aerosol.

- Ensure Deputy Responsible Persons are appointed and are competent and adequately trained.
- There is a water feature / pond in the garden that is creating an aerosol. I was informed that it is dosed with a biocide but the amount and intervals are sporadic. It should be ensured that the correct and safe biocide dosage for the total volume of water is used and at the correct intervals.
