25 Upton Grey Close

## INTRODUCTION

This report relates to a **Review** of the Legionella Risk Assessment that was carried out by Freeston Water Treatment in April 2009; this is the latest Risk Assessment for this building. The Review Survey was carried out at 25 Upton Grey Close, Harestock, Winchester, Hants SO22 6NE. The Review of Recommendations highlighted in the previous Risk Assessment was undertaken in order to comply with the Health and Safety Executive requirements on the control and prevention of Legionellosis. This Review has been carried out as asked for by Hampshire County Council in accordance with ACoP L8 'The control of Legionella bacteria in water systems' (APPROVED CODE OF PRACTICE & GUIDANCE) only:

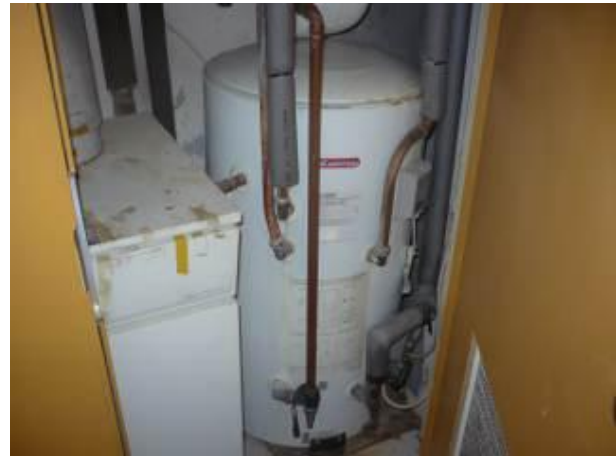
Calorifier Flow	57.0°C	This is Not Satisfactory
Calorifier Return	52.0°C	This is Satisfactory

25 Upton Grey Close domestic hot water calorifier; below recommended storage temperature of 60.0°C recorded at the time of this Review. Temperature monitoring should be carried out monthly on flow and return system.

This has not been carried out; storage temperature below 60.0°C at the time of this Review.

Hot water should be stored at 60°C at all times; I would recommend adjustment to achieve this. The hot water return temperature should be maintained at 50°C or more at all times.

It must be ensured that all hot water calorifiers in all buildings are adjusted to store hot water at 60.0°C and the return to maintain 50.0°C or more at all times.

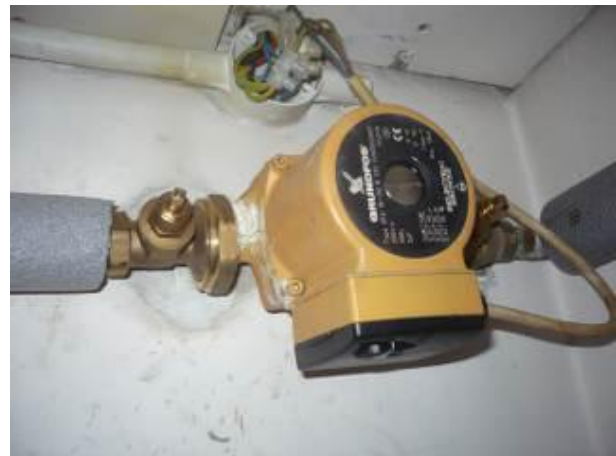
Calorifier hot water circulating / return pump; good return temperature recorded at the time of this Review. Temperature monitoring should be carried out monthly on flow and return system.

No record of this being carried out.

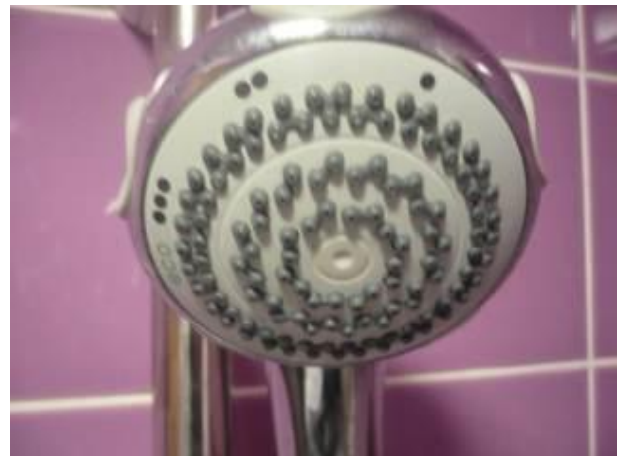
It was recommended in the original Risk Assessment that the adjustable showerheads within building 25 be replaced with new non adjustable showerheads this has not been carried out. I was informed that the procedures implemented by Hampshire County Council regarding the cleaning and disinfection and descaling are not being carried as recommended.

Showerheads have not been changed to the non adjustable type as recommended in the original Risk Assessment.

It was recommended in the last Risk Assessment that all adjustable showerheads be replaced with the non adjustable type; this has not been implemented.

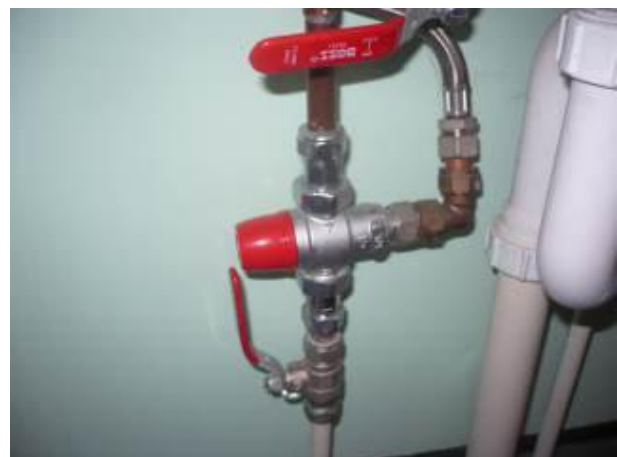
The TMV's within building 25 are being serviced and maintained by contractors EMCOR; this was last carried out in May 2011; it is assumed this is carried out annually.

Continue to service, maintain and adjust if required all TMV's; record when carried out.

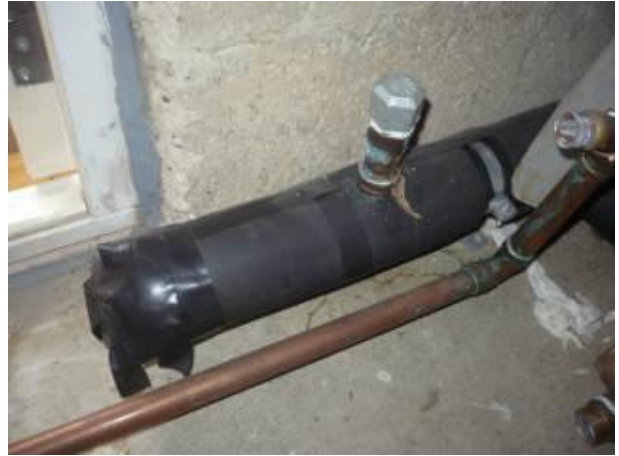
The deadleg pipe work that was highlighted in the original Risk Assessment has not been removed.

Deadleg pipe work highlighted in the original Risk Assessment in the roof void is still in place; recommend removal.

This has not been carried out; deadleg pipe work seen in roof void.

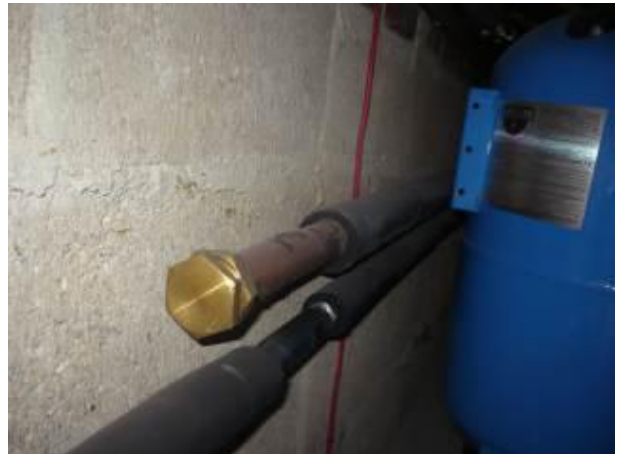
Deadleg pipe work highlighted in the original Risk Assessment in the roof void is still in place; recommend removal.

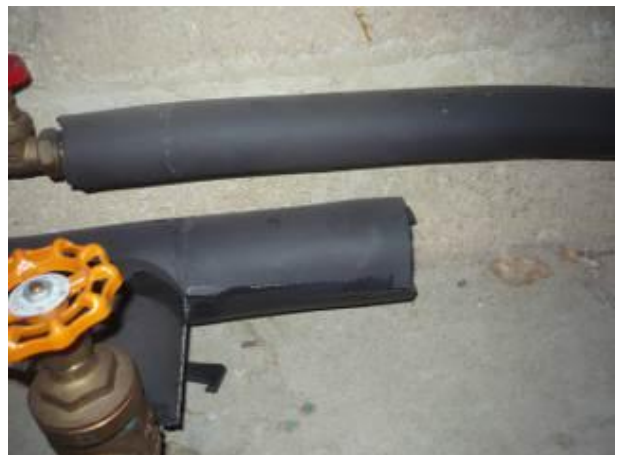
Deadleg pipe work highlighted in the original Risk Assessment in the roof void is still in place; recommend removal.
