Customer: Hampshire County Council

Site: Baycroft School
Gosport Road
Stubbington
Hampshire PO14 2AE

Date of Assessment: 3rd June 2010

INTRODUCTION

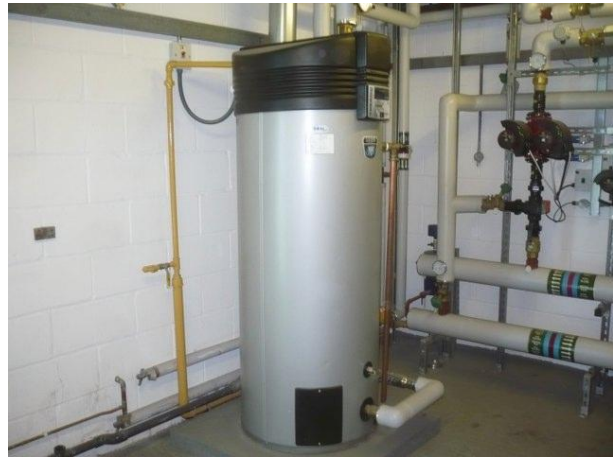
Hot water storage at Baycroft School is by one calorifier located within the main boiler room and supplies all the hot water to the main building with the exception of Room 5 and the Prep Room which both have local electric water heaters. The calorifier was manufactured by the AO Smith Products Company and is gas fired. It has fibre type insulation under a metal outer casing. There is a return system fitted to the calorifier that has a circulating pump which at the time of the survey appeared to be working correctly. The calorifier is fed from the cold water storage cisterns also located on the roof of the main building. I would recommend that the calorifier be purged to drain to check the water quality on at least a six monthly period and recorded within a water systems logbook when carried out. I was informed that it is unknown if this is being carried out as the calorifier was commissioned approximately six months ago. There is a temperature gauge on the hot flow pipe but not on the hot return pipe work. I would recommend that a temperature gauge is fitted to the return pipework for monthly temperature monitoring to be carried out.

L8 recommends that the calorifier is checked internally for scale and sludge on an annual basis. I was informed that it is unknown if this is being carried out as the calorifier was commissioned approximately six months ago.

Calorifier	Storage	63.0°C	Satisfactory
Calorifier	Return	60.4°C	Satisfactory

The hot water calorifier located within the plant room.

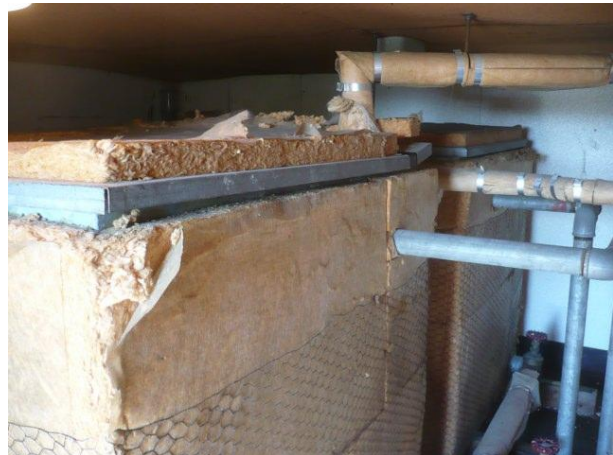
Domestic cold water storage at Baycroft School consists of two domestic cold water storage cisterns located on the roof of the main building. Domestic cold water storage Cistern No. 1 is nearest to the door and is of a galvanised steel construction with fibre sheet insulation to the body and lid. There is no vent on the lid and I would recommend that a WRAS (Water Regulations Advisory Scheme) screened vent is fitted. There is no screen fitted to the overflow and I would recommend that WRAS approved items are fitted.

As this vessel is above 1000 litre capacity it should be fitted with an overflow warning pipe with a WRAS approved screen, I would recommend that this be fitted. There is a returning vent pipe into the lid of the cistern and I would recommend that this be removed and piped to a foul drain via an air gap and the aperture in the lid be sealed with a WRAS approved material. There is a satisfactory cross flow of water through the cistern.

External view of the domestic cold water storage cisterns.

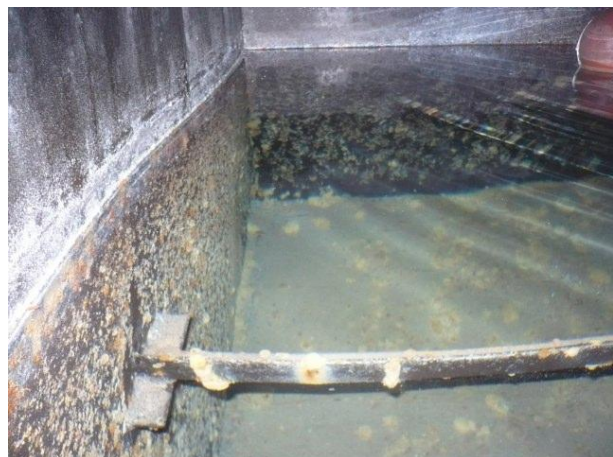
The inside of the cistern showed a heavy deposit of sediment on the base, a heavy amount of biofilm on the sides and was heavily corroded. Sediment, corrosion and biofilm act as nutrients and ideal environments for the proliferation of bacteria including Legionella. It was not known when the cistern was last cleaned and disinfected. I would recommend that the cistern be cleaned, treated with a WRAS approved coating and disinfected as soon as is practicable.

Cistern Location/ No.	Roof-Nearest to the Door/Cistern No. 1
Materials of Construction	Galvanised steel
Cistern Dimensions	1.9mtr x 1.3mtr x 1.2mtr Approximately
Lid Condition / vent fitted	Satisfactory / Not Fitted
Cistern Insulation	Satisfactory
Overflow Pipe/Insect Screen	Yes/No
Overflow Warning Pipe/Insect Screen	No/No
Isolation Valves Fitted Inlet /Outlets	Yes/Yes
Cross Flow of Water	Satisfactory
Internal Condition of Cistern	Heavy sediment, heavy biofilm and heavy corrosion
Water Temperature	14.7°C Satisfactory
Cistern linked/Single	Single
Drain Fitted	No
Any Returning Vent Pipes	One
Notes	<p>Clean, treat with a WRAS approved coating and disinfect as soon as is practicable and repeat disinfection annually if deemed necessary.</p> <p>Fit WRAS approved screened lid vent.</p> <p>Fit overflow warning pipe.</p> <p>Fit WRAS approved screens to the overflow and overflow warning pipes.</p> <p>Remove the returning vent pipe and re-route to a foul drain via an air gap. Cover the hole in the lid with a WRAS approved material.</p>

An internal view of the domestic cold water storage Cistern No 1.

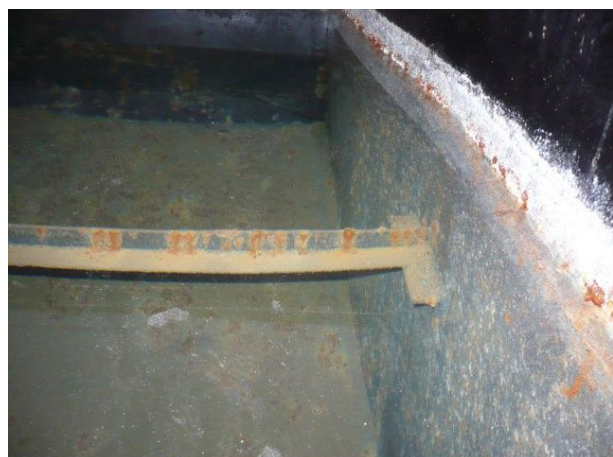
Domestic cold water storage Cistern No. 2 is furthest from the door and is of a galvanised steel construction with fibre sheet insulation to the body and lid. There is no vent on the lid and I would recommend that a WRAS (Water Regulations Advisory Scheme) screened vent is fitted. There is no screen fitted to the overflow and I would recommend that WRAS approved items are fitted.

As this vessel is above 1000 litre capacity it should be fitted with an overflow warning pipe with a WRAS approved screen, I would recommend that this be fitted. There is a satisfactory cross flow of water through the cistern. The inside of the cistern showed a heavy deposit of sediment on the base, a heavy amount of biofilm on the sides and was heavily corroded. Sediment, corrosion and biofilm act as nutrients and ideal environments for the proliferation of bacteria including Legionella.

Cistern Location/ No.	Roof-furthest from the door/Cistern No. 2
Materials of Construction	Galvanised steel
Cistern Dimensions	1.9mtr x 1.3mtr x 1.2mtr Approximately
Lid Condition / vent fitted	Satisfactory/ Not Fitted
Cistern Insulation	Satisfactory
Overflow Pipe/Insect Screen	Yes/No
Overflow Warning Pipe/Insect Screen	No/No
Isolation Valves Fitted Inlet /Outlets	Yes/Yes
Cross Flow of Water	Satisfactory
Internal Condition of Cistern	Heavy sediment, heavy biofilm and heavy corrosion
Water Temperature	16.6°C Satisfactory
Cistern linked/Single	Single
Drain Fitted	No
Any Returning Vent Pipes	No
Notes	<p>Clean and treat with a WRAS approved coating and disinfect as soon as is practicable. Repeat disinfection annually if deemed necessary.</p> <p>Fit WRAS approved screened lid vent.</p> <p>Fit overflow warning pipe.</p> <p>Fit WRAS approved screens to the overflow and overflow warning pipes.</p>

An internal view of the domestic cold water storage Cistern No. 2.

It was not known when the cistern was last cleaned and disinfected. I would recommend that the cistern be cleaned and treated with a WRAS approved coating and disinfected as soon as is practicable.

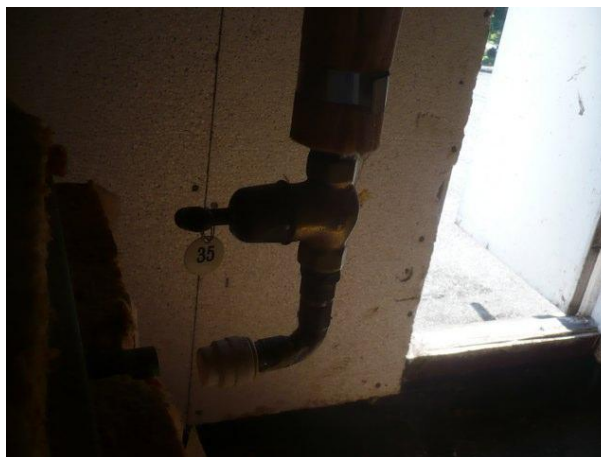
Roof

Dead legs were found on the roof, on the mains pipe that used to connect to the now redundant heating boilers F&E tank.

Dead leg on mains cold water pipe.

Site Reference/ Address	Remedial/Recommendations	Priority	Date Actioned	Signature
<u>Distribution</u> HCC Baycroft School	Remove dead leg pipe work or put on a weekly flushing regime and record in the logbook when carried out.	5		
	I would recommend Bacteriological and Legionella water samples be taken if the temperatures fall out of the recommended limits.	5		
	Commence weekly flushing of any low use outlets etc and record when carried out.	5		
	Clean and descale showerhead and hose at least quarterly. Record when carried out.	3		
	Ensure all domestic hot and cold pipe work is insulated within the building.	2		
	Clean / replace the inline scale reducer on the calorifier in-line with the manufacturer's recommendations.	3		
	Service and maintain blender taps and TMV's in-line with the manufacturers' recommendations.	4

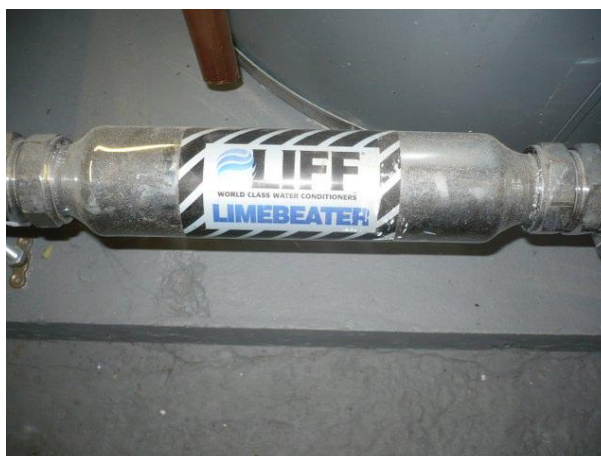
Plant Room

Scale reducing unit
