Client Address	Hampshire County Council PBRS Three Minsters House 76 High Street Winchester Hampshire SO23 8UL
Site Name	Bickerley Green OPH
Site Address	Kingsbury Lane Ringwood Hampshire BH24 1EL
Site contact	Jacque Milford
Site telephone number	01425 473312
Last risk assessment carried out by	Freeston Water Treatment Limited
Date of risk assessment	April 2011
Date of previous review	N/A
Date of new review	4th April 2012
Review carried out by	Mr Chris Wilson

This Review has been carried out in accordance with ACoP L8 'The control of Legionella bacteria in water systems' (APPROVED CODE OF PRACTICE & GUIDANCE) and BS 8580 (RISK ASSESSMENTS FOR LEGIONELLA CONTROL-CODE OF PRACTICE).

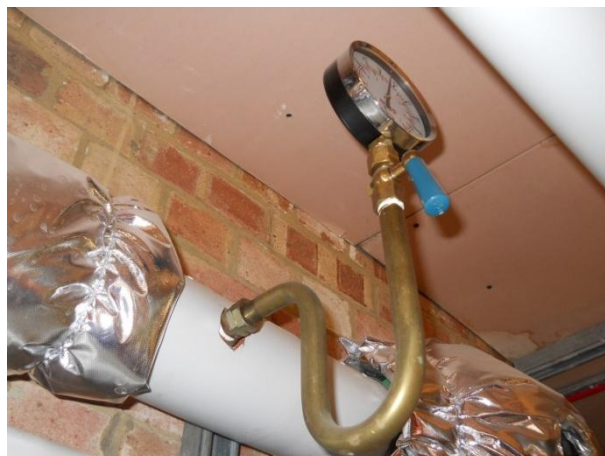
Boiler Room

Dead leg on the mains cold water pipe.

- Boiler room – There is a swan neck type dead leg pipe to the temperature gauge on the mains cold water pipe at height.
 - Boiler room - There is a swan neck type dead leg pipe to the temperature gauge on the flow pipe of calorifier no. 1. The pipe that it is on is to the pressure relief valve; this pipe is too long and also creating a dead leg and should be shortened as far as possible.

- Dead leg pipework are ideal areas for the proliferation of bacteria and should be removed or put on a weekly flushing regime (without creating an aerosol) and recorded. Dead legs were found in the following areas:-

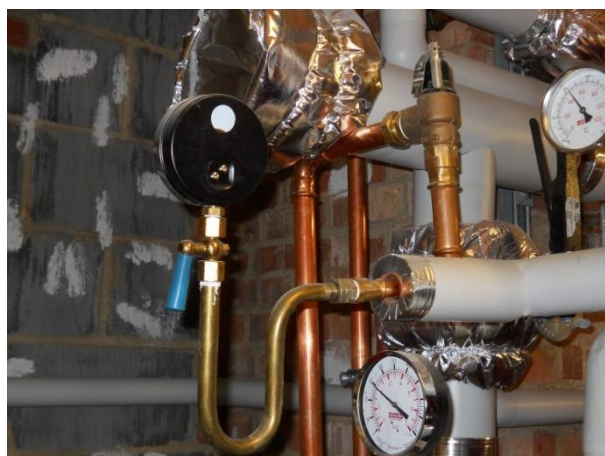
Boiler Room

Dead legs on the flow pipe of calorifier no. 1.

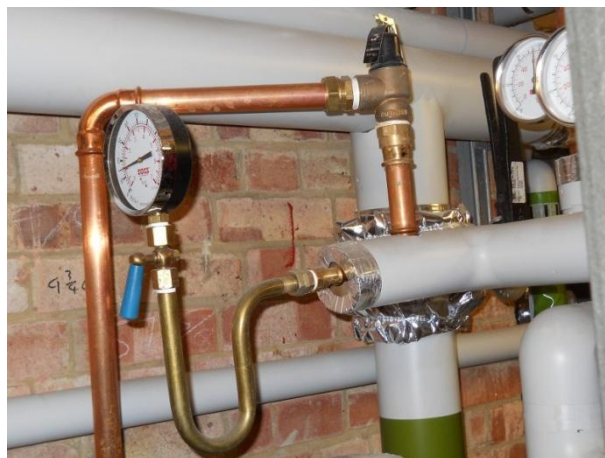
Boiler Room

Dead legs on the flow pipe of calorifier no. 2.

- Boiler room - There is a swan neck type dead leg pipe to the temperature gauge on the flow pipe of calorifier no. 2. The pipe that it is on is to the pressure relief valve; this pipe is too long and also creating a dead leg and should be shortened as far as possible.

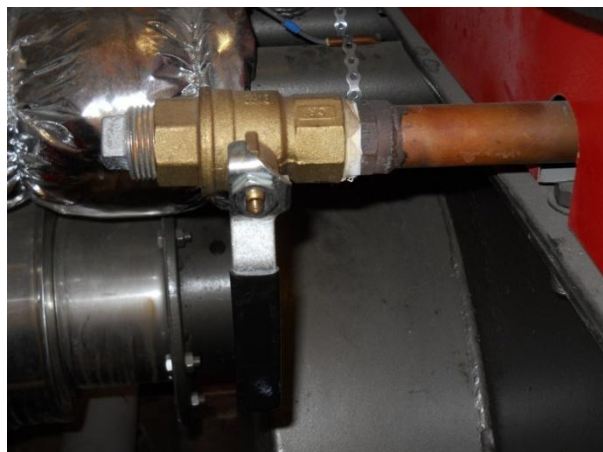
Boiler Room

Possible dead leg on the drain of calorifier no.
1.

- Boiler room - There is a drain valve on both combi boiler/calorifiers at mid height. If this is found to be a drain for the domestic hot water side of the boiler/calorifier then it should be treated as stated above. If it is on the heating boiler side of the boiler / calorifier then it can remain unchanged as the heating system is a 'closed system' and does not create an aerosol and is therefore not a Legionella risk in normal operation.

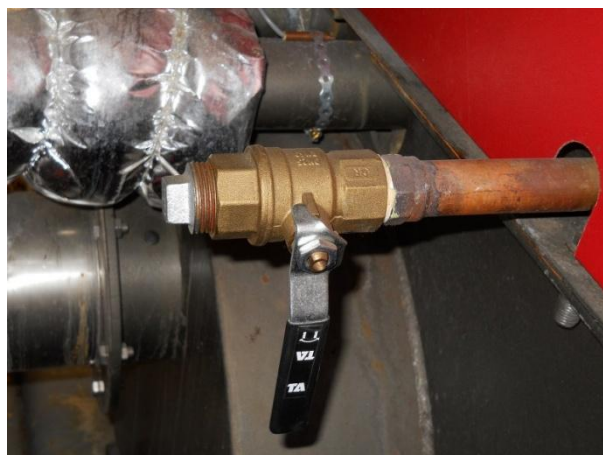
Boiler Room

Possible dead leg on the drain of calorifier no.
2.

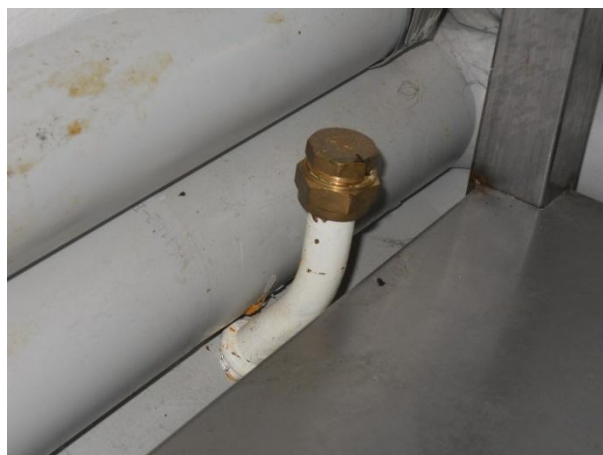
Main Kitchen

Dead leg at low level under the electric water
boiler.

- Main kitchen - There is a dead leg pipe at low level under the electric water boiler.
 - Laundry - There are two dead legs behind the washing machines.

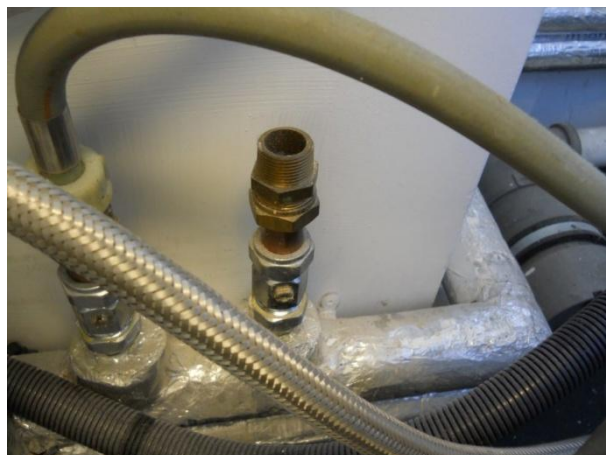
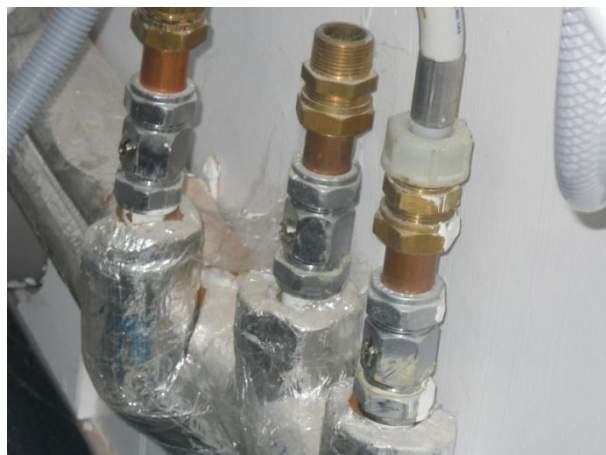
Laundry

Dead leg behind the washing machines.
