Client Address	Hampshire County Council PBRS Three Minsters House 76 High Street Winchester Hampshire SO23 8UL
Site Name	Fleming House OPH
Site Address	Heron Square Eastleigh Hampshire SO50 9JD
Site contact	Wendy Burrett
Site telephone number	02380 626640
Last risk assessment carried out by	Freeston Water Treatment Limited
Date of risk assessment	April 2011
Date of previous review	N/A
Date of new review	22nd March 2012
Review carried out by	Mr Chris Wilson

This Review has been carried out in accordance with ACoP L8 'The control of Legionella bacteria in water systems' (APPROVED CODE OF PRACTICE & GUIDANCE) and BS 8580 (RISK ASSESSMENTS FOR LEGIONELLA CONTROL-CODE OF PRACTICE).

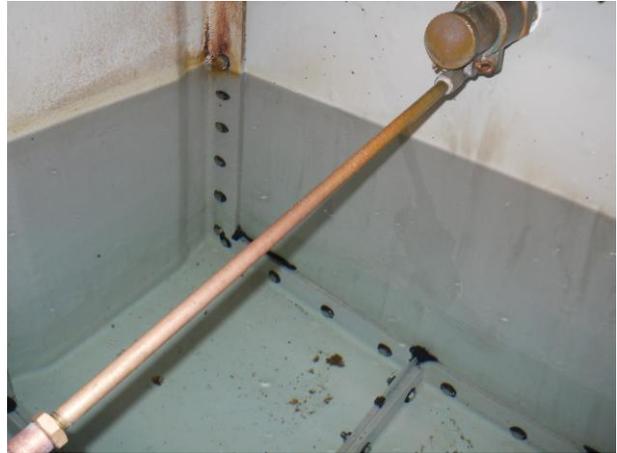
The domestic cold water storage tank is of a double skinned GRP construction and is in good condition. There is a screened vent on the lid and a screen on the overflow pipe. This vessel is over 1000 litres in capacity and should therefore have an overflow warning pipe fitted, this should have a WRAS (Water Regulations Advisory Scheme) approved insect screen fitted.

This vessel has integral insulation to the body and lid but the lid hatch is single skinned and not insulated, I would recommend that this be insulated if water temperature becomes elevated to near 20°C in the hotter months.

The inside of the tank showed a light deposit of sediment on the base, a medium amount of biofilm on the sides and heavy staining from a sealant on the stainless steel bolts. Sediment, corrosion and biofilm act as nutrients and an ideal environment for the proliferation of bacteria including legionella.

Internal view of cold water storage tank no. 1.

This tank was last cleaned and disinfected on 25th May 2011 I recommend that this be carried out again within the near future.

- Clean and disinfect the domestic cold water storage tank within the near future. Inspect the tank annually and repeat if required.
- Fit a screened overflow warning pipe to the domestic cold water storage tank.

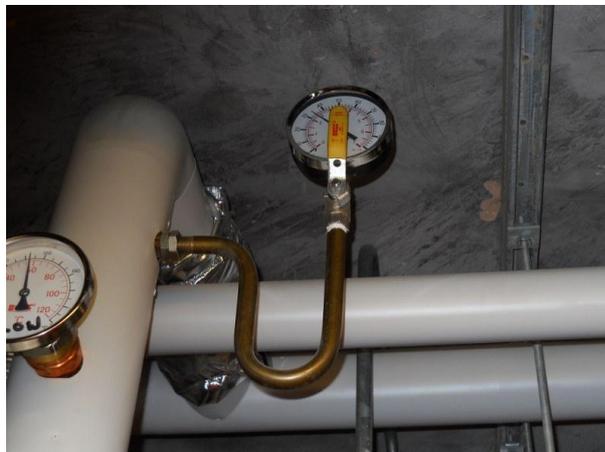
Dead leg on the flow pipe of calorifier no. 1.

- Boiler Room - There is a pig tail type dead leg pipe to the gauge on the flow pipe of calorifier no. 1.
 - Boiler Room - There is a pig tail type dead leg pipe to the gauge on the flow pipe of calorifier no. 2.

- Dead leg pipework are ideal areas for the proliferation of bacteria and should be removed or put on a weekly flushing regime (without creating an aerosol) and recorded. Dead legs were found in the following areas:-

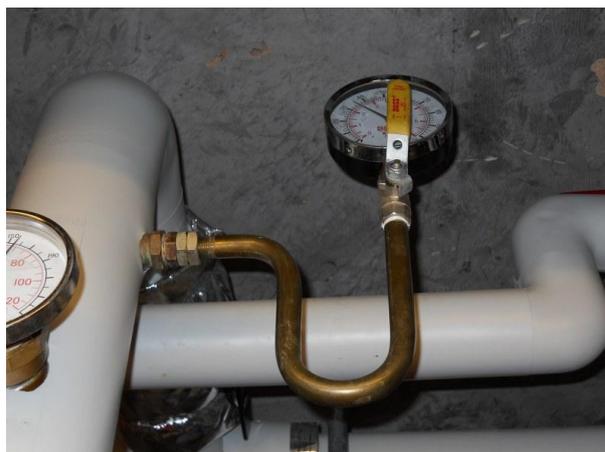
Boiler Room

Dead leg on the flow pipe of calorifier no. 2.

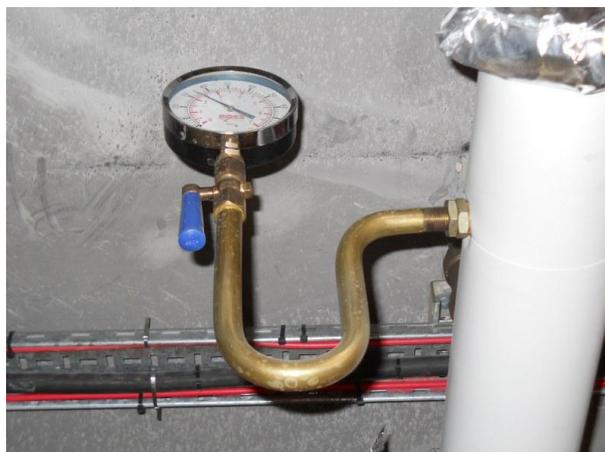
Dead leg on the common return pipe of calorifiers.

- Boiler Room - There is a pig tail type dead leg pipe to the gauge on the common return pipe of the calorifiers.
- Purge the calorifier to drain on at least an annual basis and record when carried out.
