Site: Merrydale Respite Care Centre
Church Lane
Kings Worthy
Winchester
Hampshire SO23 7QS

Date of Assessment: 17th March 2011

This report relates to a water source Risk Assessment carried out by Mr Chris Wilson of Freeston Water Treatment Ltd on the 31st March 2011 on behalf of Hampshire County Council. The Survey was carried out at Merrydale Respite Care Centre, Church Lane, Kings Worthy, Winchester, Hampshire SO23 7QS. During the course of the Survey water systems within the properties were risk assessed. These sources were chosen as being fully representative of the overall domestic water systems and outlets within the buildings.

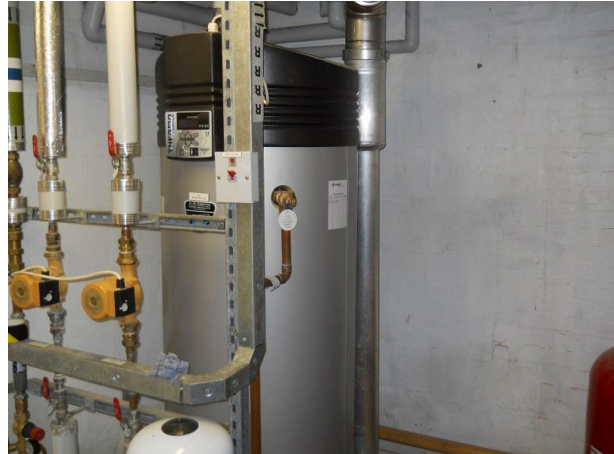
Boiler Room

Hot water storage at Merrydale Respite Care Centre is by one calorifier located within the Boiler Room. The calorifier was manufactured by AO Smith Water Products Company and is supplied by the mains cold water supply via a pressure reducer. The calorifier has insulation under the factory fitted metal outer casing, is of a steel construction and is directly heated by gas. There is a return system fitted to the calorifier which has a circulation pump that at the time of the Survey appeared to be working correctly. There is an anti-stratification pump fitted to the calorifier which again at the time of the Survey appeared to be working correctly.

There is a digital temperature gauge on the unit to show the storage temperature but no gauge on the return pipe on this unit and I would recommend that one be fitted to allow monthly temperature monitoring to be carried out.

Calorifier	Storage	63.0°C	Satisfactory
Calorifier	Return	53.7°C	Satisfactory

Calorifier.

I would recommend that the calorifier be purged to drain to check the water quality on at least a six monthly period and recorded within a water systems logbook when carried out. I was informed that this is not being carried out.

L8 recommends that calorifiers are checked internally for scale and sludge on an annual basis. It is unknown if this is being carried out.

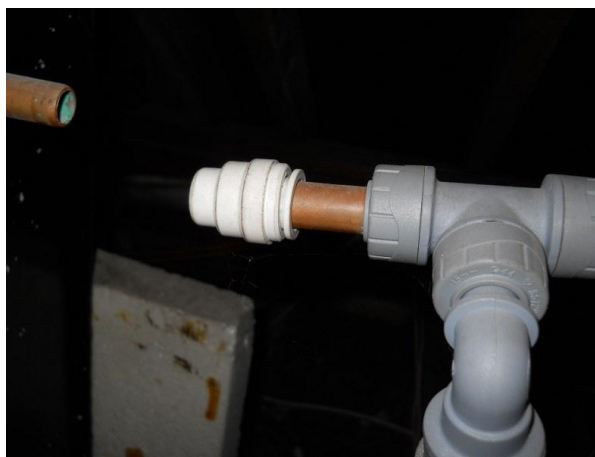
- Dead leg pipework are ideal areas for the proliferation of bacteria and should be removed or put on a weekly flushing regime (without creating an aerosol) and recorded. Dead legs were found in the following areas:-
 - Boiler Room - There is a drain on the mains cold water pipe that is too long and should be shortened.
 - House 4 Roof Space - There is a capped mains cold water pipe that used to feed the heating boilers feed and expansion tank that should be removed.
 - House 4 Laundry – There is a short pipe protruding through the ceiling which could be a dead leg on the domestic water system.

Dead leg on the mains cold water pipe.

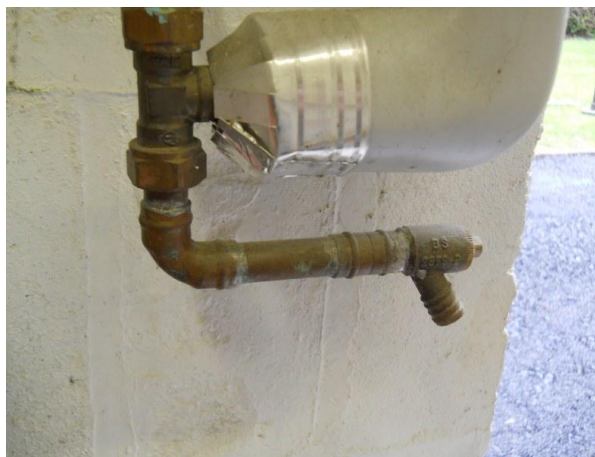
Boiler Room

Mains cold water pipe drain is too long creating a dead leg.

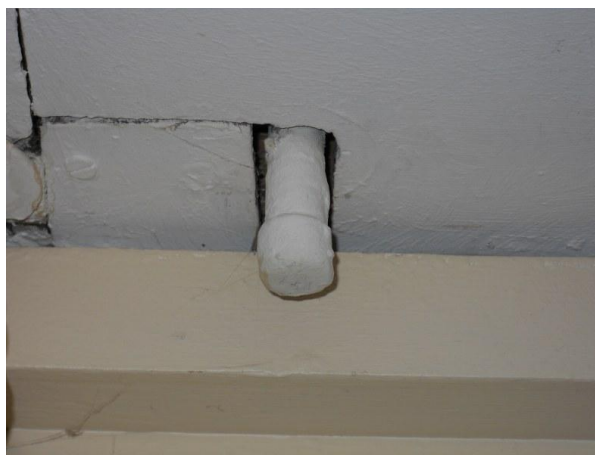
Laundry

Possible domestic water system dead leg.

Site Reference/ Address	Remedial/Recommendations	Priority	Date Actioned	Signature
<u>Distribution</u> HCC Merrydale Respite Care Centre	Investigate possible dead leg in the Laundry. If found to be a dead leg on the domestic water system then remove and record in the logbook when carried out.	5		
	I would recommend Bacteriological and Legionella water samples be taken if the temperatures fall out of the recommended limits.	5		
	Commence weekly flushing of all low use outlets, toilets, showers, outside taps etc and record when carried out.	5		
	Clean and descale showerheads quarterly, or as necessary. Record when carried out.	2		
	Ensure that the inline anti-scale device is cleaned / maintained in line with the manufacturers recommendations.	4		
	Clean, maintain and dose the bubble tube with a safe biocide inline with the manufacturers recommendations.	4

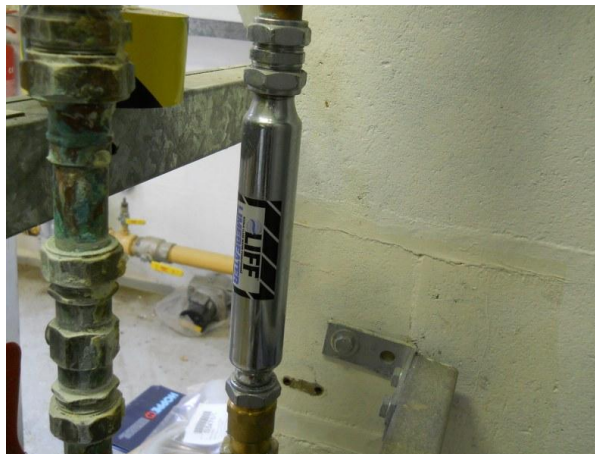
Boiler Room

- There is an inline anti-scale device on the mains cold water pipe within the Boiler Room. This should be maintained in line with the manufacturers recommendations. It is unknown if this is being carried out.

Anti scale device on the mains cold water pipe.

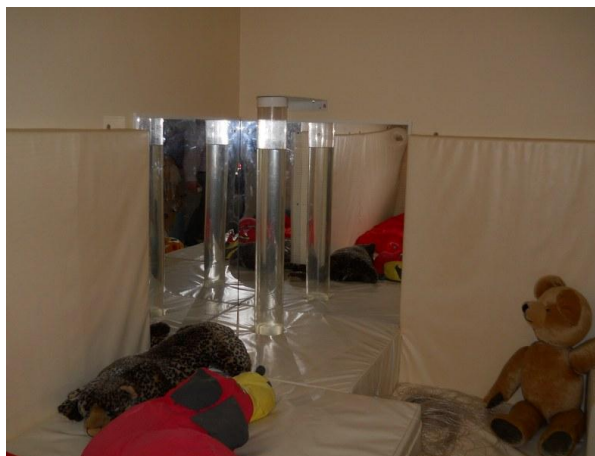
- The bubble tube within the Sensory Room should be dosed with an appropriate and safe biocide, cleaned and maintained in line with manufacturer's recommendations. I was informed that it is not known if this is being carried out.

Bubble tube.
