<b>Client Address</b>	<b>Hampshire County Council PBRs Three Minsters House 76 High Street Winchester Hampshire SO23 8UL</b>
<b>Site Name</b>	<b>Nightingale Lodge OPH</b>
<b>Site Address</b>	<b>Greatwell Drive Romsey Hampshire SO51 7QN</b>
<b>Site contact</b>	<b>Tracy Flint</b>
<b>Site telephone number</b>	<b>01794 512138</b>
<b>Last risk assessment carried out by</b>	<b>Freeston Water Treatment Limited</b>
<b>Date of risk assessment</b>	<b>April 2011</b>
<b>Date of previous review</b>	<b>N/A</b>
<b>Date of new review</b>	<b>20<sup>th</sup> March 2012</b>
<b>Review carried out by</b>	<b>Mr Chris Wilson</b>

This Review has been carried out in accordance with ACoP L8 'The control of Legionella bacteria in water systems' (APPROVED CODE OF PRACTICE & GUIDANCE) and BS 8580 (RISK ASSESSMENTS FOR LEGIONELLA CONTROL-CODE OF PRACTICE).

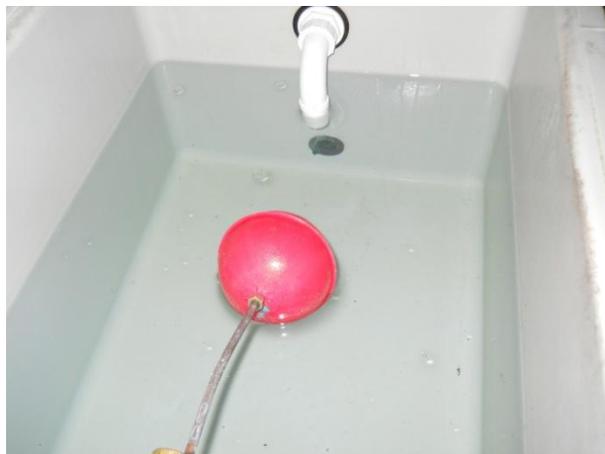
Tank no. 1 is of a double skinned GRP construction and is in good condition. There is a screened vent on the lid and a screen on the overflow pipe. This vessel is less than 1000 litres in capacity and therefore does not need an overflow warning pipe.

The inside of the tank showed no sediment on the base and no biofilm on the sides.

Internal view of cold water storage tank no. 1.

The tank was last cleaned and disinfected by Freeston Water Treatment Limited on the 24<sup>th</sup> May 2011. This vessel does not need cleaning and disinfecting and should be inspected again in 12 months.

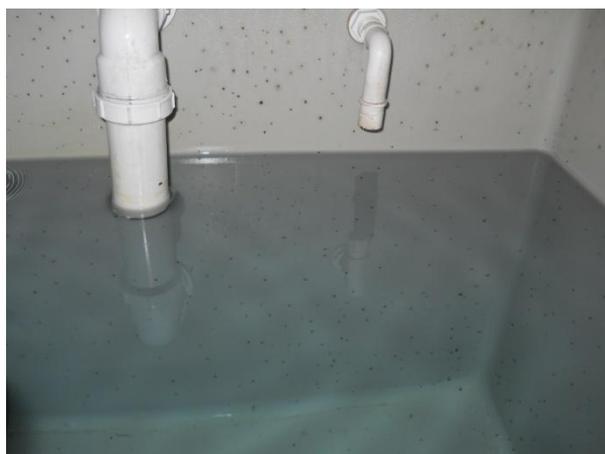
The inside of the tank showed no sediment on the base and a medium amount of biofilm / staining on the sides.

Internal view of cold water storage tank no. 2.

The tank was last cleaned and disinfected by Freeston Water Treatment Limited on the 24<sup>th</sup> May 2011 and I would recommend that this be repeated within the near future.

- Clean and disinfect the domestic cold water storage tanks within the near future. Inspect all three tanks annually and repeat if required.
- Fit extra insulation to the lids of cold water storage tank no. 2 and no. 3 if needed in hotter months.

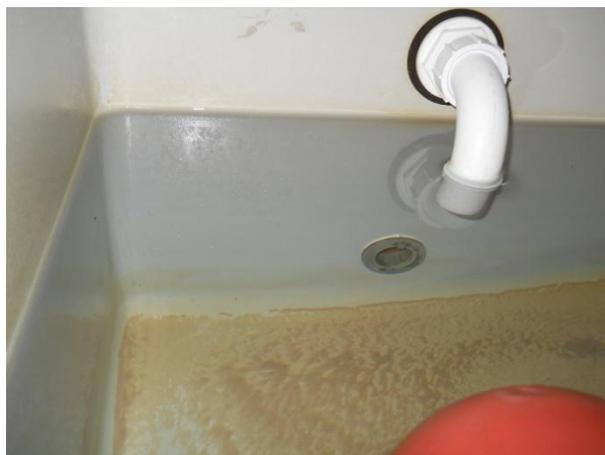
The inside of the tank showed a heavy deposit of sediment on the base and a slight amount of biofilm on the sides.

Internal view of cold water storage tank no. 3.

The tank was last cleaned and disinfected by Freeston Water Treatment Limited on the 24<sup>th</sup> May 2011 and I would recommend that this be repeated within the near future.

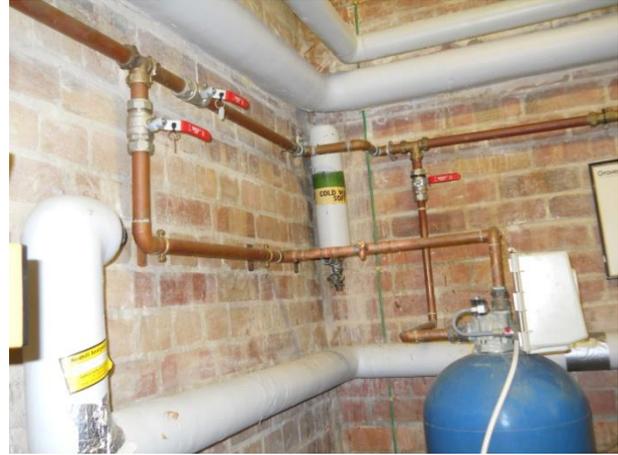
### Boiler Room

Dead legs either side of the closed valves on the water softener pipes.

- Boiler Room – The water softener pipe has two valves that are closed and this is creating dead legs either side of them.
  - Boiler Room - There are two dead legs on the top of both calorifiers.

- The water softener in the boiler room has been taken out of service. This is creating a dead leg area and should be completely removed and the bypass pipe be piped through or the water softener be disinfected, serviced and brought back into service. If the water softener is brought back into service then the bypass valve should be open at least weekly to eliminate dead legs either side of it and this be recorded within the logbook when carried out.

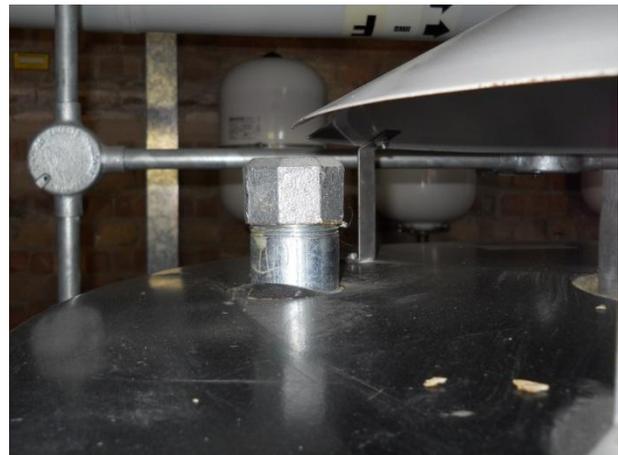
### Boiler Room

Typical example of one of the four dead legs on top of the calorifiers.

- Dead leg pipework are ideal areas for the proliferation of bacteria and should be removed or put on a weekly flushing regime (without creating an aerosol) and recorded. Dead legs were found in the following areas:-

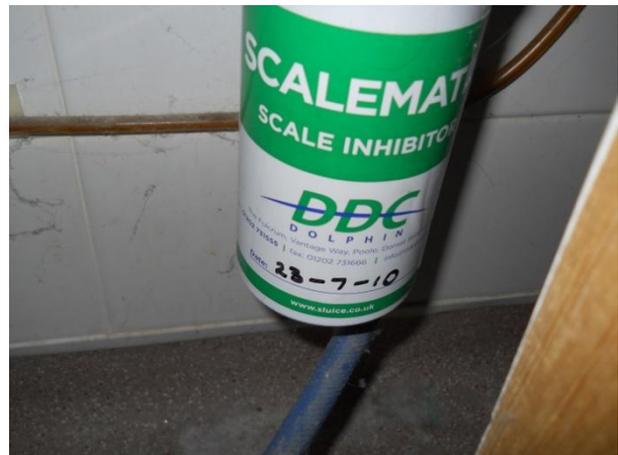
### A Wing Sluice Room

Inline scale reducing unit.

- I would recommend that the TMV's (Thermostatic Mixing Valves) are serviced, adjusted and maintained in line with the manufacturer's recommendations.
- There is an inline scale reducing cartridge on the pot wash machines in the sluice rooms. These should be replaced /cleaned / maintained in line with the manufacturer's recommendations. It is not thought that this is being carried out.
