Highfield House

This report relates to a **Review** of the Legionella Risk Assessment that was carried out by Freeston Water Treatment in April 2009; this is the latest Risk Assessment for this building. The Review Survey was carried out at Highfield House, 118 Church Road, Bishopstoke, Eastleigh, Hampshire SO50 6DR. The Review of Recommendations highlighted in the previous Risk Assessment was undertaken in order to comply with the Health and Safety Executive requirements on the control and prevention of Legionellosis. This Review has been carried out as asked for by Hampshire County Council in accordance with ACoP L8 'The control of Legionella bacteria in water systems' (APPROVED CODE OF PRACTICE & GUIDANCE) only:

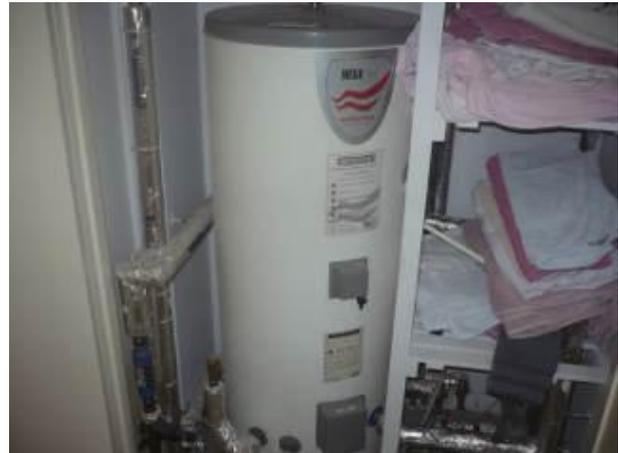
<b>Calorifier Flow</b>	<b>63.0°C</b>	<b>This is Satisfactory</b>
<b>Calorifier Return</b>	<b>56.0°C</b>	<b>This is Satisfactory</b>

Megaflow hot water calorifier serving all hot water outlets within Highfield House; good storage and return temperatures at the time of this Review.

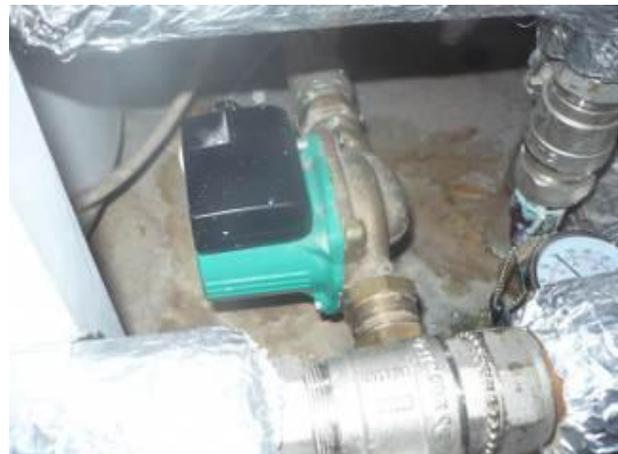
Calorifier circulating/ return pump good return temperature at time of Review; pump is checked monthly to ensure correct operation and recorded when carried out.

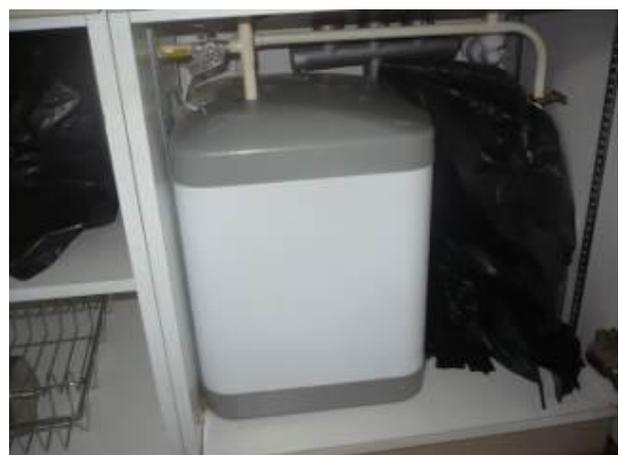
Local water heater located in the ground floor kitchen serving kitchen area only.

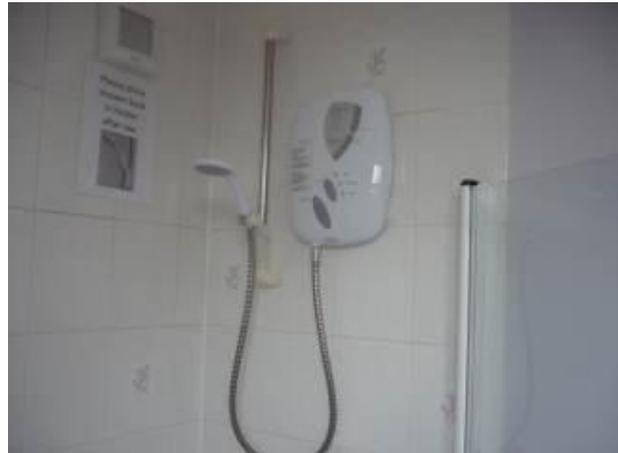
There are showers within Highfield House; most showers are fitted with non-adjustable showerheads as recommended in the last Risk Assessment; there is one shower attached to the Arjo bath that is still adjustable. The procedures implemented by Hampshire County Council regarding the cleaning and disinfection and descaling are being carried out and are up to date.

Ensure all showers are used and continue with current cleaning and descale regime that has been implemented.

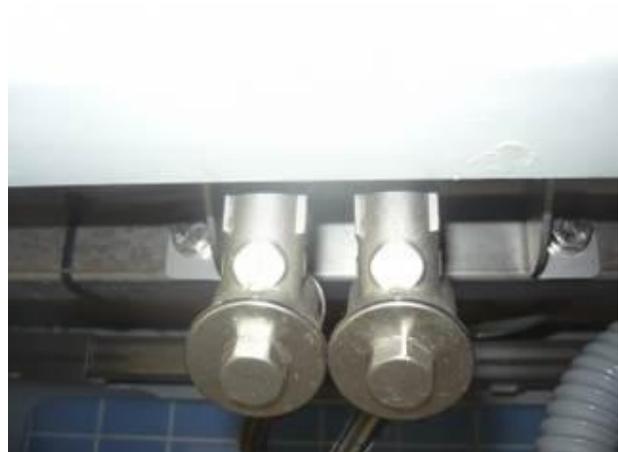
There are inline strainers fitted on the water supplies to the Arjo bath; these should be cleaned on a regular basis as they are ideal areas for bacteria proliferation.

Ensure inline strainers fitted on the water supplies to the Arjo bath are cleaned on a regular basis; as they are ideal areas for bacteria proliferation.

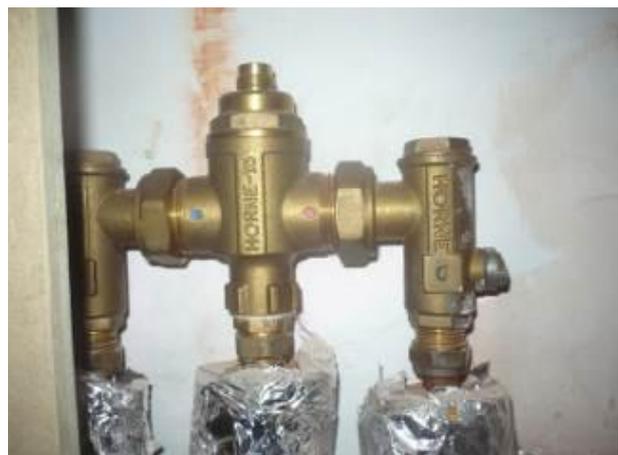
The TMV's within Highfield House are being serviced and maintained by contractors Carillion; this is assumed being carried out on a six monthly basis. All maintenance records for the TMV's are being filed in a separate folder from the water systems logbook. The TMV's are adjusted to meet the correct water temperatures by contractors during servicing and maintenance; this was last carried out in April 2011.

Continue to service, maintain and adjust if required all TMV's on a six monthly basis; record when carried out.
