**Meadowcroft**

## INTRODUCTION

This report relates to a **Second Review** of the Legionella Risk Assessment that was carried out by Freeston Water Treatment in February 2008; this is the latest Risk Assessment for this building. The Review Survey was carried out at Meadowcroft, Whitchurch Close, Aldershot Hampshire GU11 3RU. The Review of Recommendations highlighted in the previous Risk Assessment Review was undertaken in order to comply with the Health and Safety Executive requirements on the control and prevention of Legionellosis. This Review has been carried out as asked for by Hampshire County Council in accordance with ACoP L8 'The control of Legionella bacteria in water systems' (APPROVED CODE OF PRACTICE & GUIDANCE) only:

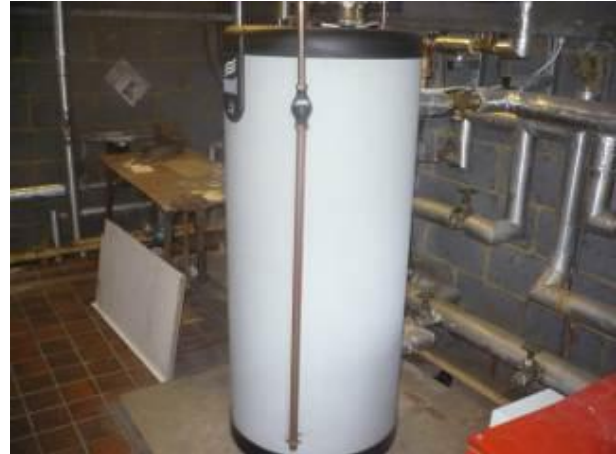
Calorifier Flow	69.5°C	This is Satisfactory
Calorifier Return	66.0°C	This is Satisfactory

Hot water calorifier located within the boiler room; good storage temperature at the time of this Review.

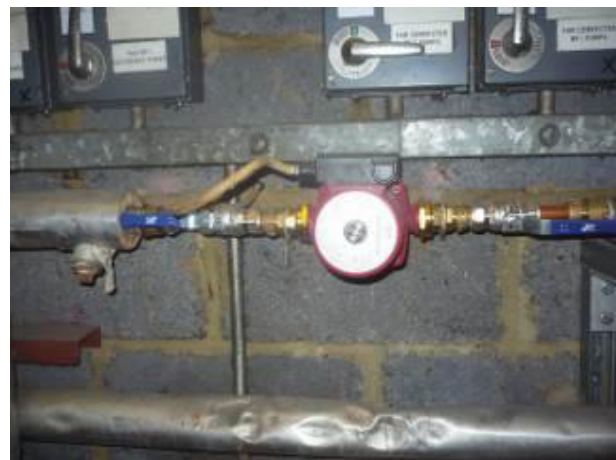
Calorifier hot water circulating / return pump; good return temperature recorded at the time of this Review.

**Manually check circulating pump monthly to ensure effective operation.**

No record of this being carried out.

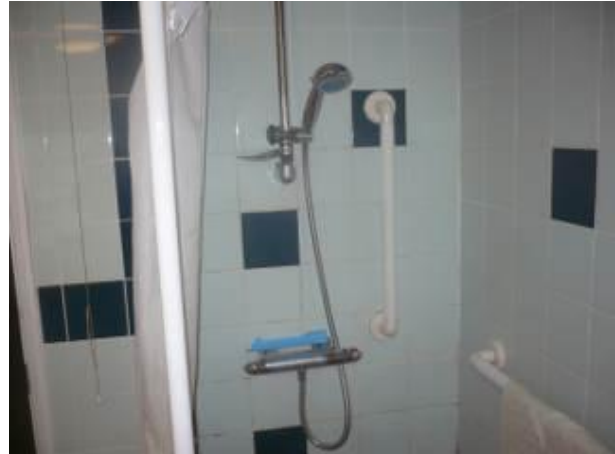
Ensure all showers are used and continue with current cleaning and descale regime that has been implemented. Ensure this is carried out and maintained up to date.

Showerheads are being cleaned and disinfected but is being carried out sporadically; it should be ensured it is carried out as recommended by Hampshire County Council or at least on a quarterly basis or as required; record when carried out.

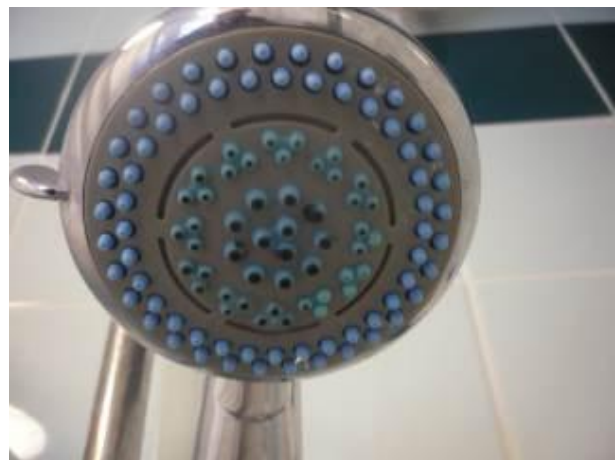
There are several showers within Meadowcroft; it was recommended in the last Risk Assessment Review that the adjustable showerheads be replaced with new non adjustable showerheads, this has not been carried out. The procedures implemented by Hampshire County Council regarding the cleaning and disinfection and descaling are being carried out sporadically; it should be ensured this is carried out as recommended or at least on a quarterly basis.

Ensure all showerheads are changed to the non adjustable type as recommended in the original Assessment and last Review.

This has not been carried out.

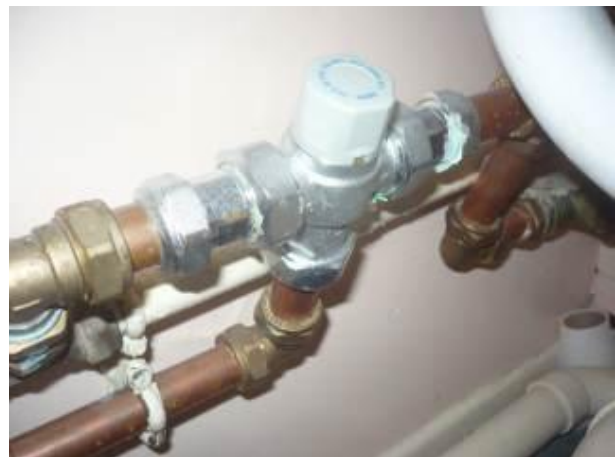
The TMV's within Meadowcroft are being serviced and maintained by contractors KIER; this is being carried out on a six monthly basis. The TMV's within Meadowcroft are adjusted to meet the correct water temperatures by contractors during servicing and maintenance; this was last carried out in March 2011.

Continue to service, maintain and adjust if required all TMV's on a six monthly basis; record when carried out.

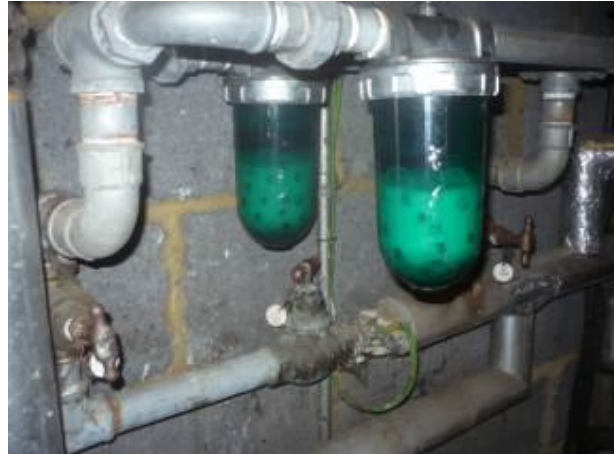
It was recommended in the last Review that the inline filters on the mains water service within the boiler room be changed on a regular basis; I was informed that these filters have recently been changed. The by-pass around these filters is shut off creating deadleg pipe work; I would recommend the by-pass is opened at least on a weekly basis to flush through the deadleg pipe work.

Inline filters in boiler room have recently been changed. Ensure by-pass around filters is opened and flushed on a weekly basis as it is deadleg pipe work; ideal areas for bacteria proliferation.
