**Site: Chatham Maritime Marina
The Lock Building
Leviathan Way
Chatham Maritime
Chatham
Medway ME4 4LP**

Risk Assessment Consultant: Mr Chris Wilson MWM Society

Date of Assessment: 11th December 2013

Date of Review: December 2015

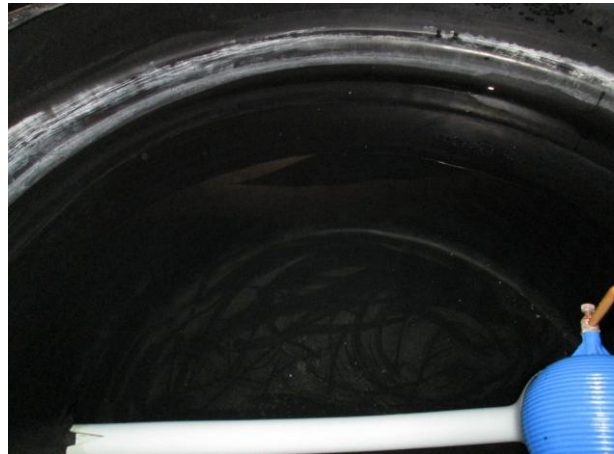
Marina Office Roof Space

There are two domestic cold water storage tanks on this site one located within the roof space of the Marina office and one located within the plant room of the facilities block. Upon inspection of the Marina office domestic cold water storage tank this was found to be a round plastic tank insulated with a poly fibre jacket. The storage tank is fitted with a good lid which has a screened lid vent fitted to it and the overflow pipework is now fitted with an insect screen.

There is good crossflow of water through this vessel as a sparge pipe has been fitted to the outlet pipe. There is a light build up of sediment on the base and a slight amount of biofilm on the sides. Sediment and biofilm act as a nutrient to bacteria and can therefore aid its proliferation.

10.2°C Satisfactory

Internal view of the domestic cold water storage tank.

This storage tank only serves one wash basin and a toilet; I would consider removing this storage tank and plumbing the wash basin and toilet into the existing water mains to remove the stored water.

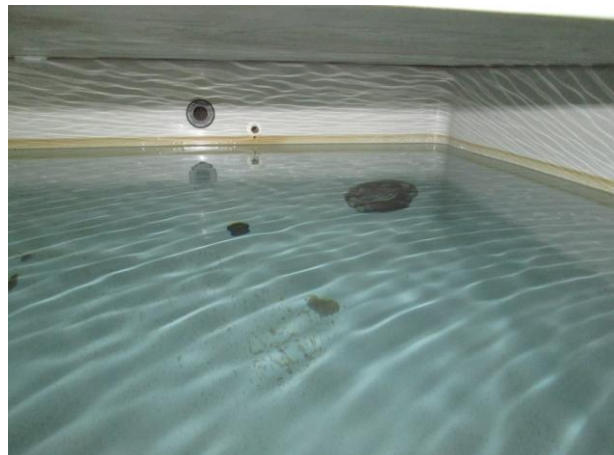
Facilities Block Plant Room

The Facilities Block domestic cold water storage tank is of a double skinned GRP construction with integral insulation. The tank has a good fitting lid which is fitted with a screened vent; the overflow pipe work is also fitted with an insect screen.

The inlet and outlet are fully opposed therefore there is a good cross flow of water through this tank.

There is a slight build up of sediment on the base and a medium amount of biofilm on the sides. Sediment and biofilm act as a nutrient to bacteria and can therefore aid its proliferation.

10.4°C Satisfactory

Internal view of the domestic cold water storage tank.

ACoP L8 recommends storage tanks to be inspected annually and cleaned and disinfected if required. This vessel was last cleaned and disinfected in March 2013 and I would recommend that this is carried out again within the near future.

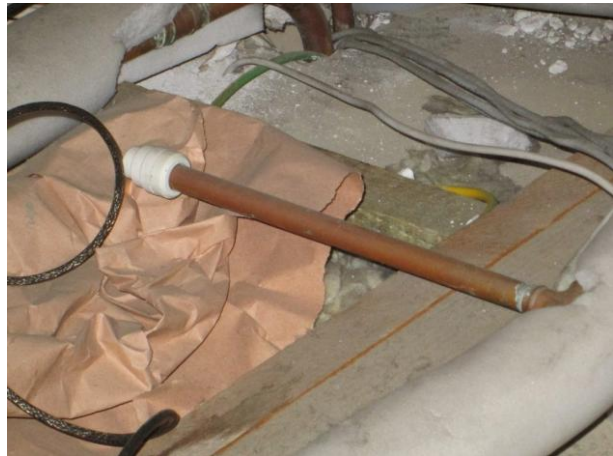
Marina Office Roof Space

Dead leg pipe on the mains cold water pipe to the inlet of the domestic cold water storage tank.

Remove all dead leg pipe work or put on a weekly flushing regime without creating an aerosol, record when carried out.
