Customer: Marina Developments Limited

Site: Hythe Marina Village
Shamrock Way
Hythe
Southampton
Hampshire S045 6DY

Risk Assessment Consultant: Mr Chris Wilson MWM Society

Date of Review: 23rd January 2013

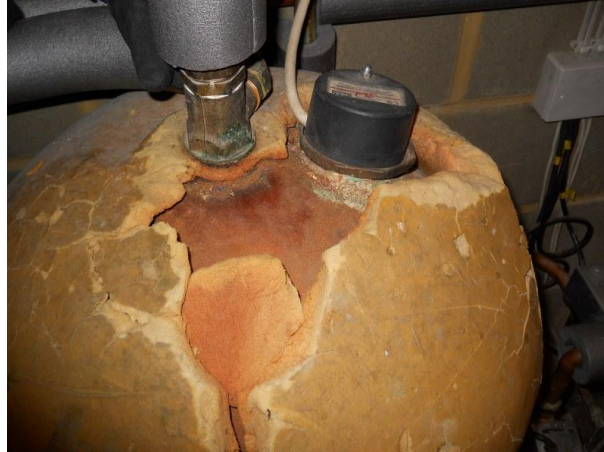
Insulation damage on hot water cylinder calorifiers. Cylinder No 7.

Add poly fibre jackets to hot water storage cylinders where needed to prevent heat loss where insulation has been worn away.

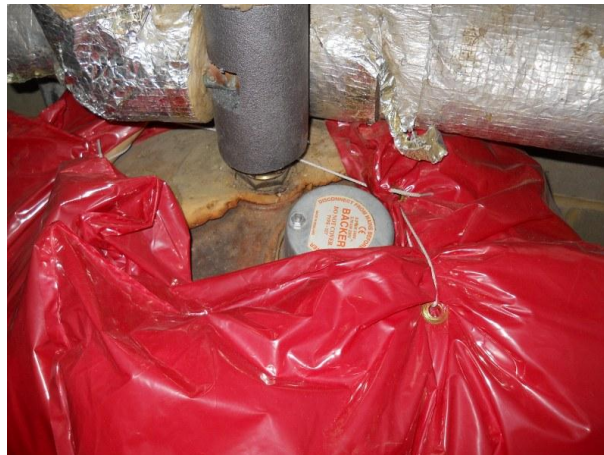
Gaps in insulation on hot water cylinder calorifiers that should be covered with insulation. Cylinder No 9.

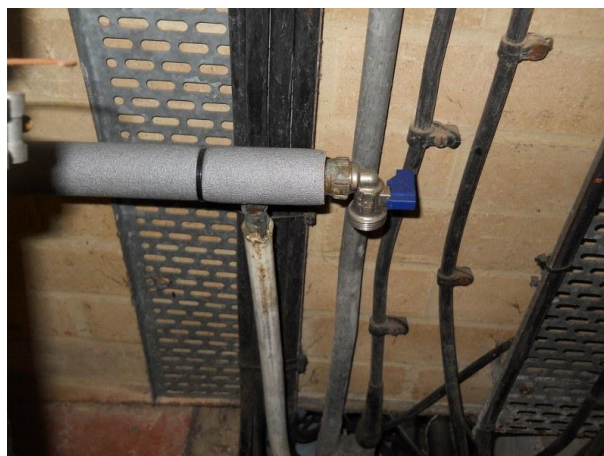
Dead leg mains cold water pipes under the Lock Office.

- Dead leg pipe work is an ideal area for the proliferation of bacteria and should be removed or put on a weekly flushing regime (without creating an aerosol) and recorded within the logbook when carried out. Dead legs were found in the following areas:-
 - Under the Lock Office - There is a mains cold water pipe that runs out and under the wooden ducting boards that is believed to be a dead leg.
