Customer: Marina Developments Limited

Site: Northney Marina
Northney Road
Hayling Island
Hampshire PO11 0NH

Date of Review: December 2015

This Second Risk Assessment Review survey was carried out by Mr Chris Wilson of Freeston Water Treatment Limited on the 4th December 2013 at Northney Marina, Northney Road, Hayling Island, Hampshire PO11 0NH.

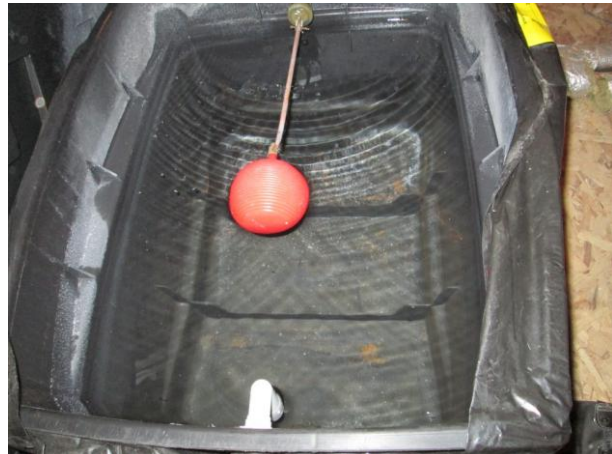
**Marina Office Roof Space
Above Toilets**

There was found to be a light layer of sediment on the base and a light amount of biofilm on the base of both tanks, this could act as a nutrient for the proliferation of bacteria including legionella bacteria.

Internal view of the left domestic cold water storage tank.

ACoP L8 recommends that cold water storage tanks be cleaned and disinfected on an annual basis if required. These storage tanks were last cleaned and disinfected in April 2009 and I would recommend that this be repeated within the near future. These storage tanks supply the toilet flushing in the ladies, gents and disabled toilets.

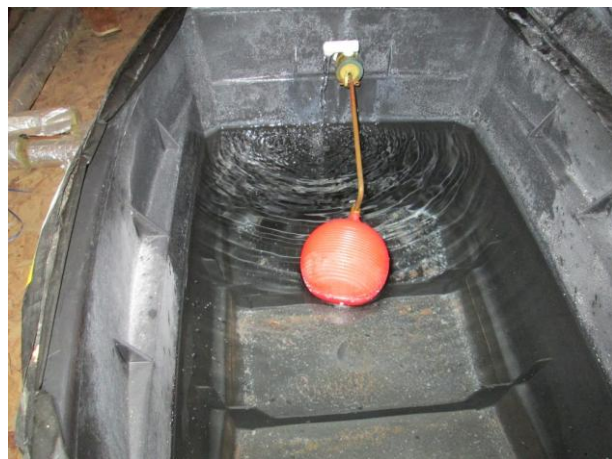
**Marina Office Roof Space
Above Toilets**

Internal view of the right domestic cold water storage tank.

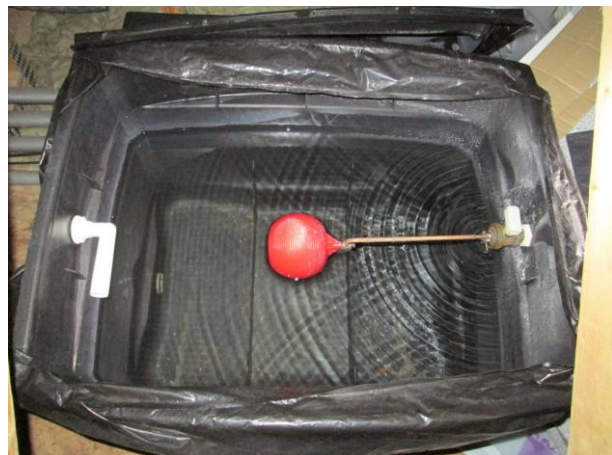
**Marina Office Roof Space
Above The Boiler Room**

There was found to be a light layer of sediment on the base and a light amount of biofilm on the base of this tank, this could act as a nutrient for the proliferation of bacteria including legionella bacteria.

Internal view of the domestic cold water storage tank.

ACoP L8 recommends that cold water storage tanks be cleaned and disinfected on an annual basis if required. This storage tank was last cleaned and disinfected in April 2009 and I would recommend that this be repeated within the near future. This tank serves the toilet flushing for the outside toilets.

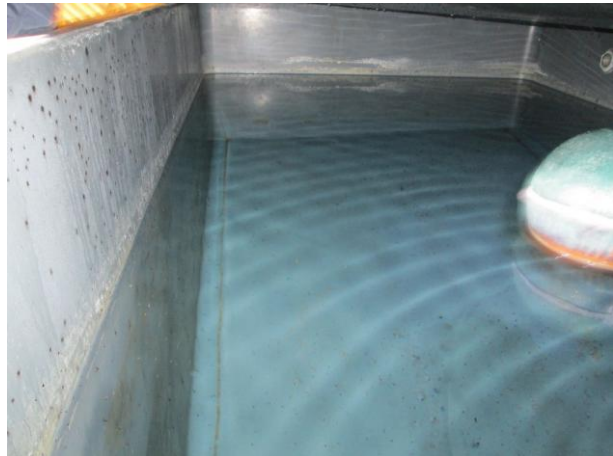
Main Building Roof Space

The tank is of a GRP construction and there was no vent on the lid. There was no insulation on either the body or lid to prevent heat gain / loss. There is an overflow pipe fitted but it has no insect screen and therefore could allow the ingress of insects and other airborne bacteria. A vessel of this size should be fitted with an overflow warning pipe in addition to an overflow pipe, this was also missing. The cross flow of water was very good with the inlet pipe and outlet pipes being at opposing ends. There was found to be a light to medium layer of sediment on the base of this tank and a light to medium amount of biofilm on the sides, this could act as a nutrient for the proliferation of bacteria including legionella bacteria.

Internal view of the domestic cold water storage tank.

L8 recommends that cold water storage tanks be cleaned and chlorinated on an annual basis if required. It was not known when this storage tank was last cleaned and chlorinated. I would recommend this storage tank be scheduled in for cleaning and chlorination.

If it is correct that this tank only feeds the calorifiers then there is a possibility that it could be over capacity as many of the toilet areas etc. have local and point of use heaters that it is believed are mains fed. I would recommend that a drop test is carried out on this tank to ensure that it is of the correct capacity as over capacity can lead to stagnation.

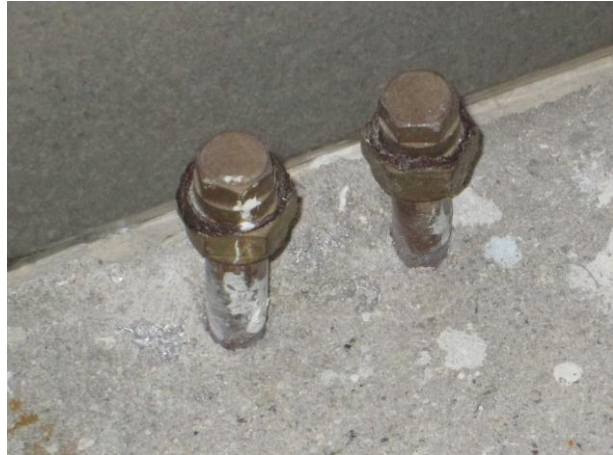
ADDITIONAL PHOTOGRAPHS**DL1****Main Building**

In Unit 105 there are two possible dead legs from the floor near the door.

- Deadlegs are ideal areas for the proliferation of bacteria and should be removed or put on a weekly flushing regime (without creating an aerosol) and this be recorded in the logbook when carried out. Dead legs were found in the following areas:-
 - DL1 - Main Building - In Unit 105 there are two possible deadlegs from the floor near the door.
 - DL2 - Main Building - In the roof space above Room 101 there is a dead on one of the pipes that is connected to the domestic cold water storage tank.
 - DL3 - Unit F (Outside Block) - There is small dead leg on the cold water pipe. Note - the hot pipe is not connected to the water system.
 - DL4 - Marina Office Block Mess Room - There is a small dead leg on the cold water pipe under the sink.

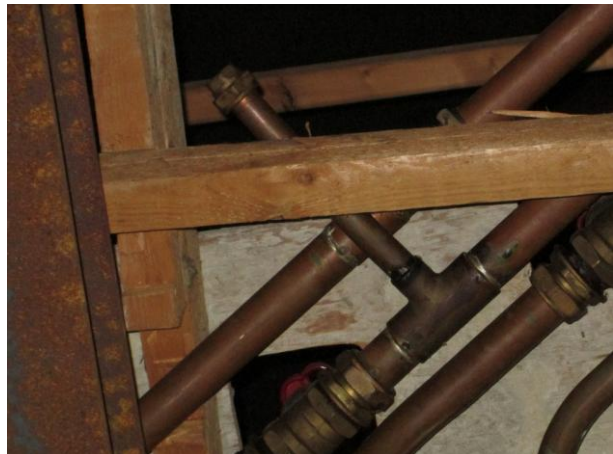
**DL2****Main Building**

In the roof space above Room 101 there is a dead leg on one of the pipes that is connected to the domestic cold water storage tank.

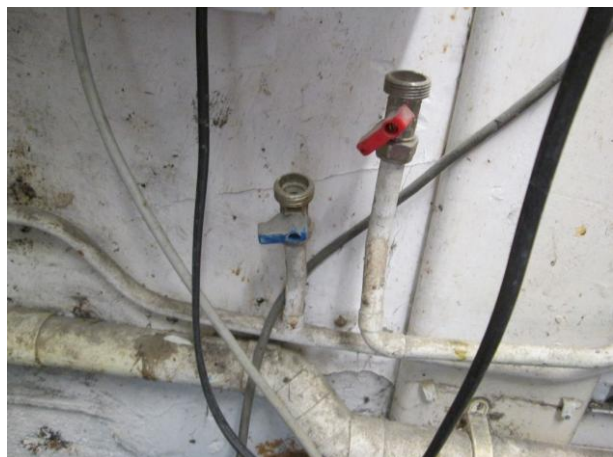
**DL3****Unit F (Outside Block)**

There is small dead leg on the cold water pipe. Note - the hot pipe is not connected to the water system.

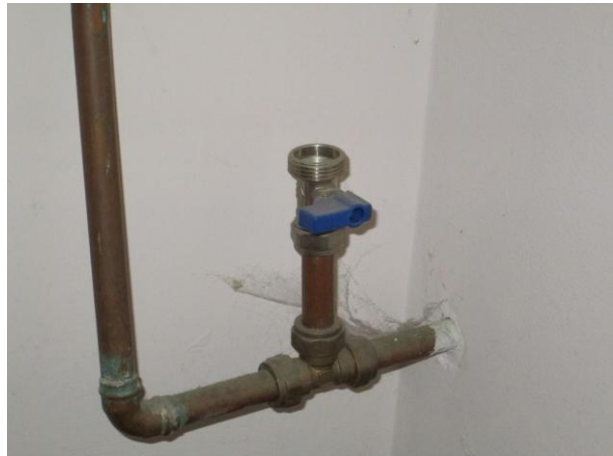
DL4

There is a small dead leg on the cold water pipe under the sink.
