**Customer: Marina Developments Limited**

**Site: Ocean Village Marina  
2 Channel Way  
Southampton  
Hampshire SO14 5QF**

**Date of Assessment: 2<sup>nd</sup> December 2013**

**Freeston Water Treatment Limited  
Water Risk Assessment Review Survey**

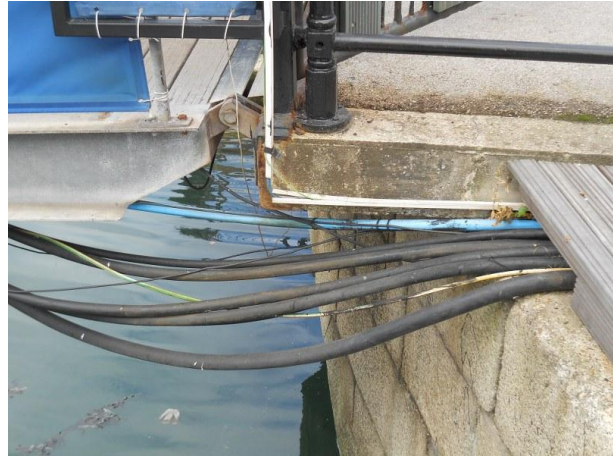
**Northside Pontoon**

- The Pontoon hose reels are supplied by a blue UPVC type plastic water hose that is run along the side of the pontoons. This is un-insulated and I would expect the water temperature in the summer to exceed the recommend maximum of 20.0°C, as outlined in L8. I would recommend that temperature monitoring and flushing of the hose is carried out as regularly as needed to keep the water temperature to below 20.0°C.

Uninsulated water hose.
