**Site:** Saxon Wharf Marina  
Lower York Street  
Northam  
Southampton  
Hampshire SO14 5QF

**Date of Assessment:** 9<sup>th</sup> December 2013

Freeston Water Treatment Limited  
Water Risk Assessment Review Survey

This Second Risk Assessment Review survey was carried out by Mr Chris Wilson of Freeston Water Treatment Limited on the 9<sup>th</sup> December 2013 at Saxon Wharf Marina, Lower York Street, Northam, Southampton SO14 5QF.

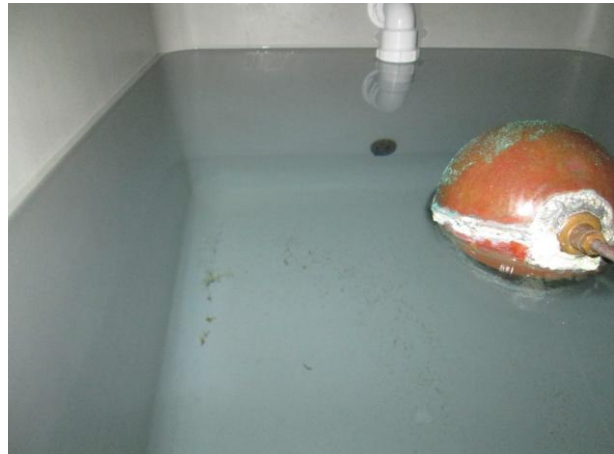
**Marina Office Roof Space**

Cold water storage within the Marina Office Block consists of one storage tank located in the roof space. Upon inspection the tank was found to be of GRP construction. The tank is insulated with a double skin thickness. The tank is fitted with a good fitting lid and has been fitted with a screened vent. The inlet and one outlet are fully opposed therefore there is a good cross flow of water through this tank. There is an overflow pipe work fitted to the tank, this is fitted with an insect screen. This storage tank serves the toilet flushing and wash basins in the three shower rooms; it also serves the outside sinks, wash basins and toilet flushing in the outside toilets. There was a pipe that joins the mains water pipe near the inlet ball valve, this has since been removed but has left a small dead leg which should be removed. The tank was found to have a slight layer of sediment on the base but there was no biofilm on the sides.

ACoP L8 recommends storage tanks to be inspected annually and cleaned and disinfected if required. This vessel was last cleaned and disinfected in April 2009 and currently does not need repeating.

**Tank      10.4°C.      Satisfactory**

Internal view of the domestic cold water storage tank.

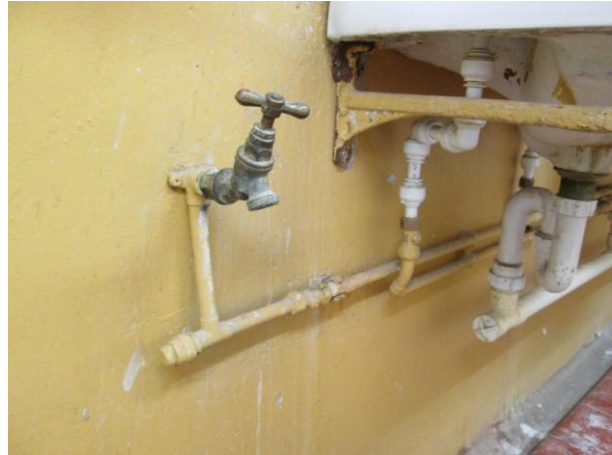
**Unit 16**

There is a dead leg on the cold water pipe in the ground floor gents' toilets.

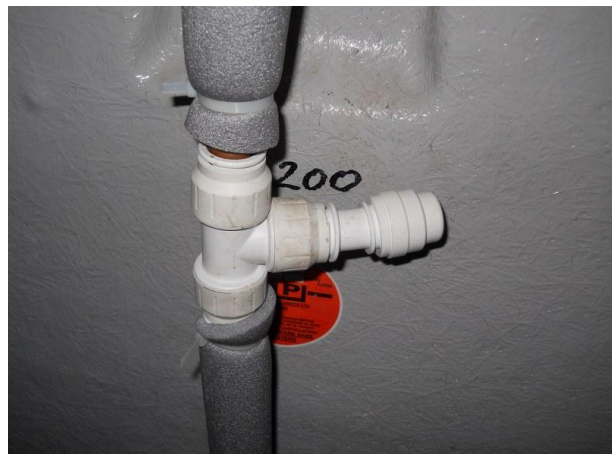
**DL2**

There is a small dead leg on the mains cold water pipe to the inlet ball valve.
