**Site: Woolverstone Marina  
Woolverstone  
Ipswich  
Suffolk IP9 1AS**

**Date of Assessment: 11<sup>th</sup> December 2013**

**Date of Review: December 2015**

This Second Risk Assessment Review survey was carried out by Mr Chris Wilson of Freeston Water Treatment Limited on the 11<sup>th</sup> December 2013 at Woolverstone Marina, Woolverstone, Ipswich, Suffolk IP9 1AS.

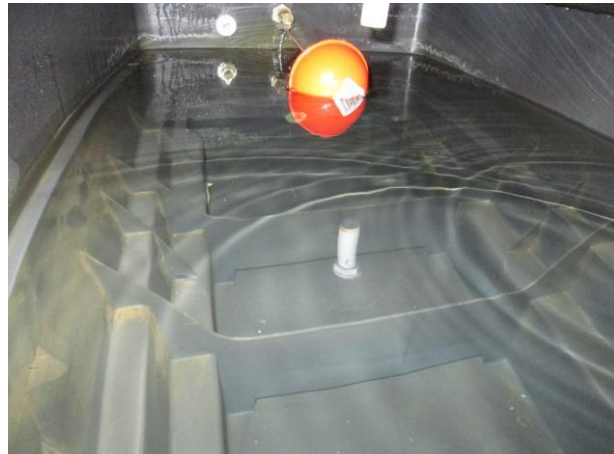
**Restaurant Roof Space**

Domestic cold water storage within Woolverstone Marina consists of one storage tank located within the roof space of the restaurant building. The tank is of plastic construction and is fitted with fibre jacket type insulation to the body and lid. The lid now has a screened vent and a screen on the overflow pipe. There is a returning vent pipe penetrating the lid and I would recommend that this is re-routed to a foul drain via an air gap and the hole be covered with a WRAS (Water Regulations Advisory Scheme) approved material.

There is a good cross flow of water through this vessel as a sparge pipe has been fitted to an outlet pipe. The inside of the tank was found to have a slight sediment build up on the base and a light amount of biofilm on the sides.

Sediment and biofilm act as a nutrient to bacteria and can therefore aid its proliferation.

ACoP L8 recommends storage tanks to be inspected annually and cleaned and disinfected if required. This vessel was last cleaned and disinfected in March 2013 and this does not currently need repeating.

Internal view of the domestic cold water storage tank.

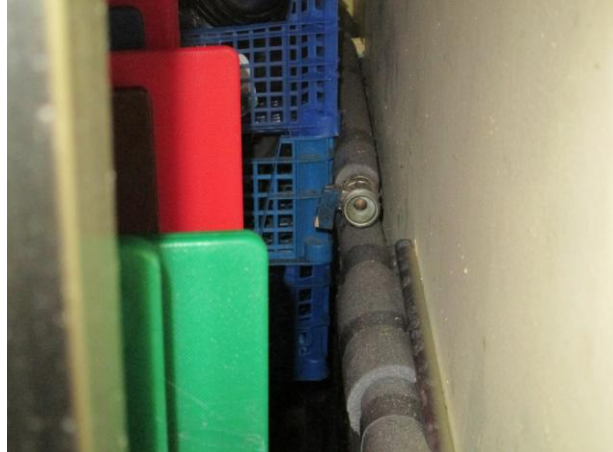
**Restaurant Bar Store Area**

- Dead leg pipe work is an ideal area for the proliferation of bacteria including Legionella. Dead legs should be removed or put on a weekly flushing regime (without creating an aerosol) and recorded in the logbook when carried out. At the time of the 2013 Review survey dead legs were found in the following areas:-

- DL1 - Restaurant - There is a dead leg on the pipework behind the freezer within the Bar store area.
  - DL2 - Marina Office - The cold water supply in the Marina office building has been converted from cold water storage tanks to mains fed only. At the time of the 2007 survey I was unable to survey the tanks that have been left in the roof space (due to many large items that have been stored in there) but could see that some of the pipe work was still in place. The 2011 and 2013 Surveys found this remains unchanged.

Dead leg pipe behind the freezer.
