Client Address	Hampshire County Council PBRs Three Minsters House 76 High Street Winchester Hampshire SO23 8UL
Site Name	Copper Beeches OPH
Site Address	Woodlands Way London Road Andover Hampshire SP10 2QU
Site contact	Lynn McGloughlan
Site telephone number	01264 353703
Last risk assessment carried out by	Freeston Water Treatment Limited
Date of risk assessment	June 2011
Date of previous review	N/A
Date of new review	20th April 2012
Review carried out by	Mr Chris Wilson

This Review has been carried out in accordance with ACoP L8 'The control of Legionella bacteria in water systems' (APPROVED CODE OF PRACTICE & GUIDANCE) and BS 8580 (RISK ASSESSMENTS FOR LEGIONELLA CONTROL-CODE OF PRACTICE).

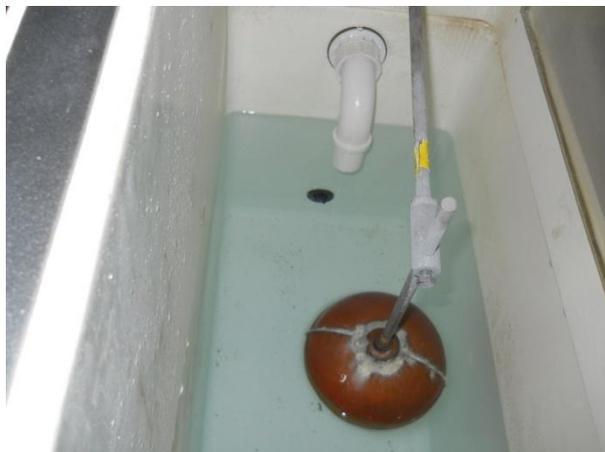
Tank no. 1 is of a sectional, double skinned GRP construction and in good condition. There is a screened vent on the lid, gauze screens on the inlet valve housing and a screen on the overflow pipe. As this vessel is less than 1000 litres in capacity there is no requirement for an overflow warning pipe to be fitted.

The inside of the tank showed a light deposit of sediment on the base and a slight amount of biofilm on the sides. Sediment, corrosion and biofilm act as nutrients and an ideal environment for the proliferation of bacteria including Legionella.

An internal view of domestic cold water storage tank no. 1.

The vessel was last cleaned and disinfected on the 24th June 2011 and I would recommend that this be carried out again within the near future.

- Clean and disinfect domestic cold water storage tank no. 1 and no. 2 within the near future and repeat annually if required.
- I would recommend that further investigation be carried out to confirm that the mains cold water only supplies the domestic cold water storage tanks, the heating boilers (via an RPZ backflow protection device) and the main kitchen and laundry.

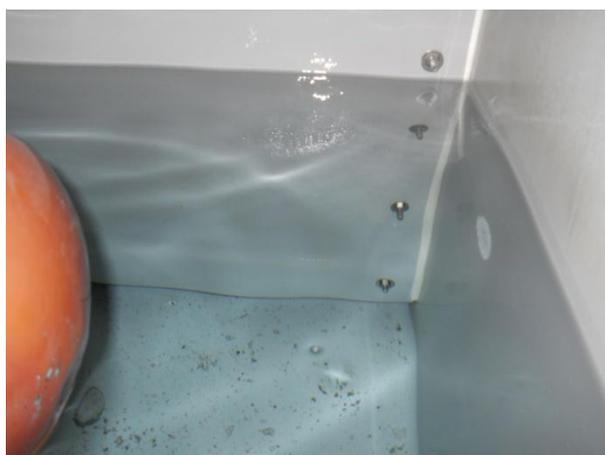
Tank no. 2 is of a one piece, double skinned GRP construction and is in good condition and is supplied by the mains cold water supply via a silver /copper ionisation disinfection unit. There is a screened vent on the lid, gauze screens on the inlet valve housing and screens on the overflow pipes and overflow warning pipes.

The inside of the tank showed a light deposit of sediment on the base but no biofilm on the sides. Sediment, corrosion and biofilm act as nutrients and an ideal environment for the proliferation of bacteria including Legionella.

An internal view of domestic cold water storage tank no. 2.

The vessel was last cleaned and disinfected on the 24th June 2011 and I would recommend that this be carried out again within the near future.

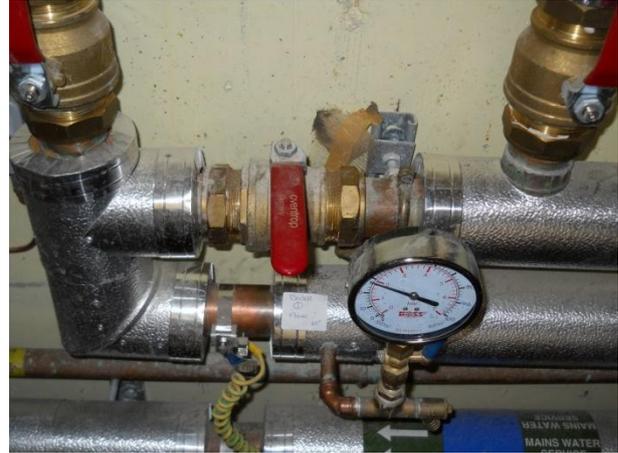
The valve on the hot flow balance pipe between the circulation pumps of the calorifiers is closed and therefore creating dead legs either side of it.

- Dead leg pipework are ideal areas for the proliferation of bacteria and should be removed or put on a weekly flushing regime (without creating an aerosol) and recorded. Dead legs were found in the following areas:-

- Boiler Room – The valve on the hot flow balance pipe between the circulation pumps of the calorifiers is closed and therefore creating dead legs either side of it.

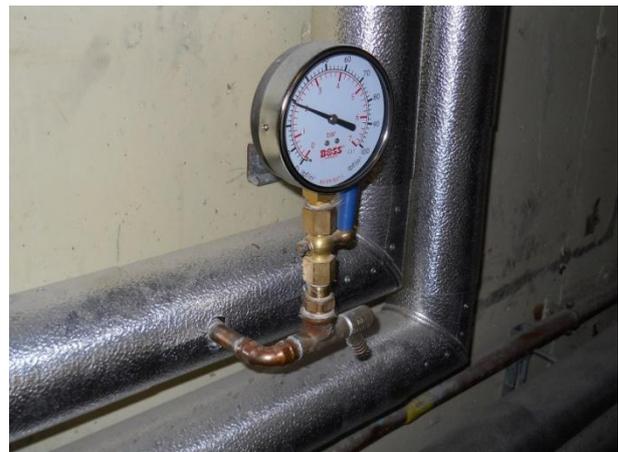
The pipe to the pressure gauge on the flow pipe of calorifier no. 1 is too long and creating a small dead leg.

- Boiler Room – The pipe to the pressure gauge on the flow pipe of calorifier no. 1 is too long and creating a small dead leg.
 - Boiler Room – The valve on the ionisation unit bypass pipe is closed and therefore creating dead legs either side of it.

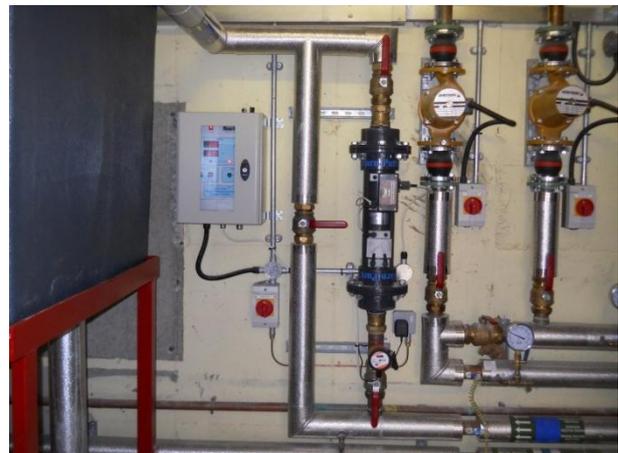
Boiler Room

The valve on the ionisation unit bypass pipe is closed and therefore creating dead legs either side of it.

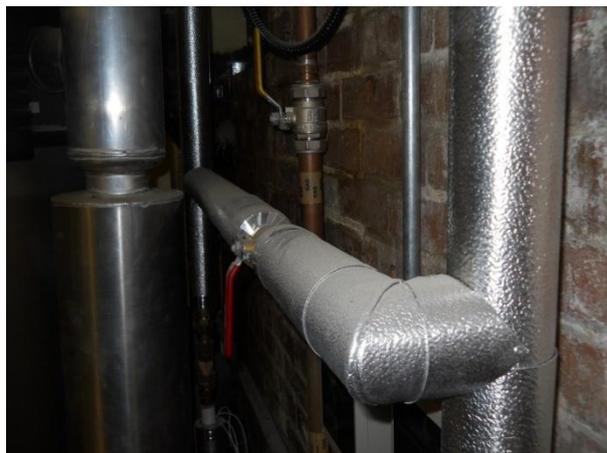
The valve on the hot return balance pipe to the calorifiers is closed and therefore creating dead legs either side of it.

- Boiler Room – The valve on the hot return balance pipe to the calorifiers is closed and therefore creating dead legs either side of it.
 - Laundry - The two JLA D30 tumble driers have a fire sprinkler system inside which is piped to the mains cold water supply within the laundry. As this is rarely, if ever, used I would recommend that a suitable backflow protection device is fitted on each tumble drier water supply pipe as close as possible to the main water header pipe.
