CONTENTS

INTRODUCTION

This report relates to a Review of the Legionella Risk Assessments that were carried out by Freeston Water Treatment in April 2009; these were the latest Risk Assessments for these buildings. The Review Survey was carried out at 110A, B and C West St, Havant, Hampshire PO9 1LN. The Review of Recommendations highlighted in the previous Risk Assessments was undertaken in order to comply with the Health and Safety Executive requirements on the control and prevention of Legionellosis. This Review has been carried out as asked for by Hampshire County Council in accordance with ACoP L8 'The control of Legionella bacteria in water systems' (APPROVED CODE OF PRACTICE & GUIDANCE) only.

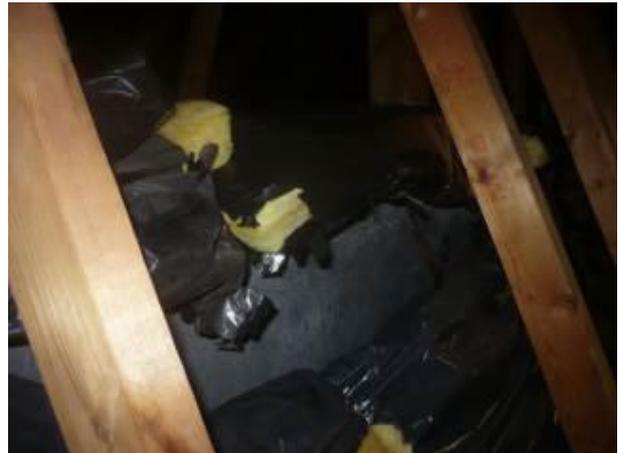
Building 110A

The domestic cold water storage tank is of a GRP construction with a poly fibre jacket for insulation which was in a poor condition; I would recommend this is replaced. There is a screened vent fitted to the lid and screened overflow pipe work. The returning vent pipe from the calorifier has been re-routed from the storage tank to a tundish via an air gap as recommended in the original assessment; it would appear the hole left from the vent pipe work has not been capped to help prevent ingress of contaminants; I would recommend this hole be capped. Internal inspection proved the tank to have a slight amount of sediment on the base of the tank; this storage tank was last cleaned and disinfected in November 2010; I would recommend this is continued annually if required.

Water storage tank located in roof void.
Poor insulation fitted recommend this is replaced.

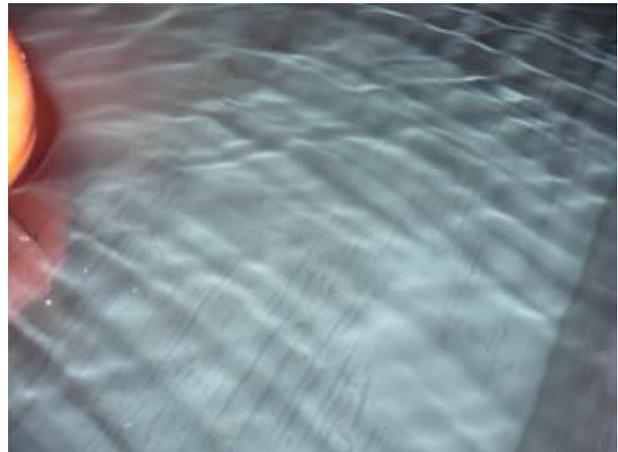
Internal view of water storage tank at time of Review. Last clean and disinfection was in November 2010; clean and disinfect annually if required.

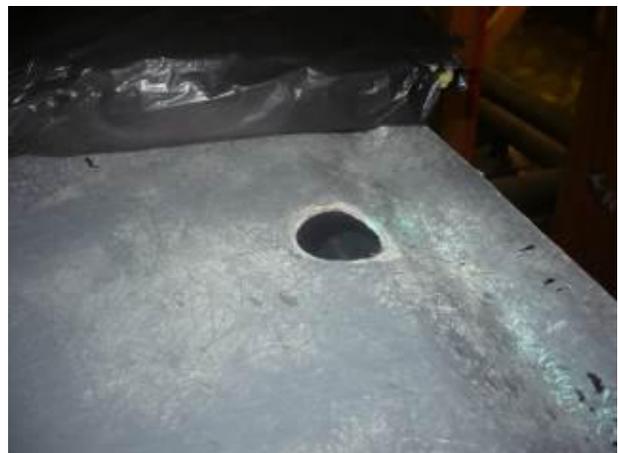
Returning vent pipe hole in storage tank has not been capped to prevent ingress of contaminants; recommend hole is capped.

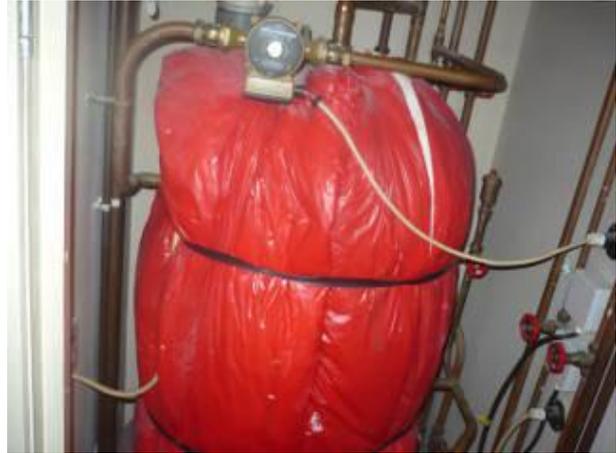
Building 110A

Calorifier Flow	55.0°C	This is Not Satisfactory
Calorifier Return	50.0°C	This is Satisfactory

Hot water calorifier located in the first floor bathroom cupboard space. Start temperature monitoring of the flow and return temperatures on a monthly basis as soon as possible.

Hot water should be stored at 60°C at all times; I would recommend adjustment to achieve this. The hot water return temperature should be maintained at 50°C or more at all times.

Maintain storage at 60.0°C.

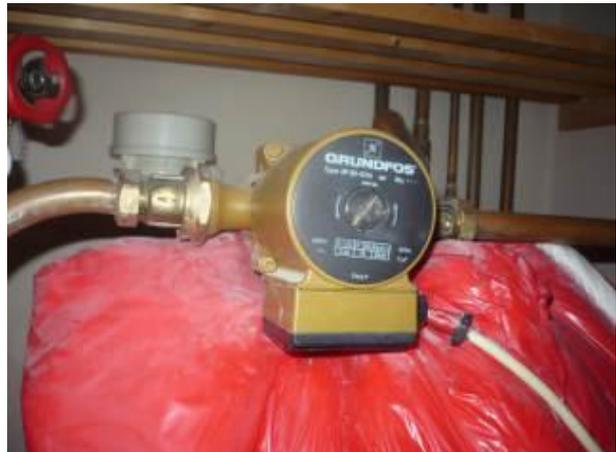
Hot water calorifier circulating/return pump. Start temperature monitoring of the flow and return temperatures on a monthly basis as soon as possible.

Maintain return temperature at 50.0°C or more at all times.

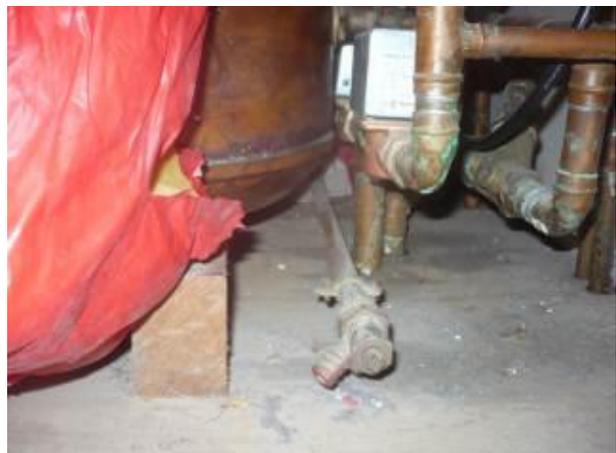
Calorifier has a long drain creating deadleg pipe work; recommend this is purged to drain on a regular basis.

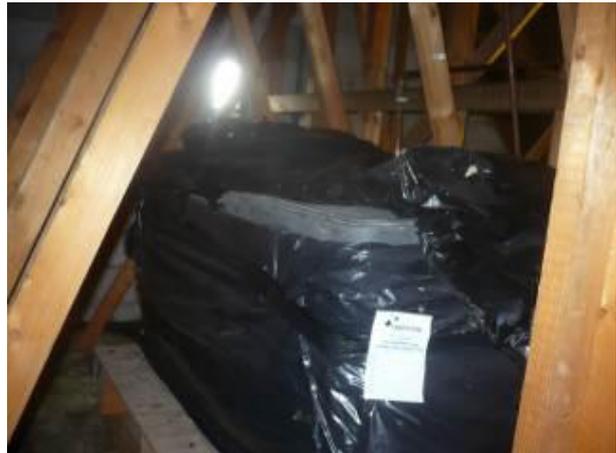
Building 110B

Cold water storage tank located in the roof void; returning vent pipe work has been re-routed to tundish and the hole in the tank lid has been capped.

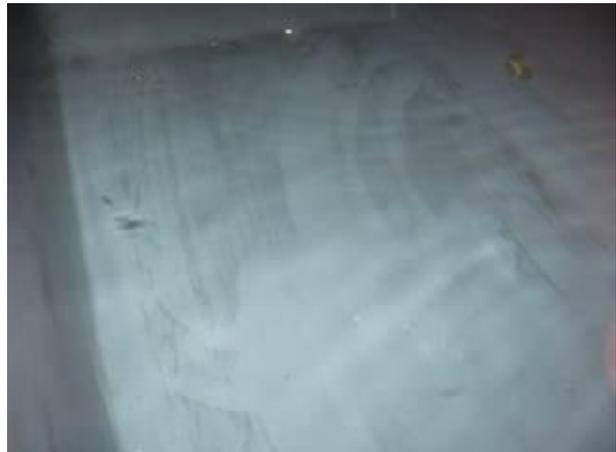
Internal view of water storage tank at time of Review. Last clean and disinfection was in November 2010; clean and disinfect annually if required.

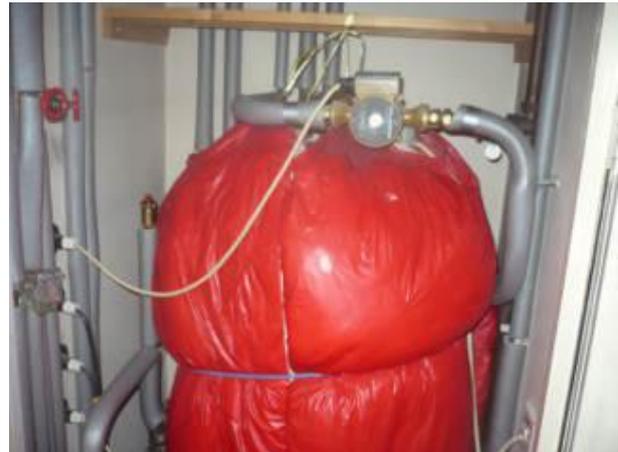
Building 110B

Hot water calorifier located in the first floor bathroom cupboard space. Start temperature monitoring of the flow and return temperatures on a monthly basis as soon as possible.

Maintain storage at 60.0°C.

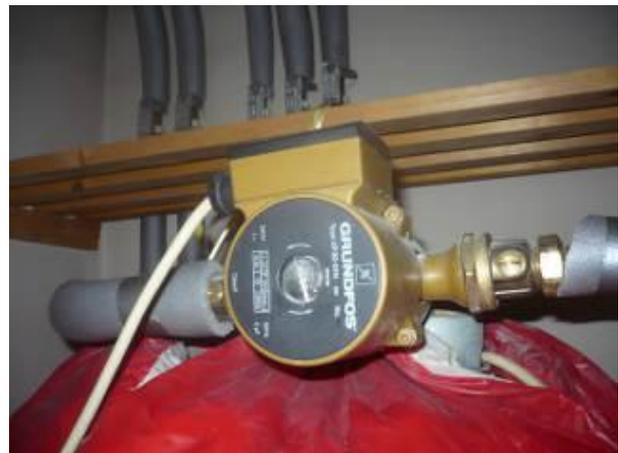
Hot water calorifier circulating/return pump. Start temperature monitoring of the flow and return temperatures on a monthly basis as soon as possible.

Maintain return temperature at 50.0°C or more at all times.

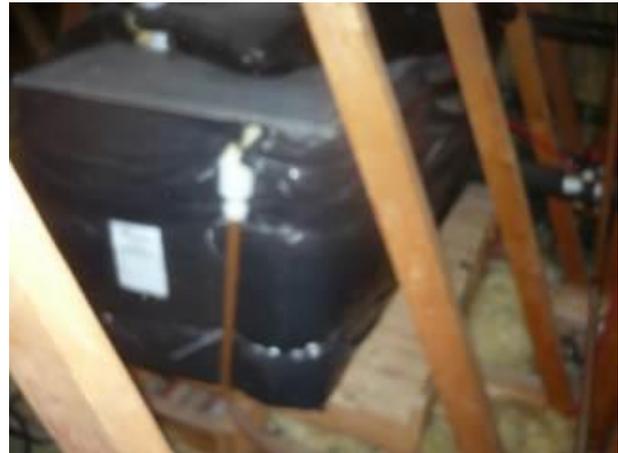
Building 110C

Far end cold water storage tank located in the roof void.

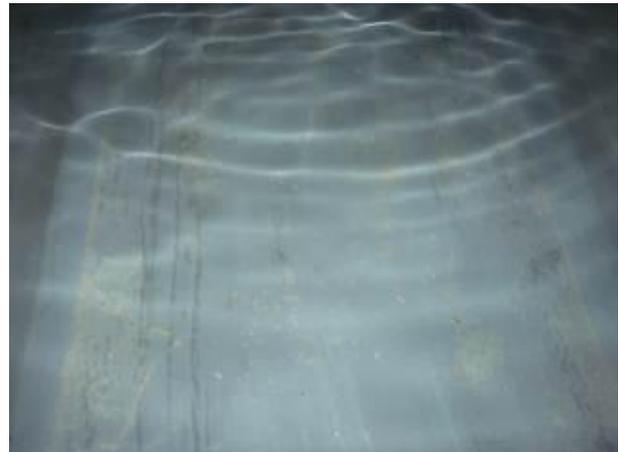
Internal view of the water storage tank at the time of this Review; some sediment build up on base. Last clean and disinfection was in November 2010; clean and disinfect annually if required.

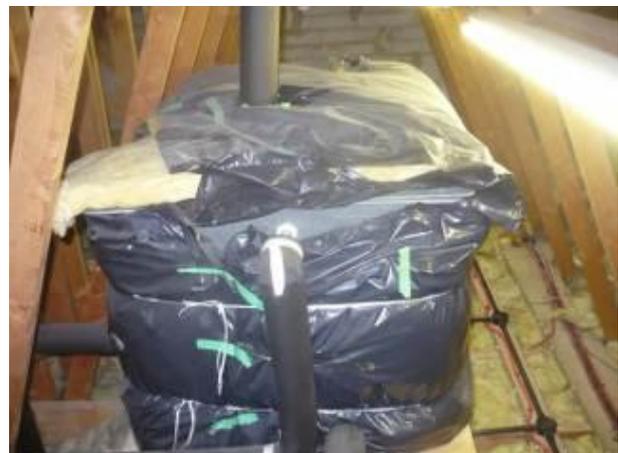
Bedsit cold water storage tank located in roof void above flat; this tank has not been cleaned and disinfected I would recommend it is scheduled in for cleaning and disinfection at earliest opportunity.

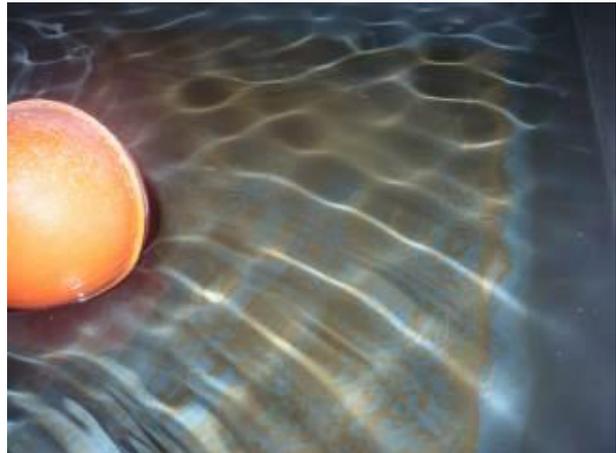
Building 110C

At the time of this Review the cold water storage tank was internally inspected and found to have a build up of sediment on the base of the tank; this sediment could act as a nutrient for the proliferation of bacteria. I would therefore recommend the tank be cleaned and disinfected at the earliest opportunity and continued annually if required. The storage tank was insulated with a poly fibre jacket this was seen to be in a good condition; the tank lid is fitted with a screened vent; the overflow pipe work is also fitted with an insect screen. The inlet and outlets are not fully opposed therefore there is not a good flow of water through this tank; consider fitting sparge pipes to help create a good flow of water through the tank. This cold water storage tank appears to serve the bedsit flat on the first floor in the administration area of 110C; it also serves cold water to the hot water calorifier located beneath it in a cupboard space. The returning vent pipe work from the calorifier has not been re-routed as the overflow from this tank discharges over the buildings front door so it was not deemed appropriate.

Internal view of bedsit water storage tank at the time of this Review, sediment build up on base of tank I would recommend it is scheduled in for cleaning and disinfection at earliest opportunity.

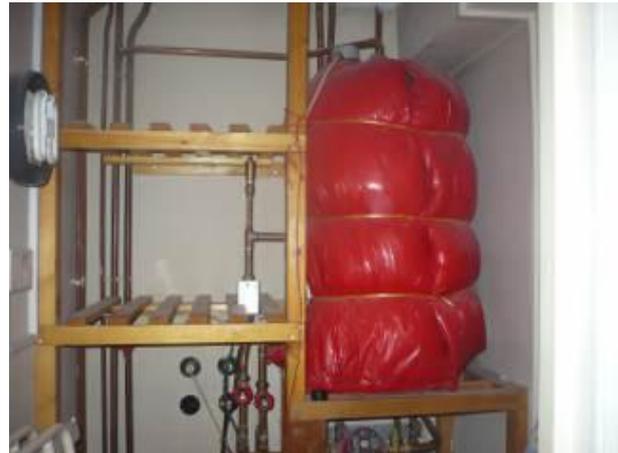
Bedsit Flat

Calorifier Flow 77.0°C This is Satisfactory

Hot water calorifier located in the first floor bedsit flat cupboard space. Start temperature monitoring of the flow temperature on a monthly basis as soon as possible and record in logbook.

I would recommend the calorifier storage temperature be reduced to 60.0°C

Maintain storage at 60.0°C.

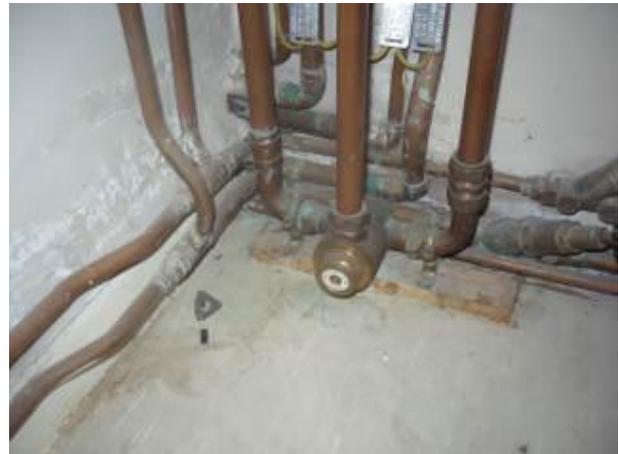
At the time of this Review the TMV serving the bedsit flat was not operating correctly as it was allowing water temperatures of 50.0°C at the outlets; I would recommend this is adjusted to deliver a maximum of 43.0°C or as recommended in the TMV temperature reference from NHS Estates Guidance (1988) and Thermostatic Mixing Valve Manufacturers Association (TMVA).

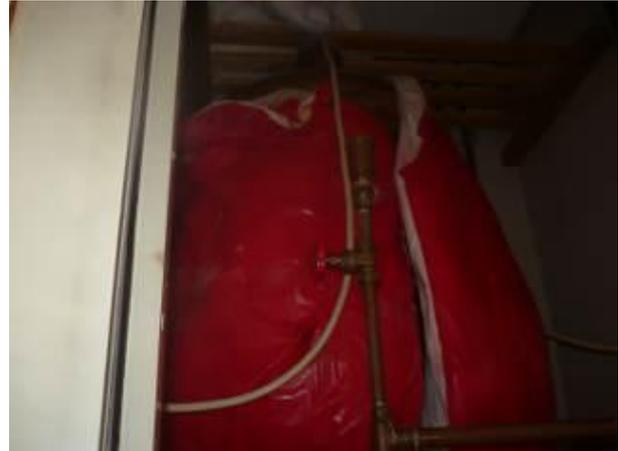
Building 110C

Calorifier Flow	43.0°C	This is Not Satisfactory
Calorifier Return	43.0°C	This is Not Satisfactory

Hot water calorifier located in the first floor bathroom cupboard space. Start temperature monitoring of the flow and return temperatures on a monthly basis as soon as possible.

Hot water should be stored at 60°C at all times and the hot water return temperature should be maintained at 50°C or more at all times; I would recommend adjustment to achieve this.

Maintain storage at 60.0°C.

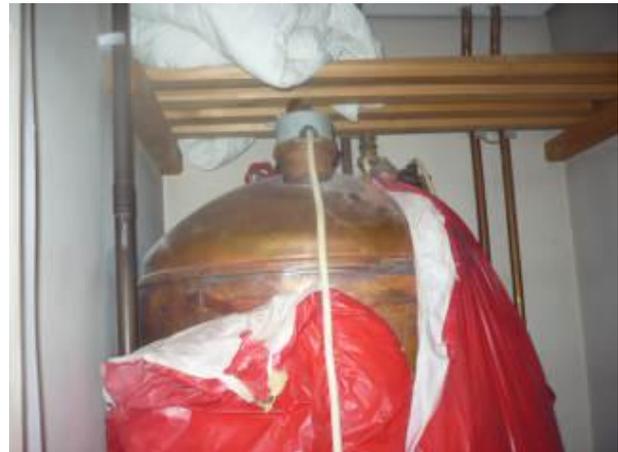
Calorifier insulation is in a poor condition and in need of replacement to prevent heat loss.

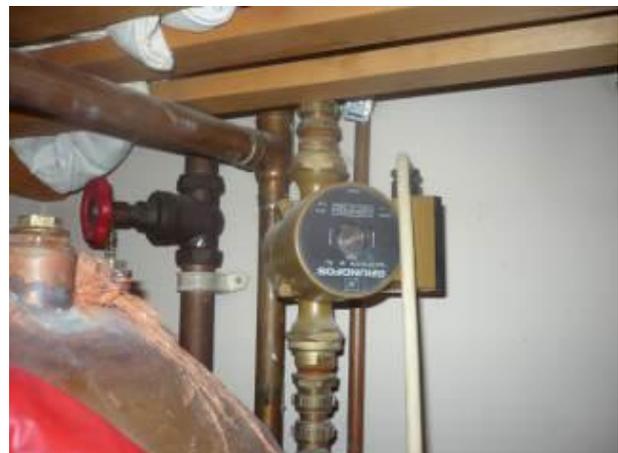
Hot water calorifier circulating/return pump. Start temperature monitoring of the flow and return temperatures on a monthly basis as soon as possible.

Maintain return temperature at 50.0°C or more at all times.

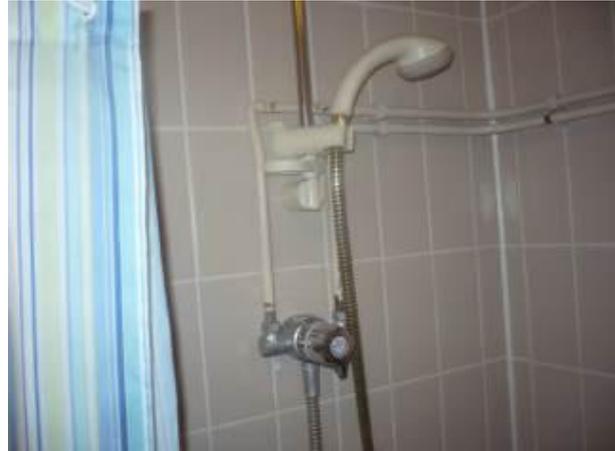
General

Ensure all showers are used and continue with current cleaning and descale regime that has been implemented.

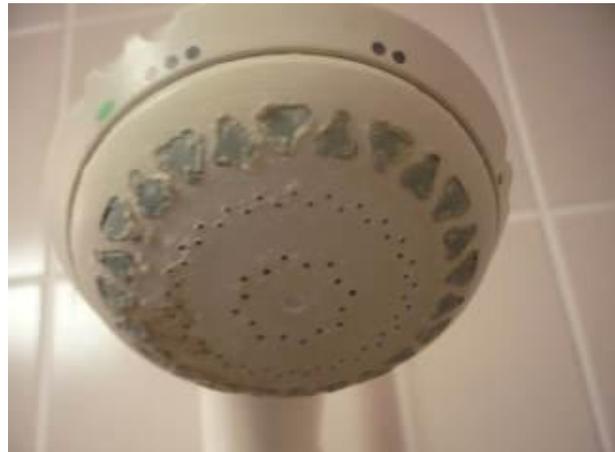
It was recommended in the original Risk Assessment that all showerheads are changed to the non adjustable type.

Ensure all showerheads are cleaned and descaled at least quarterly or as required.

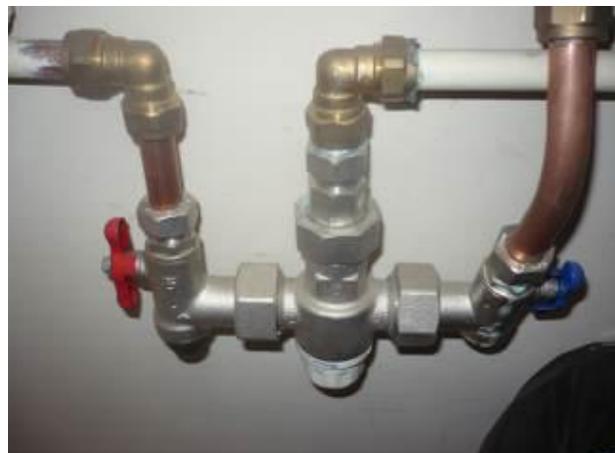
The TMV's within buildings 110A, B and C are assumed to be being serviced and maintained by contractors; no records were seen for this at the time of this Review.

Ensure all TMV's are being serviced, maintained and adjusted if required; record when carried out.
