**23A Upton Grey Close**

**23B Upton Grey Close**

## INTRODUCTION

This report relates to a **Review** of the Legionella Risk Assessments that were carried out by Freeston Water Treatment in April 2009; these were the latest Risk Assessments for these buildings. The Review Survey was carried out at 23A & B Upton Grey Close, Harestock, Winchester, Hants SO22 6NE. The Review of Recommendations highlighted in the previous Risk Assessments was undertaken in order to comply with the Health and Safety Executive requirements on the control and prevention of Legionellosis. This Review has been carried out as asked for by Hampshire County Council in accordance with ACoP L8 'The control of Legionella bacteria in water systems' (APPROVED CODE OF PRACTICE & GUIDANCE) only.

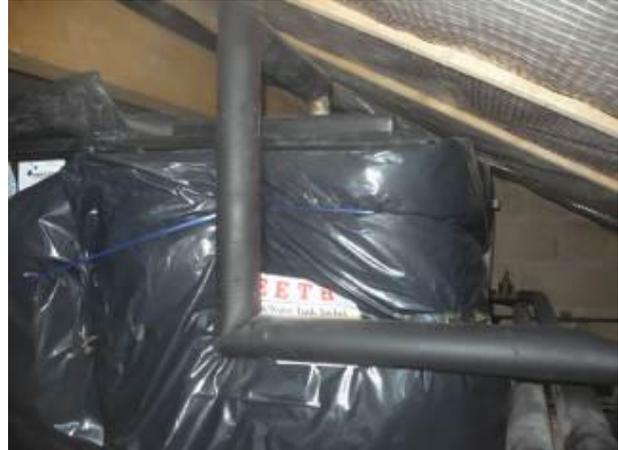
Water storage tanks no.1 & 2 located in roof void. Tank no.2 still has returning vent pipe work; recommend re-routed to drain or tundish.

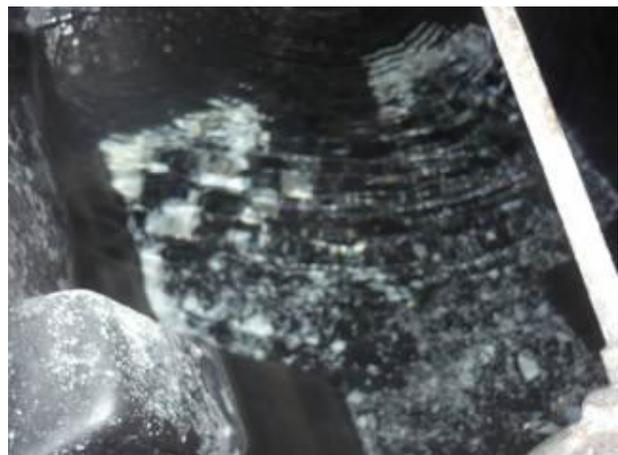
Internal inspection of no.1 tank proved there to be a build up of sediment and scale; both of these tanks have labels to indicate they were both cleaned and disinfected in October 2010; I would recommend this is carried out annually if required. Both storage tanks no.1 and 2 are linked and are also linked with storage tank no.3 through the distribution pipe work.

Internal view of no.1 water storage tank at the time of this Review. Build up of sediment and scale; last clean and disinfection was in October 2010; clean and disinfect annually if required.

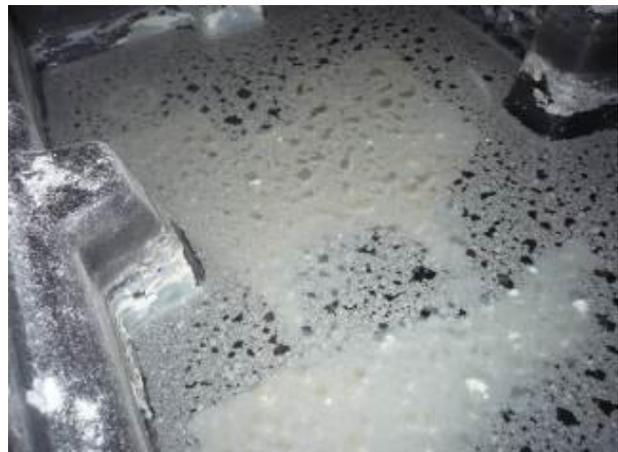
There are three domestic cold water storage tanks located within the roof void of this building; no.1 & 2 storage tanks are of plastic construction and have poly fibre jackets for insulation; this was in a fair condition. Both storage tanks have fitted lids with screened vents; there is still a returning vent pipe to no.2 storage tank; this was recommended for re-routing in the original Risk Assessment but has not been carried out. There is a partial cross flow of water through tank no.1 and also through tank no.2; no.1 tank is fitted with a ball valve but no.2 tank has no ball valve and internal inspection proved there to be a heavy build up of surface stagnation.

Internal view of no.2 water storage tank at the time of this Review. Heavy build up of surface stagnation and also sediment on base of tank. No ball valve fitted consider plumbing arrangements to prevent stagnation. Recommend tanks removed and all cold water services supplied directly from the mains water service.

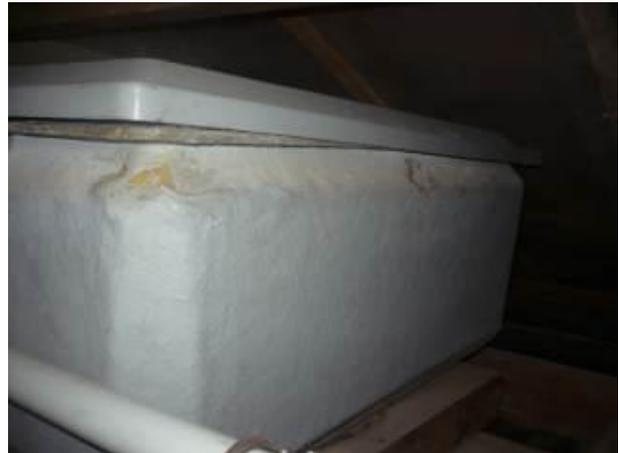
No.3 storage tank is located behind tanks no.1 & 2 and is of GRP construction with integral insulation. The ball valve supply to this tank is shut off as it was when reported in the original Risk Assessment; this creates deadleg pipe work on the mains water supply pipe work.

Water storage tanks no.3 located in roof void behind tanks 1 & 2. Tank should be investigated to determine if still in use or required. Main isolated to ball valve creates deadleg pipe work. Are distribution outlets open? No label to indicate if storage tank was cleaned and disinfected in October 2010.

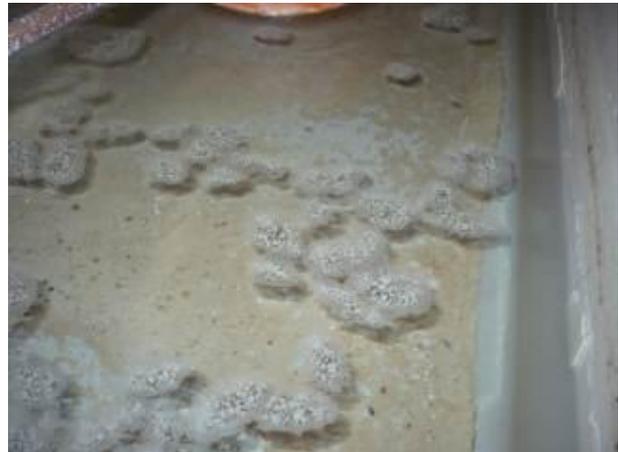
Internal inspection of this tank proved there to be a heavy build up of surface stagnation and sediment; there is no label on this tank to indicate that it was cleaned and disinfected in October 2010. I was unable to determine if this tank is in use as the outlet has no valve handle; I would recommend an investigation on this tank to determine if required and if still in use as the ball valve is isolated there is no movement of water within the tank creating stagnation.

Internal view of no.3 water storage tank at the time of this Review. Heavy build up of surface stagnation and also sediment on base of tank. Ball valve is isolated consider plumbing arrangements to prevent stagnation. Recommend tanks removed and all cold water services supplied directly from the mains water service.

Clean and disinfect all storage tanks annually if required.

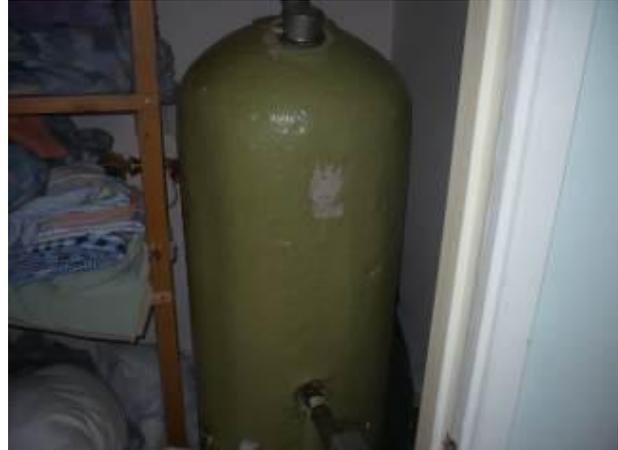
At the time of this Review the calorifier flow and return temperatures were found to be very low this should be addressed as soon as possible.

Calorifier Flow	40.0°C	This is Not Satisfactory
Calorifier Return	39.0°C	This is Not Satisfactory

Hot water calorifier located in the first floor airing cupboard space. Start temperature monitoring of the flow and return temperatures on a monthly basis as soon as possible.

Maintain storage at 60.0°C.

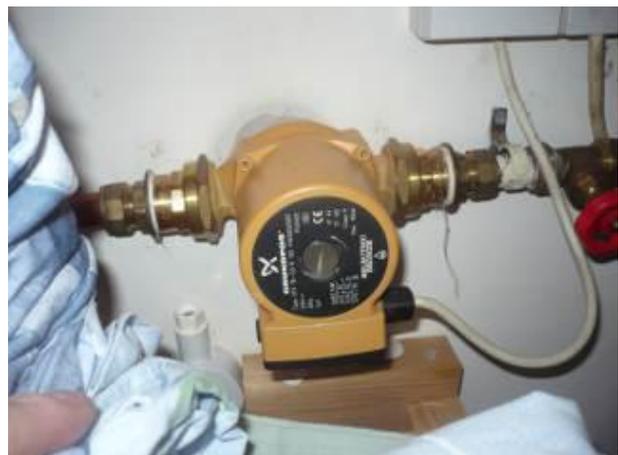
Hot water calorifier circulating/return pump. Start temperature monitoring of the flow and return temperatures on a monthly basis as soon as possible.

Maintain return temperature at 50.0°C or more at all times.

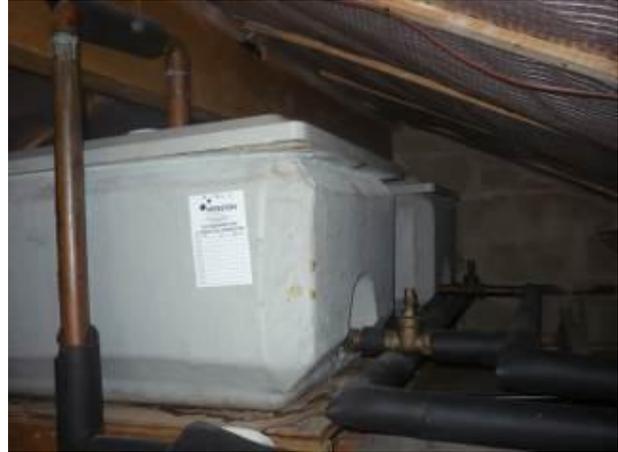
There are two domestic cold water storage tanks located within the roof void of this building; no.1 & 2 storage tanks are of GRP construction and have integral insulation; both tanks are linked through common distribution pipe work. No.2 tank was not accessed at the time of this Review due to restricted access the rear tank is very awkward to access for cleaning and maintenance. Upon internal inspection of tank no.1 the front tank this was proved to be in a good clean condition; this tank is the only tank labelled to indicate it was cleaned and disinfected in October 2010; the rear tank has no label to indicate it was cleaned and disinfected.

Water storage tanks no.1 & 2 located in roof void. No access to rear tank no.2 at the time of this Review due to limited access space. Only no.1 tank has cleaning and disinfection label last cleaned and disinfected in October 2010.

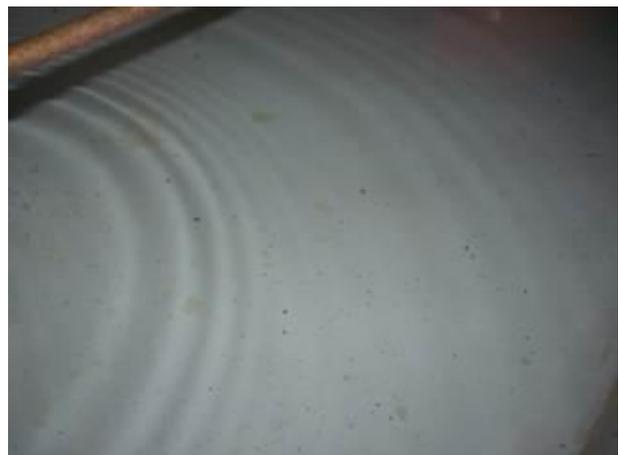
Internal view of no.1 water storage tank at time of this Review. Last clean and disinfection was in October 2010; clean and disinfect annually if required.

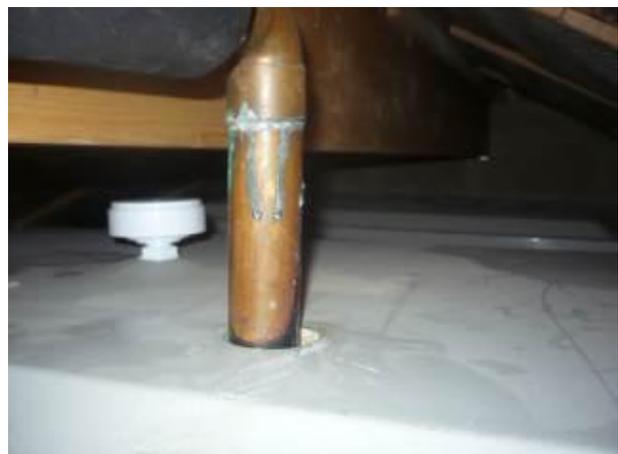
It was recommended in the original Risk Assessment that the returning vent pipe work be re-routed to a drain or tundish this has not been carried out. No.1 tank has had a screened vent fitted in the lid but there is no screened vent fitted to no.2 tank lid; there is a cross flow of water through both tanks.

Tank no.1 still has returning vent pipe work; recommend re-routed to drain or tundish.

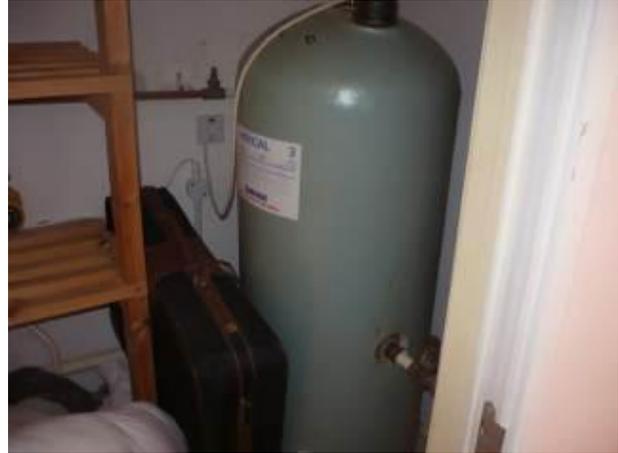
Calorifier Flow	56.0°C	<b>This is Not Satisfactory</b>
Calorifier Return	54.0°C	<b>This is Satisfactory</b>

Hot water calorifier located in the first floor airing cupboard space. Start temperature monitoring of the flow and return temperatures on a monthly basis as soon as possible.

Maintain storage at 60.0°C.

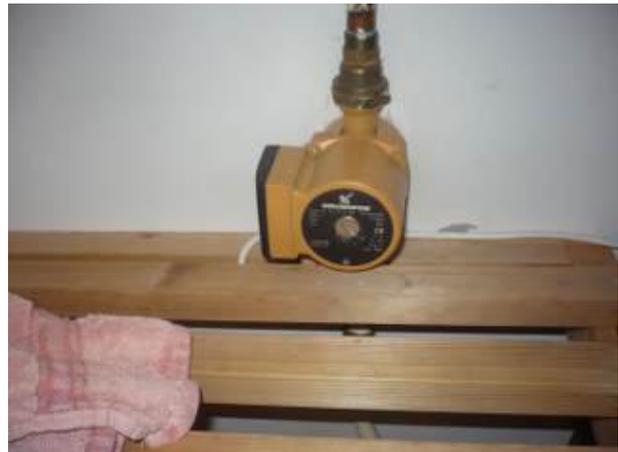
Hot water calorifier circulating/return pump. Start temperature monitoring of the flow and return temperatures on a monthly basis as soon as possible.

Maintain return temperature at 50.0°C or more at all times.

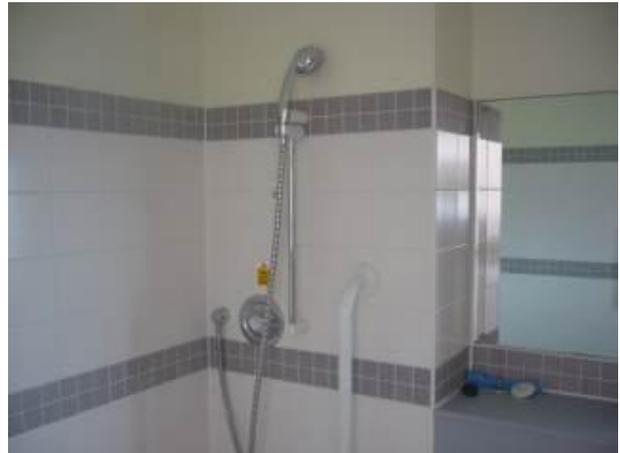
Ensure all showers within buildings 23A & B are used on a regular basis or flushed at least on a weekly basis; record when carried out.

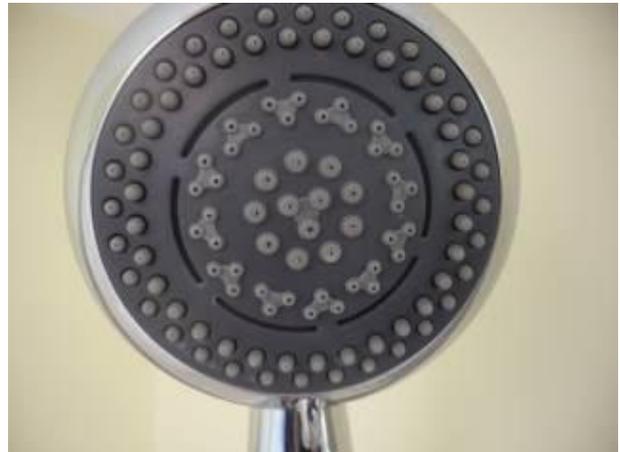
It was recommended in the original Risk Assessment that the adjustable showerheads within buildings 23A & B be replaced with new non adjustable showerheads this has not been carried out. I was informed that the procedures implemented by Hampshire County Council regarding the cleaning and disinfection and descaling are not being carried out as recommended.

It was recommended in the original Risk Assessment that all showerheads are changed to the non adjustable type.

Ensure all showerheads within buildings 23A & B are cleaned and descaled at least quarterly or as required.

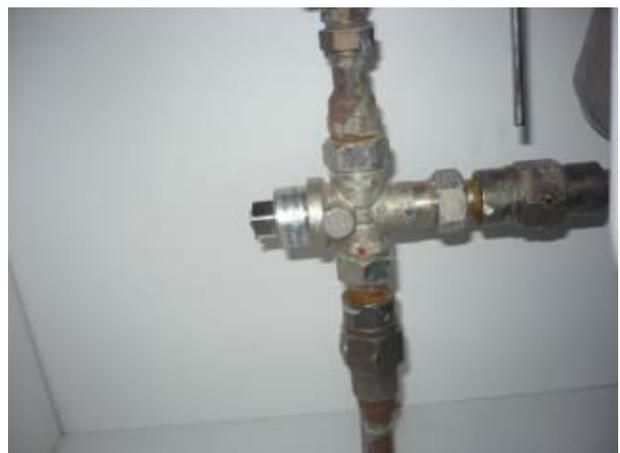
Ensure all TMV's are being serviced, maintained and adjusted if required; record when carried out.
