27 Upton Grey Close

INTRODUCTION

This report relates to a **Review** of the Legionella Risk Assessment that was carried out by Freeston Water Treatment in April 2009; this is the latest Risk Assessment for this building. The Review Survey was carried out at 27 Upton Grey Close, Harestock, Winchester, Hants SO22 6NE. The Review of Recommendations highlighted in the previous Risk Assessment was undertaken in order to comply with the Health and Safety Executive requirements on the control and prevention of Legionellosis. This Review has been carried out as asked for by Hampshire County Council in accordance with ACoP L8 'The control of Legionella bacteria in water systems' (APPROVED CODE OF PRACTICE & GUIDANCE) only:

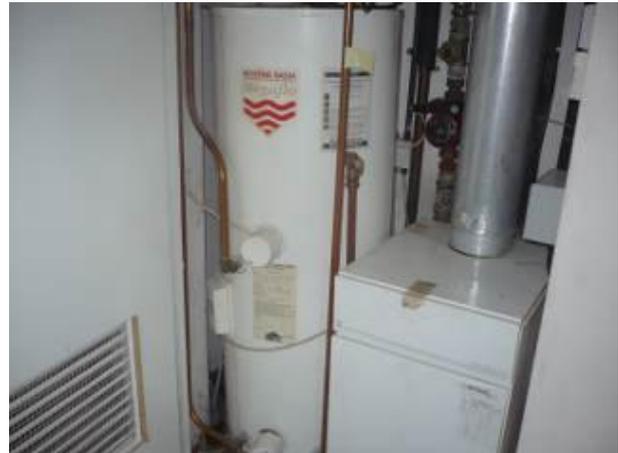
Calorifier Flow	55.0°C	This is Not Satisfactory
Calorifier Return	52.0°C	This is Satisfactory

27 Upton Grey Close domestic hot water calorifier; below recommended storage temperature of 60.0°C recorded at the time of this Review. Temperature monitoring should be carried out monthly on flow and return system.

Hot water should be stored at 60°C at all times; I would recommend adjustment to achieve this. The hot water return temperature should be maintained at 50°C or more at all times

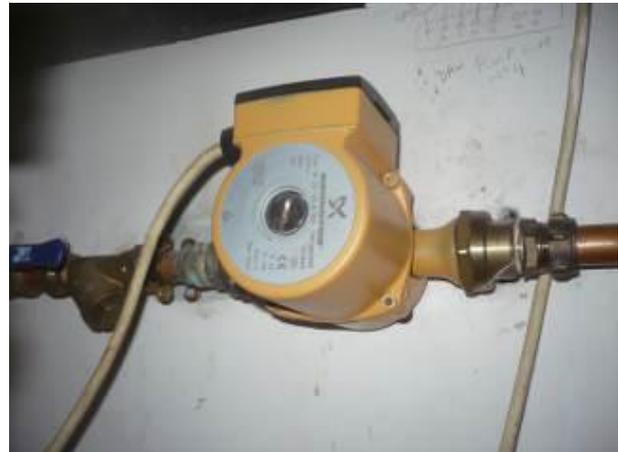
Calorifier hot water circulating / return pump; good return temperature recorded at the time of this Review. Temperature monitoring should be carried out monthly on flow and return system.

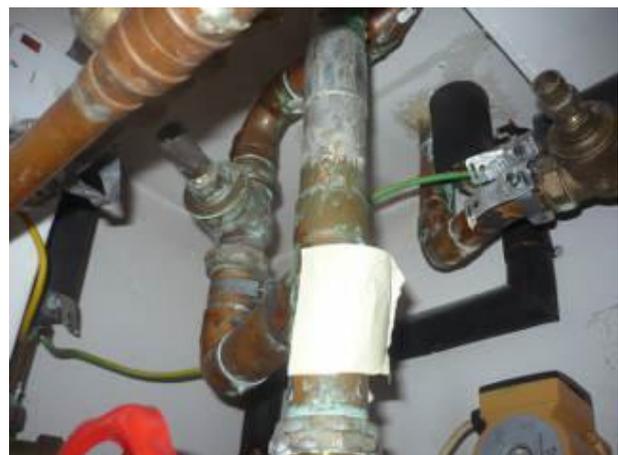
Insulation missing from calorifier pipe work; recommend pipe work is insulated to help prevent heat loss.

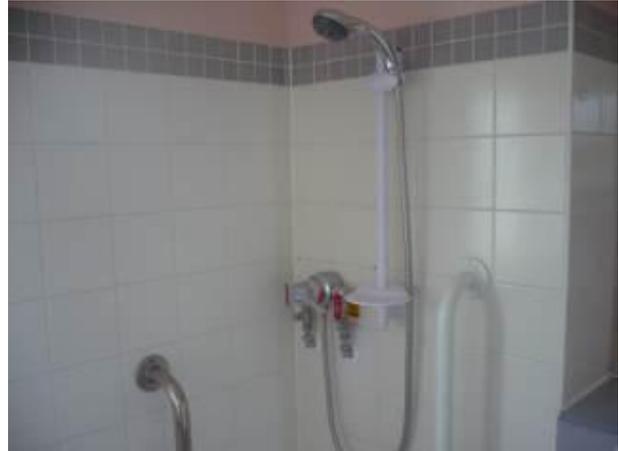
Ensure all showers are used regularly and start cleaning and disinfection regime as implemented by Hampshire County Council as soon as possible.

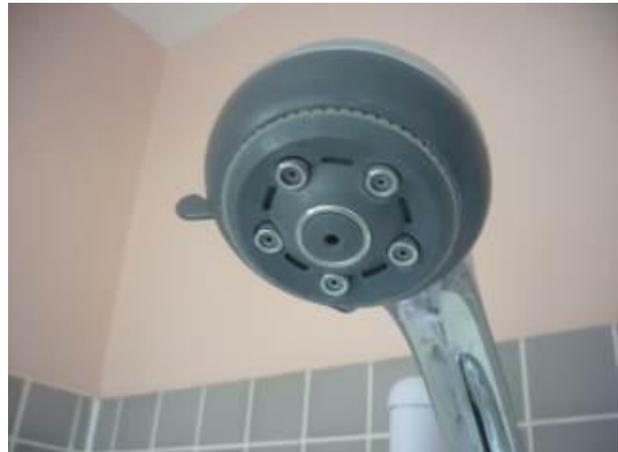
It was recommended in the original Risk Assessment that the adjustable showerheads within building 27 be replaced with new non adjustable showerheads this has not been carried out. I was informed that the procedures implemented by Hampshire County Council regarding the cleaning and disinfection and descaling are not being carried as recommended.

Showerheads have not been changed to the non adjustable type as recommended in the original Risk Assessment.

Replace adjustable spray showerheads with non adjustable item as recommended in HTM 04-01.

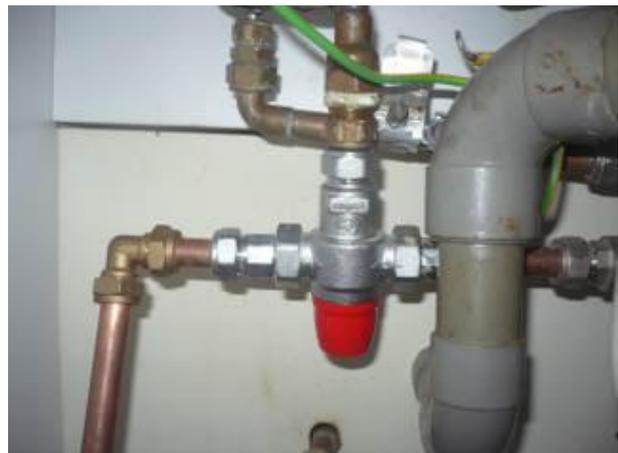
The TMV's within building 27 are being serviced and maintained by contractors EMCOR; this was last carried out in May 2011; it is assumed this is carried out annually.

Continue to service, maintain and adjust if required all TMV's; record when carried out.

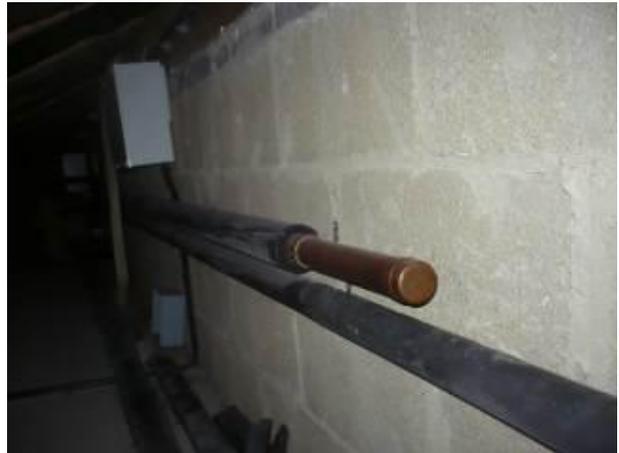
The deadleg pipe work that was highlighted in the original Risk Assessment has not been removed.

Deadleg pipe work highlighted in the original Risk Assessment in the roof void is still in place; recommend removal.

Remove dead legs.

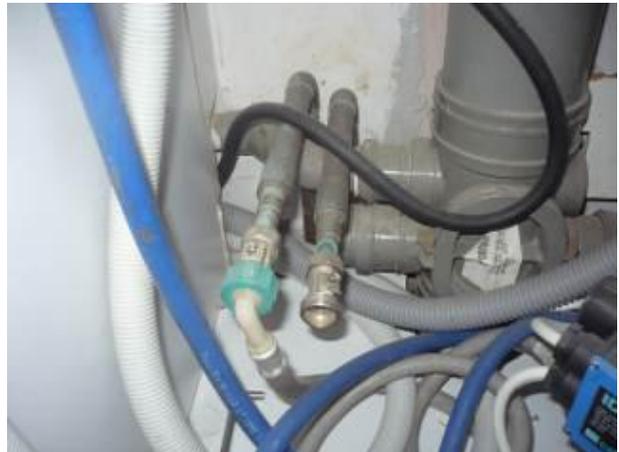
Deadleg pipe work seen by dishwasher in kitchen area.

This has not been carried out; possible deadleg pipe work seen in roof void and in kitchen by dishwasher.

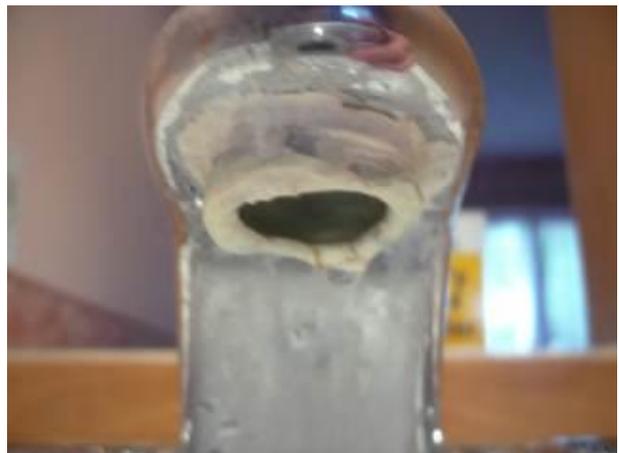
Scale build up on tap outlets could act as a nutrient for bacteria proliferation; recommend tap outlets are cleaned and descaled on a regular basis.

Scale build up on tap outlets can act as a nutrient for bacteria proliferation; I would recommend that tap outlets be cleaned and descaled on a regular basis.
