111 Leigh Road
Hampshire County Council

Site: 111 Leigh Road
Eastleigh
Hampshire SO50 9DS

Date of Assessment: 15th August 2011

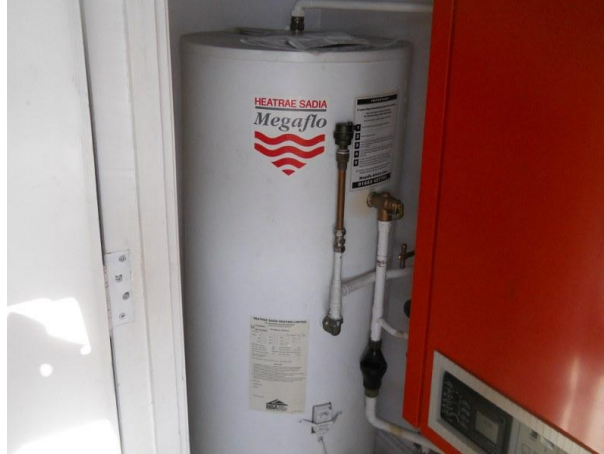
Cupboard in first floor rear/side office

At the time of the Survey the calorifier was not being heated by either the internal coil from the central heating boiler or the electrical element. I would recommend that the calorifier is brought back into service as soon as is practicable and brought up to 70°C for one hour before use to create a thermal disinfection and then kept at a minimum of 60°C at all times. There is no return system fitted to this unit.

Calorifier	Storage	24.6°C	Not Satisfactory
Calorifier	Return		No return system fitted

Calorifier.

I would recommend that the calorifier be purged to drain to check the water quality on at least a six monthly period and recorded within a water systems logbook when carried out. I was informed that it is unknown if this is being carried out.

There is no temperature gauge on the calorifier flow pipe and I would recommend that one be fitted.

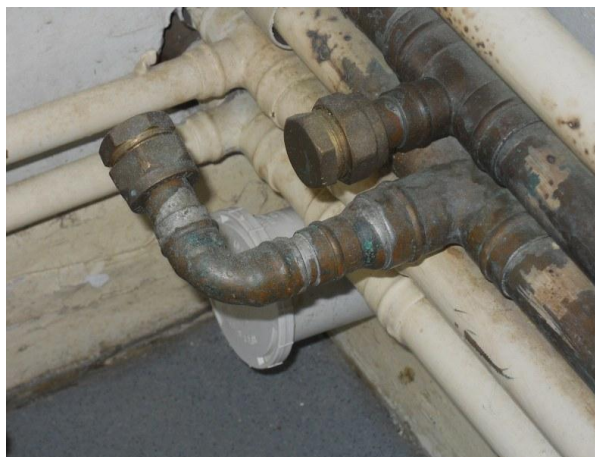
Ground floor toilet

- Ground Floor Toilet – There is a dead leg pipe on the domestic hot water pipe and another on the domestic cold water pipe.
- There are no showers on site.

Dead legs on the domestic hot and cold water pipes.

- Dead leg pipework are ideal areas for the proliferation of bacteria and should be removed or put on a weekly flushing regime (without creating an aerosol) and recorded. Dead legs were found in the following areas:-

Site Reference/ Address	Remedial/Recommendations	Priority	Date Actioned	Signature
<u>Distribution</u> 111 Leigh Road	Remove dead leg pipe work or put on a weekly flushing regime and record in the logbook when carried out.	5		
	I would recommend Bacteriological and Legionella water samples be taken if the temperatures fall out of the recommended limits.	3		
	Commence weekly flushing of all low use outlets, toilets, showers, outside taps etc and record when carried out.	5		
	Ensure that the TMV is serviced and maintained regularly.	3		
	Create a water services logbook.	4
