<b>Client Address</b>	<b>Hampshire County Council PBRS Three Minsters House 76 High Street Winchester Hampshire SO23 8UL</b>
<b>Site Name</b>	<b>Addenbrooke OPH and Day Centre</b>
<b>Site Address</b>	<b>Willis Road Gosport Hampshire PO12 1NA</b>
<b>Site contact</b>	<b>Sue Webber</b>
<b>Site telephone number</b>	<b>02392 581088</b>
<b>Last risk assessment carried out by</b>	<b>Freeston Water Treatment Limited</b>
<b>Date of risk assessment</b>	<b>May 2011</b>
<b>Date of previous review</b>	<b>N/A</b>
<b>Date of new review</b>	<b>2<sup>nd</sup> April 2012</b>
<b>Review carried out by</b>	<b>Mr Chris Wilson</b>

This Review has been carried out in accordance with ACoP L8 'The control of Legionella bacteria in water systems' (APPROVED CODE OF PRACTICE & GUIDANCE) and BS 8580 (RISK ASSESSMENTS FOR LEGIONELLA CONTROL-CODE OF PRACTICE).

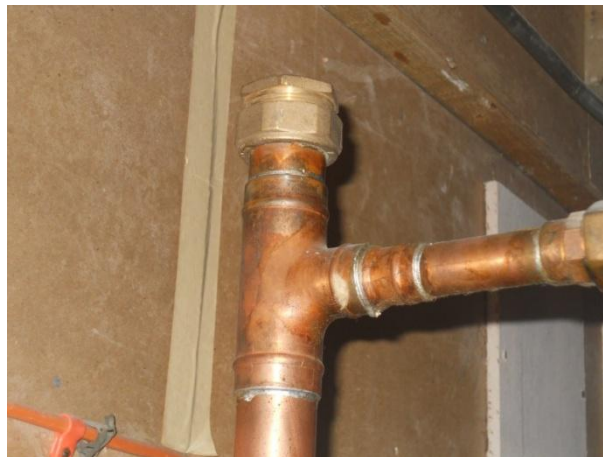
### Tank Room

Dead leg on the mains cold water supply to the feed and expansion tank.

- Tank Room - There is a dead leg on the mains cold pipe to the inlet pipe of the heating boilers feed and expansion pipe.
  - Tank Room - There is a dead leg on the mains cold pipe that used to be connected to the domestic cold water storage tank.

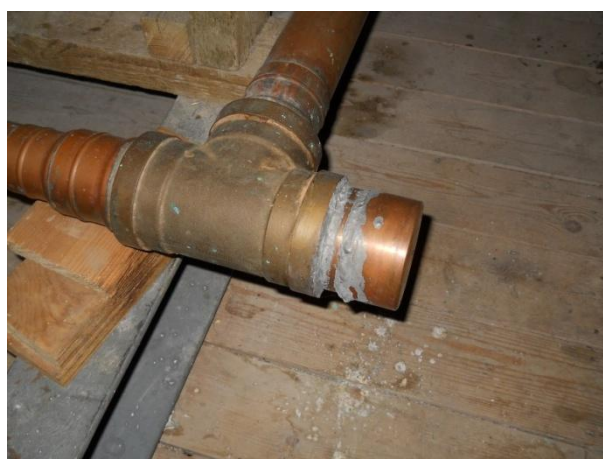
### Tank Room

Dead leg on the mains cold water pipe that used to be connected to the outlet pipe of the now disconnected domestic cold water tank.

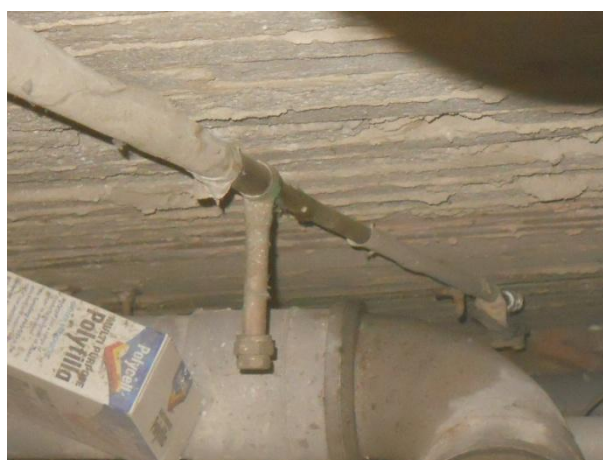
### Tank Room

Dead leg on the mains cold water pipe in the void space under the plasterboards.

- Tank Room - There is a dead leg on the mains cold water pipe in the void space under the plasterboard panels.
  - Boiler Room - There is a bypass pipe valve on the water softener that is shut. This is creating a dead leg either side of it.

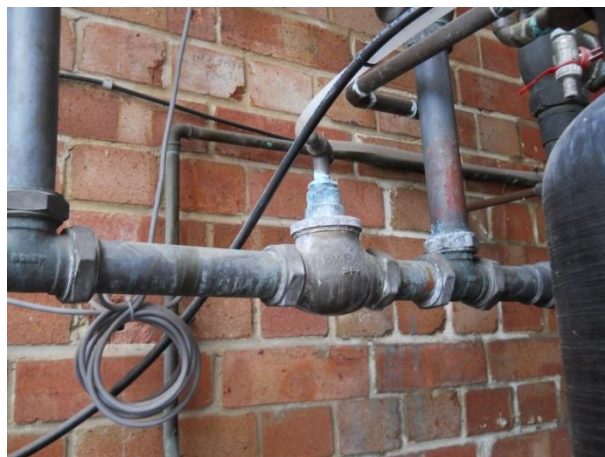
### Boiler Room

Dead legs either side the shut valve on the bypass pipe on the water softener.

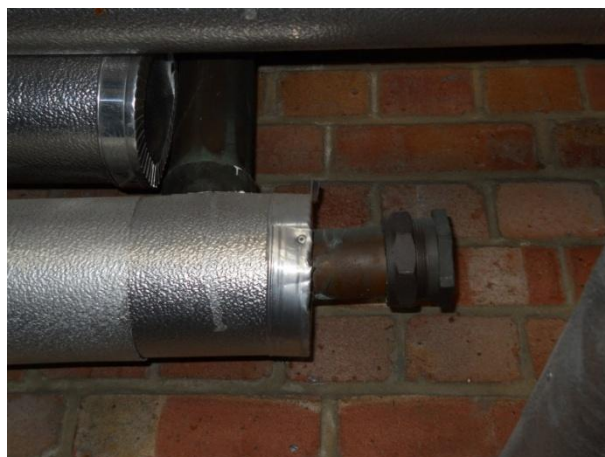
### Boiler Room

Dead leg on the softened mains water pipe at the rear of the room.

- Boiler Room - There is a dead leg on the softened cold water pipe at height at the rear of the room.
  - Boiler Room - There is a pipe to a temperature gauge on the new flow pipework on calorifier no. 1 that is too long and should be shortened to remove the dead leg.

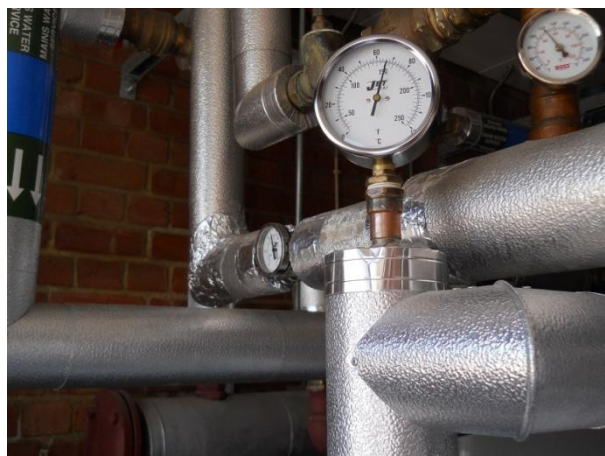
### Boiler Room

There are temperature gauges on the on flow and return pipes. The second temperature gauges from calorifier on the flow pipes of both calorifiers are inaccurate. They should be replaced but in reality there were gauges on the existing pipework when the new calorifiers were installed. New gauges were fitted at the time nearer to the calorifiers and therefore these gauges are not needed.

The pipe to the temperature gauge on the flow pipe of calorifier no. 1 is too long and is creating a dead leg.

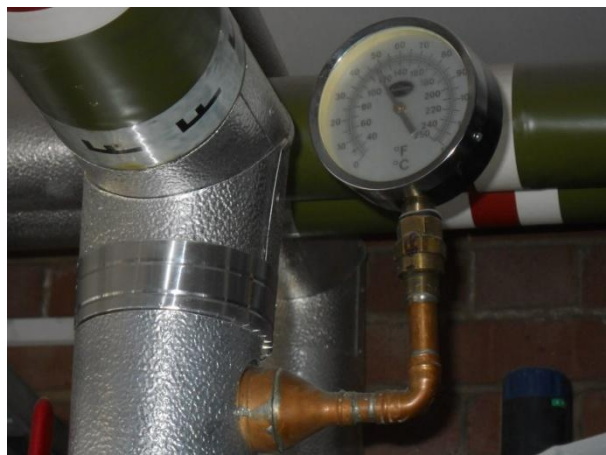
### Boiler Room

The pipe to the temperature gauge on the flow pipe of calorifier no. 1 is too long and is creating a dead leg.

- Boiler Room - There is a pipe to a temperature gauge on the old flow pipework on calorifier no. 1 that is too long and no longer needed and should be removed.

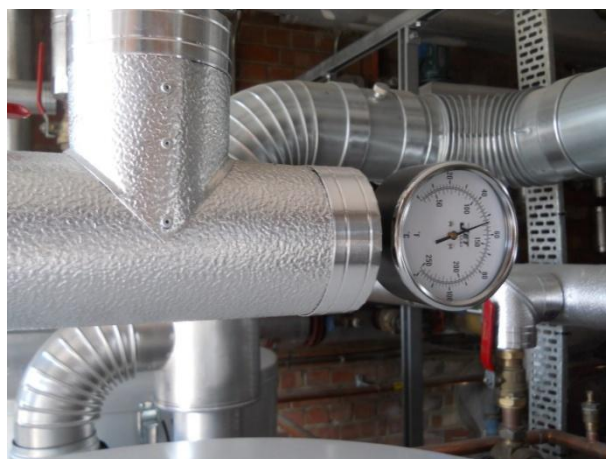
### Boiler Room

The pipe to the temperature gauge on the flow pipe of calorifier no. 2 is too long and is creating a dead leg.

- Boiler Room - There is a pipe to a temperature gauge on the new flow pipework on calorifier no. 2 that is too long and should be shortened to remove the dead leg.

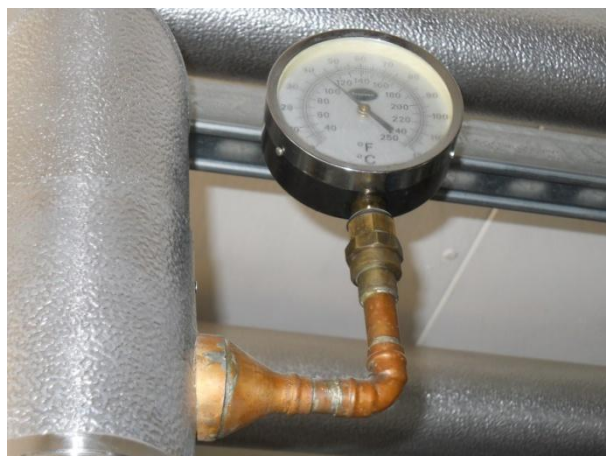
### Boiler Room

The pipe to the temperature gauge on the flow pipe of calorifier no. 2 is too long and is creating a dead leg.

- Boiler Room - There is a pipe to a temperature gauge on the old flow pipework on calorifier no. 2 that is too long and no longer needed and should be removed.

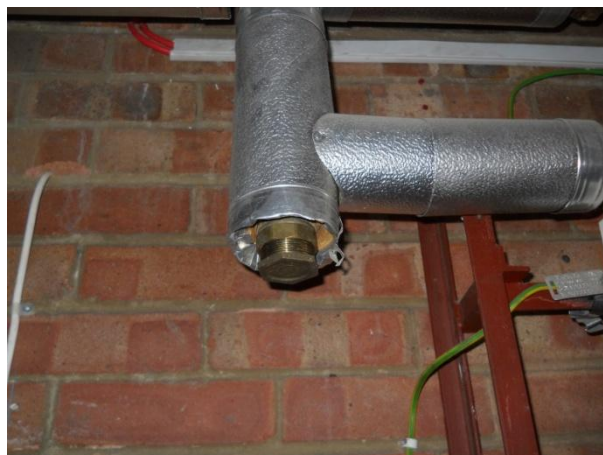
### Boiler Room

One of the four dead legs on the flow circulation pump assembly.

- Boiler Room - There are four dead leg pipes on the hot flow circulation pumps assembly.
  - Boiler Room - There is a pipe to a temperature gauge on the return pipework that is too long and no longer needed and should be removed.

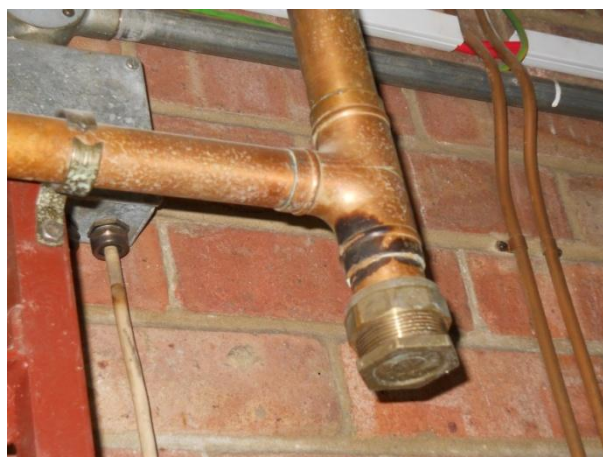
### Boiler Room

One of the four dead legs on the flow circulation pump assembly.

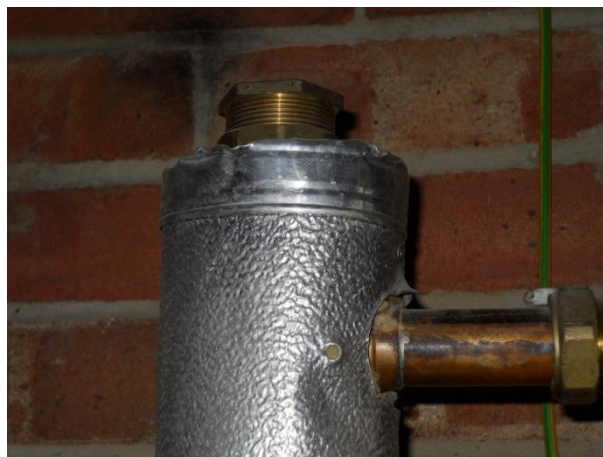
### Boiler Room

One of the four dead legs on the flow circulation pump assembly.

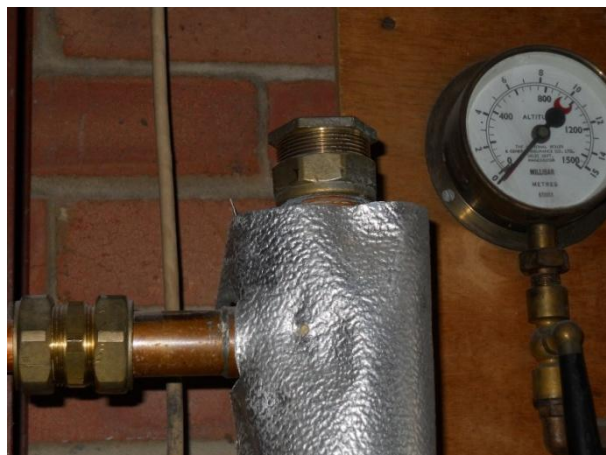
### Boiler Room

One of the four dead legs on the flow circulation pump assembly.

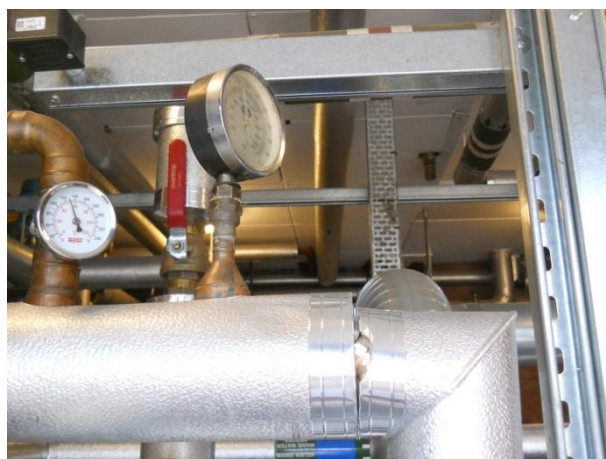
### Boiler Room

The pipe to the temperature gauge on the return pipe is too long and is creating a dead leg.

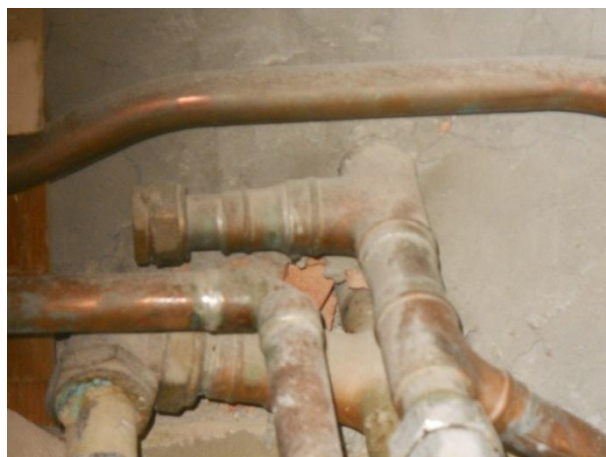
### Unit 4 Bathroom

Dead leg behind the panel.

- Unit 4 Bathroom (wrongly referred to as Unit 3 Bathroom in the Risk Assessment Report) There is a dead leg behind the large panel near the wash basin.

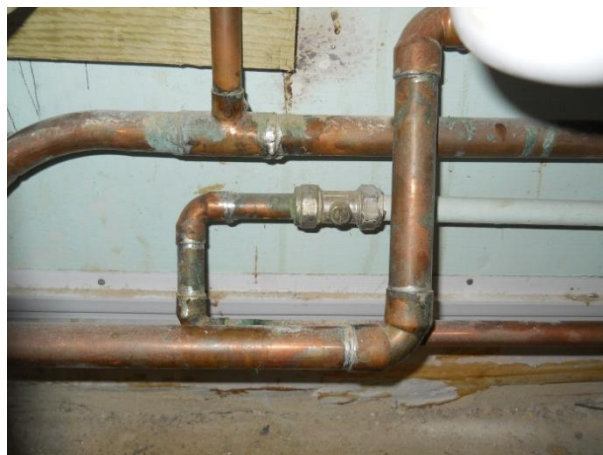
**Unit 4 Bathroom**

Dead leg behind the panel.

The bathroom within Unit 4 has had an ongoing positive Legionella issue and during this Review I removed various panels to try and find a possible problem which could cause this. A new dead leg pipe identified since the Risk Assessment survey was found on the hot water pipe behind the panel under the hand basin. This 15mm copper pipe has a ballfix valve which is in the closed position and is creating a dead leg back to the hot water header pipe. The pipe continues after the valve and enters the wall cavity behind the large panels on the right of the hand basin where it penetrates the floor below and the wall to the left. It should be investigated further to ascertain what the two pipes supply. This dead leg should be removed back to the header pipe, put on a weekly flushing regime (without creating an aerosol) or the two pipes it supplies be put back into service as soon as is practicable. **If the two pipes are to be brought back into service then it is of paramount importance that they (and all associated pipes and any appliances and outlets that they supply) be cleaned and disinfected before first use.**

- Unit 4 Bathroom – A new dead leg pipe identified since the Risk Assessment survey was found on the hot water pipe behind the panel under the hand basin. This 15mm copper pipe has a ballofix valve which is in the closed position and is creating a dead leg back to the hot water header pipe. The pipe continues after the valve and enters the wall cavity behind the large panels on the right of the hand basin where it penetrates the floor below and the wall to the left. It should be investigated further to ascertain what the two pipes supply. This dead leg should be removed back to the header pipe or the two pipes it supplies be put back into service.

**If the two pipes are to be brought back into service then it is of paramount importance that they (and all associated pipes and any appliances and outlets that they supply) be cleaned and disinfected before first use.**

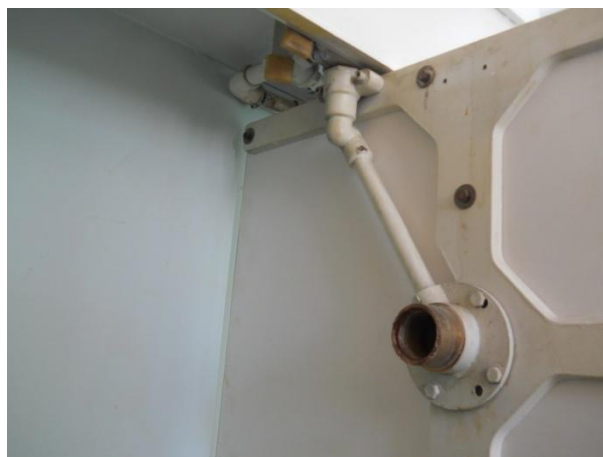
**All site**

Ensure all fire hose supply pipes are fully disconnected from the mains cold water supply leaving no dea

- The fire hoses have been removed but some of the pipework remains. I was unable to ascertain if all this pipework is completely disconnected from the mains water supply or are dead legs. This should be investigated further and appropriate action taken if found to be still connected.
