CONTENTS

Client Address	Hampshire County Council PBRS Three Minsters House 76 High Street Winchester Hampshire SO23 8UL
Site Name	Bickerley Green NCU
Site Address	Kingsbury Lane Ringwood Hampshire BH24 1EL
Site contact	Jacque Milford
Site telephone number	01425 473312
Last risk assessment carried out by	Freeston Water Treatment Limited
Date of risk assessment	April 2011
Date of previous review	N/A
Date of new review	4th April 2012
Review carried out by	Mr Chris Wilson

This Review has been carried out in accordance with ACoP L8 'The control of Legionella bacteria in water systems' (APPROVED CODE OF PRACTICE & GUIDANCE) and BS 8580 (RISK ASSESSMENTS FOR LEGIONELLA CONTROL-CODE OF PRACTICE).

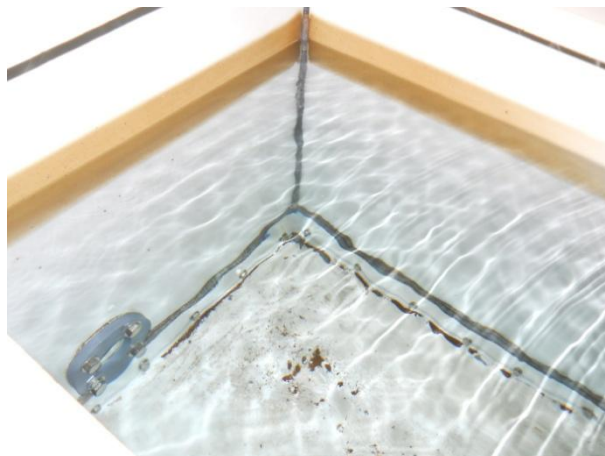
The inside of the tank no. 1 (nearest to the roof space access hatch) showed a light deposit of sediment on the base and a medium to heavy amount of biofilm on the sides.

Sediment, corrosion and biofilm act as nutrients and an ideal environment for the proliferation of bacteria including Legionella.

Internal view of cold water storage tank no. 1.

The vessels were last cleaned and disinfected on the 9th May 2011 and I would recommend that this be carried out again within the near future.

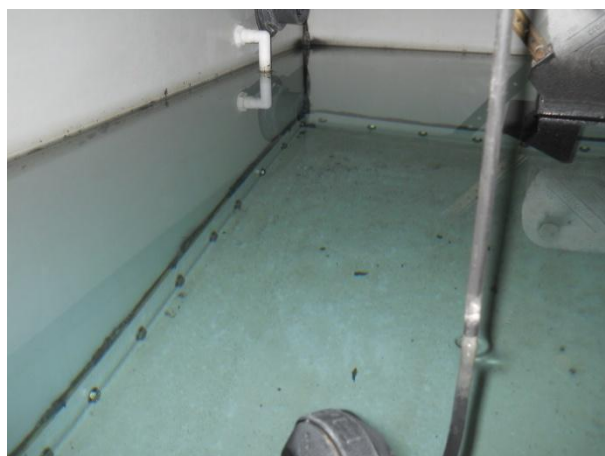
The inside of the tank no. 2 showed a light deposit of sediment on the base and a medium amount of biofilm on the sides.

Internal view of cold water storage tank no. 2.

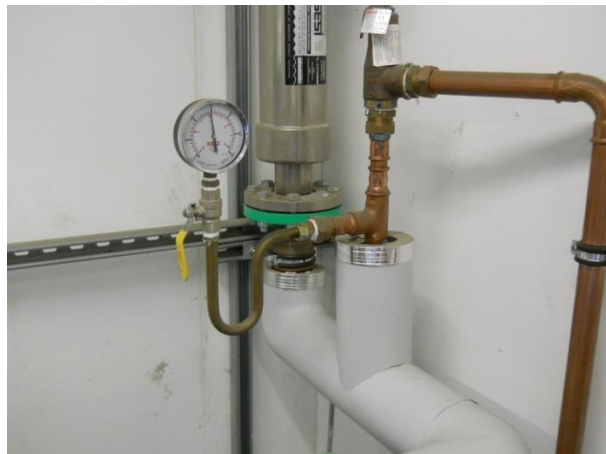
Swan neck dead leg type pipe and also the pipe to the pressure relief valve is too long creating a dead leg. These are on the outlet of the cold water booster pump set.

- Dead leg pipework are ideal areas for the proliferation of bacteria and should be removed or put on a weekly flushing regime (without creating an aerosol) and recorded. Dead legs were found in the following areas:-

- Boiler Room - There is a swan neck type dead leg pipe to the pressure gauge on the outlet pipe of the booster pump set. The pipe that it is on is to the pressure relief valve, this pipe is too long and also creating a dead leg and should be shortened as far as possible.

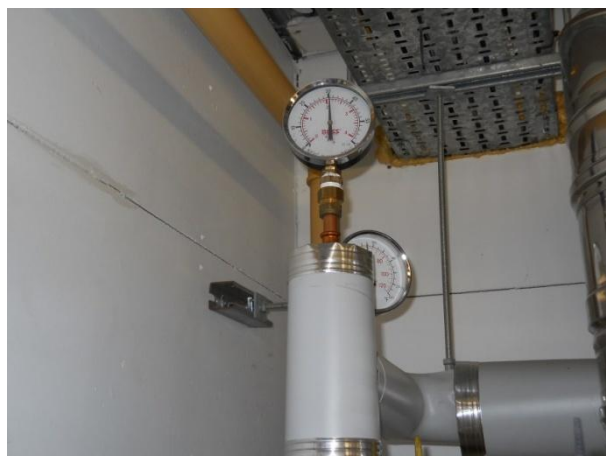
Pipe to the pressure gauge on the calorifier flow pipe is too long and creating a dead leg.

- Boiler Room - The pipe to the pressure gauge on the flow pipe of the calorifier is too long and creating a dead leg.
 - Boiler Room - The drain on the pipe from the tanks to the booster pump set is too long and creating a dead leg.

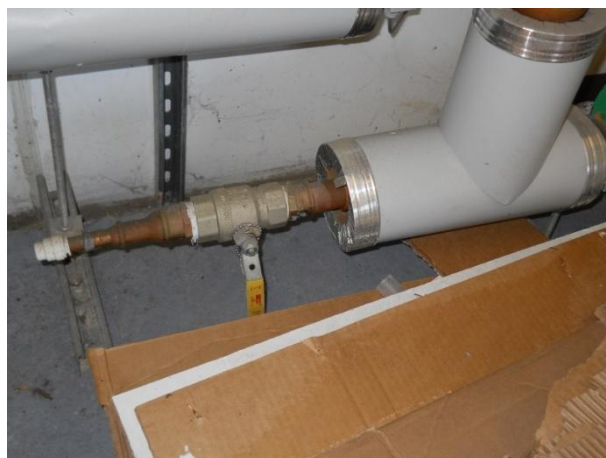
Boiler Room

The drain on the pipe from the domestic cold water storage tanks to the booster pump set is too long a creating a dead leg.
