Client Address	Hampshire County Council PBRs Three Minsters House 76 High Street Winchester Hampshire SO23 8UL
Site Name	Cranleigh Paddock Resource Centre OPH
Site Address	Calpe Avenue Lyndhurst Hampshire SO43 7AT
Site contact	Jenny Parsons
Site telephone number	02380 283602
Last risk assessment carried out by	Freeston Water Treatment Limited
Date of risk assessment	April 2011
Date of previous review	N/A
Date of new review	29th March 2012
Review carried out by	Mr Chris Wilson

This Review has been carried out in accordance with ACoP L8 'The control of Legionella bacteria in water systems' (APPROVED CODE OF PRACTICE & GUIDANCE) and BS 8580 (RISK ASSESSMENTS FOR LEGIONELLA CONTROL-CODE OF PRACTICE).

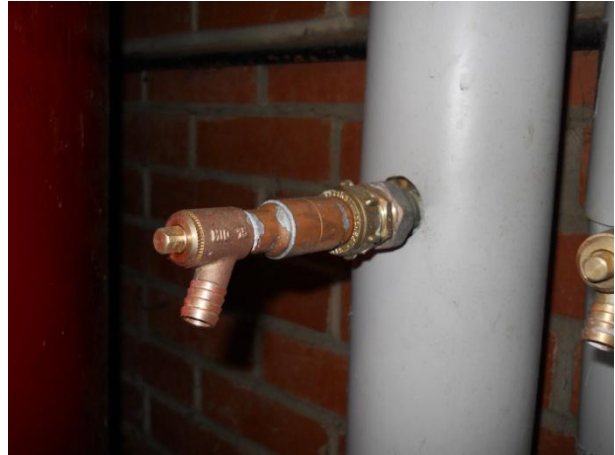
Dead leg on the mains cold water riser. This has replaced the inoperable valve dead leg as a temporary measure (as the water could not be shut off for long) and requires weekly flushing.

- Boiler Room - There is a drain pipe on the mains cold water rising main. The pipe is too long and is therefore a dead leg. This has replaced the inoperable valve dead leg as a temporary measure (as the water could not be shut off for long) and requires weekly flushing.

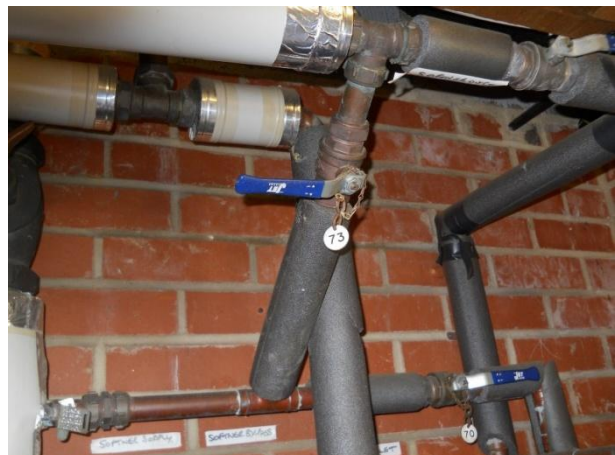
Dead leg on the water softener bypass pipe.

- Boiler Room - There is a valve on the mains cold water, water softener bypass pipe that is closed and this is creating a dead leg either side of it.

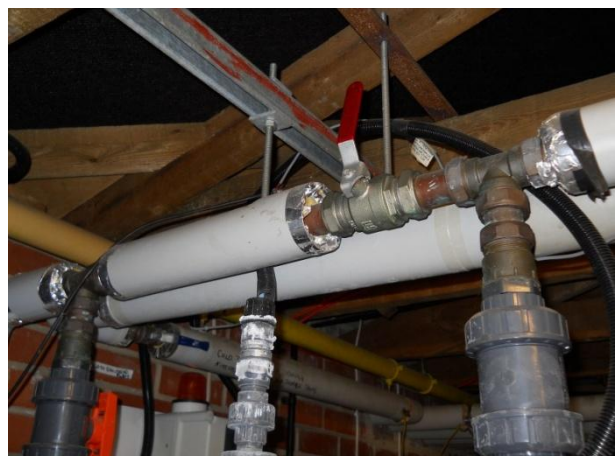
Dead leg on the water filter bypass pipe.

- Boiler Room - There is a valve on the softened cold water, water filter bypass pipe that is closed and this is creating a dead leg either side of it.

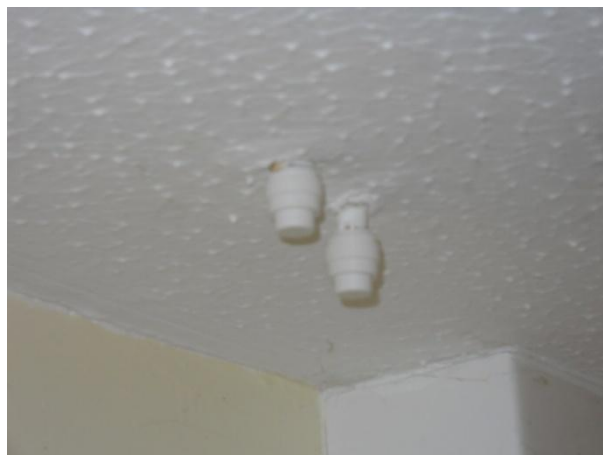
Toilet next to Room 57

Dead legs in ceiling.

- Oakwood Wing toilet next to room 57 - There are two capped dead leg pipes protruding through the ceiling.
 - Main Kitchen - There are two dead legs behind the water softener.

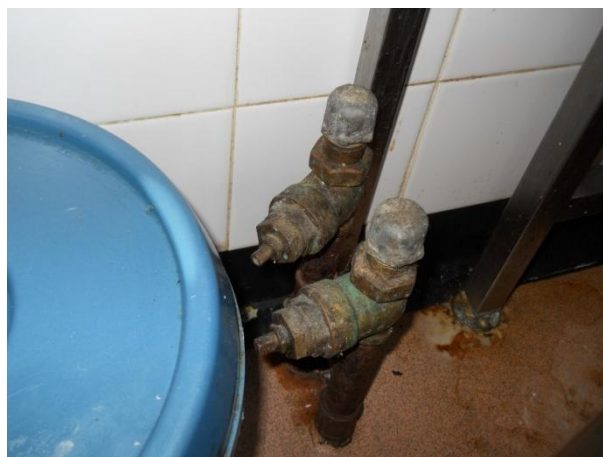
Main Kitchen

Dead legs behind the water softener.

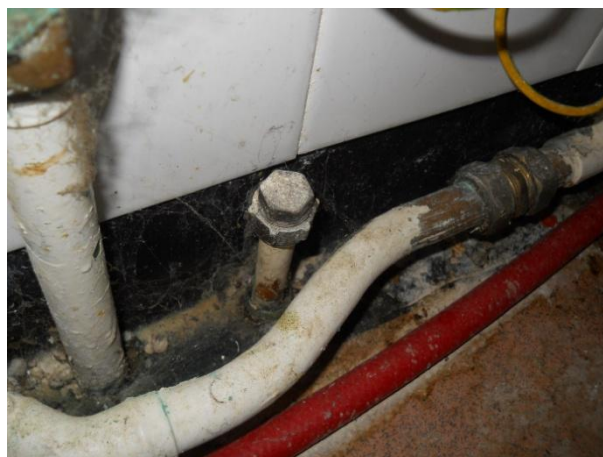
Dead leg behind the sinks.

- Main Kitchen - There is a dead leg behind the sinks.
 - Laundry - There is a dead leg on the wall between the washing machines and the sinks.
 - Medical Room - There are two dead legs protruding through the ceiling on the left side of the room.

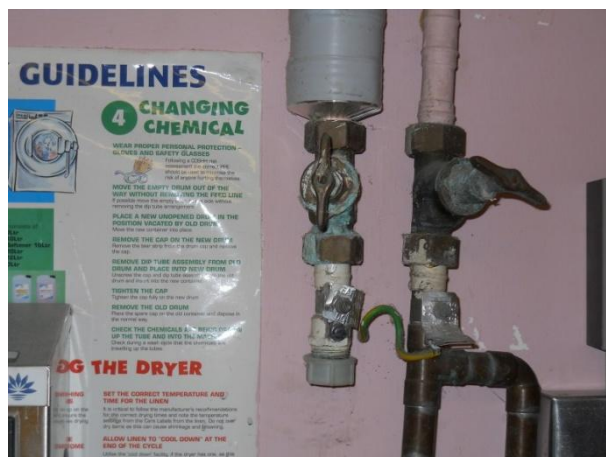
Laundry

Dead leg.

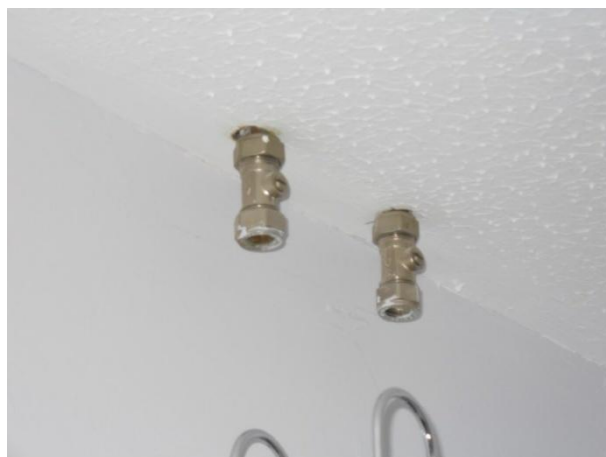
Medical Room

Dead legs in ceiling.

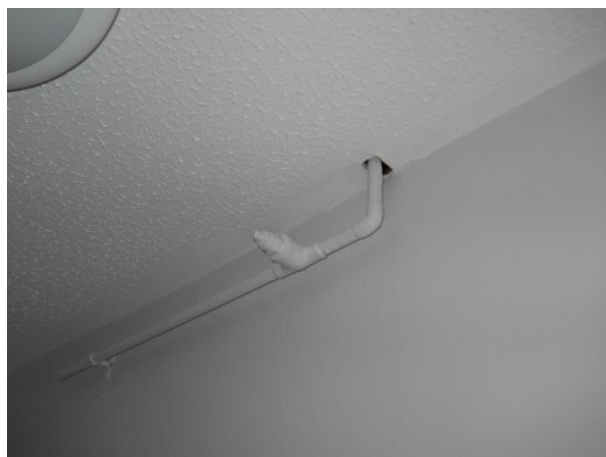
Medical Room

Dead leg in ceiling.

- Medical Room- There is dead leg protruding through the ceiling on the right side of the room.
 - Receptionists Room - There is a dead leg from the floor.

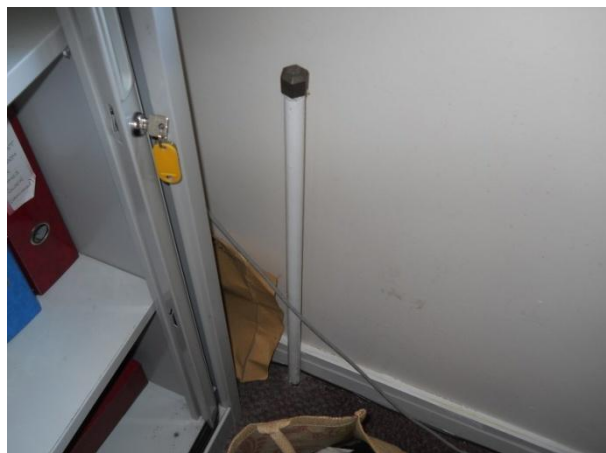
Receptionists Room

Dead leg

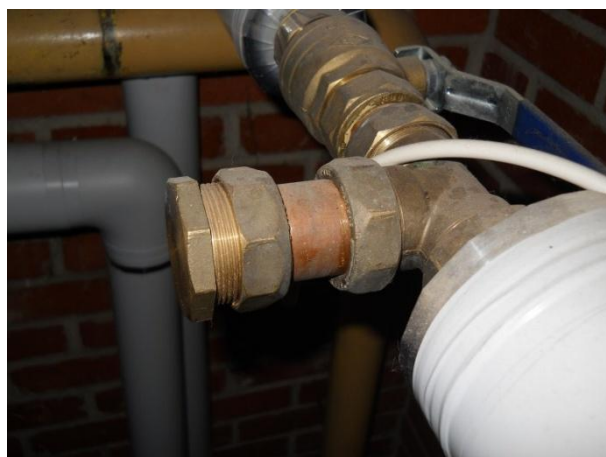
Dead leg on the common return pipe.

- Boiler Room - There is a dead leg on the common return pipe to the right side of calorifier no. 1.
- Purge the calorifier and hot water storage vessel to drain on at least an annual basis and record when carried out.

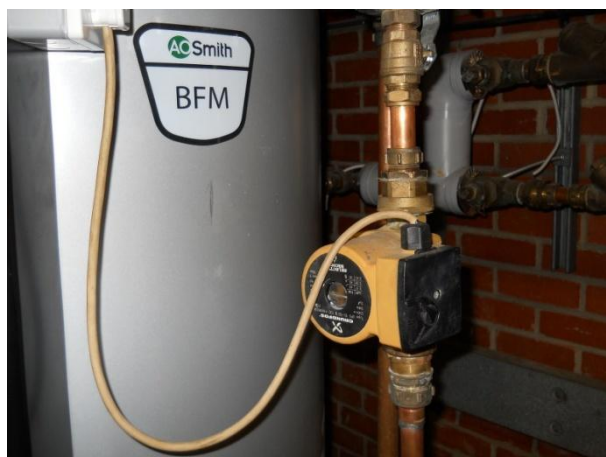
Boiler Room

Each calorifier is fitted with an anti-stratification pump to circulate the water around the calorifier. At the time of the survey the pump on calorifier no. 1 (the furthest calorifier from the entrance) was not working and this should be rectified as soon as is practicable. The pump on calorifier no. 2 appeared to be working correctly.

The faulty anti-stratification pump on calorifier no. 1.

- Repair or replace the faulty anti-stratification pump on calorifier no. 1.
- Commence monthly temperature monitoring of inlet pipe to the TMV's (not just the blended water outlet) and record in the water systems logbook.
