Fernmount House  
Hampshire County Council

**Date of Assessment:** 26<sup>th</sup> July 2011

This report relates to a water source Risk Assessment carried out by Mr Chris Wilson of Freeston Water Treatment Ltd on the 26<sup>th</sup> July 2011 on behalf of Hampshire County Council. The Survey was carried out at the Fernmount House, Forest Pines, New Milton, Hampshire BH25 5SX. During the course of the Survey water systems within the properties were risk assessed. These sources were chosen as being fully representative of the overall domestic water systems and outlets within the buildings.

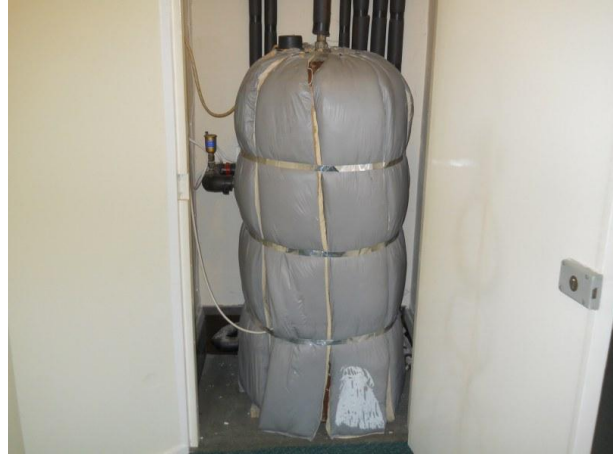
Hot water storage at Fernmount House is by one calorifier located within a cupboard outside the office. The manufacturer of the calorifier is unknown and it is a domestic copper cylinder type unit. The calorifier has a fibre jacket type insulation and the unit is indirectly heated by the central heating boiler via an internal coil. There is also an electric immersion heater fitted as a back up. The calorifier supplies all the hot water on site. There is no return system fitted to this calorifier and it is supplied by the domestic cold water storage tank within the roof space.

I would recommend that the calorifier be purged to drain to check the water quality on at least a six monthly period and recorded within a water systems logbook when carried out. I was informed that it is not thought that this is being carried out.

L8 recommends that calorifiers are checked internally for scale and sludge on an annual basis. It is unknown if this is being carried out.

There is no temperature gauge on the calorifier flow pipe and I would recommend that a temperature gauge be fitted to allow monthly temperature monitoring to be carried out.

Cupboard outside of the office

Calorifier.

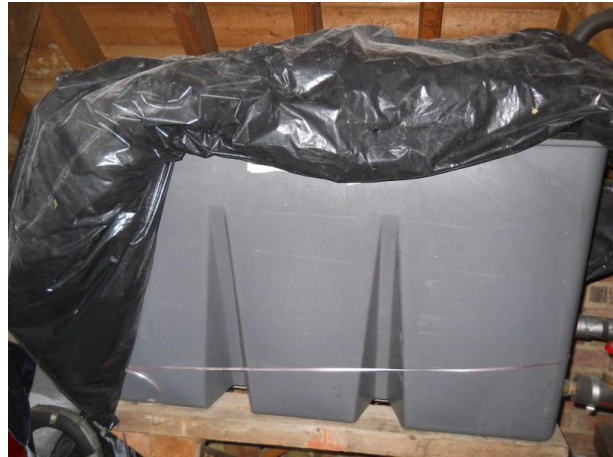
Domestic cold water storage at Fernmount House consists of one domestic cold water storage tank located within the roof space. The tank is of a one piece plastic construction with fibre jacket insulation to the body and lid which needs refitting. There is no screened lid vent and no screen on the overflow pipe and I would recommend that WRAS (Water Regulations Advisory Scheme) approved items be fitted.

As the vessel is under 1000 litres in capacity there is no requirement for an overflow warning pipe to be fitted. There is a returning vent pipe entering the vessel and I would recommend that this is re-routed to a foul drain via an air gap and the hole in the lid be covered with a WRAS approved material.

An external view of the domestic cold water storage tank.

Notes	<p>Clean and disinfect as soon as is practicable; repeat annually if deemed necessary.</p> <p>Replace the corroded overflow pipe fitting.</p> <p>Take water temperatures from the tank on a six monthly basis and record within the logbook.</p> <p>Fit a WRAS approved screened lid vent.</p> <p>Fit a WRAS approved screen to the overflow pipe.</p> <p>Re-fit the insulation.</p> <p>Re-route the returning vent pipe to a foul drain via an air gap and cover the hole in the lid with a WRAS approved material.</p>
-------	--

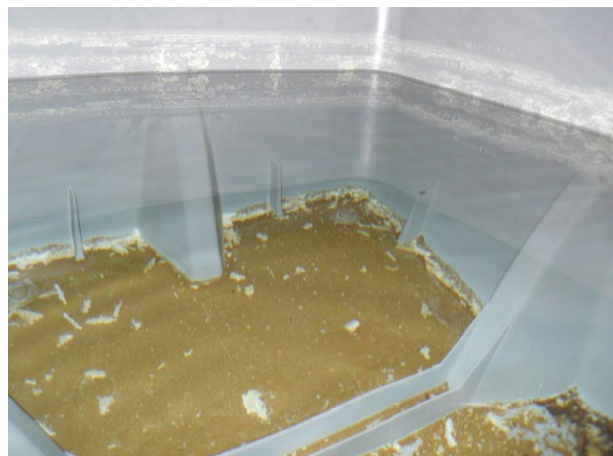
The inside of this vessel showed a heavy deposit of sediment on the base, a heavy amount of biofilm on the sides and heavy corrosion on the steel overflow pipe fitting. It is unknown when this vessel was last cleaned and disinfected and I would recommend that this is carried out as soon as is practicable and the corroded pipe fitting be replaced.

An internal view of the domestic cold water storage tank.

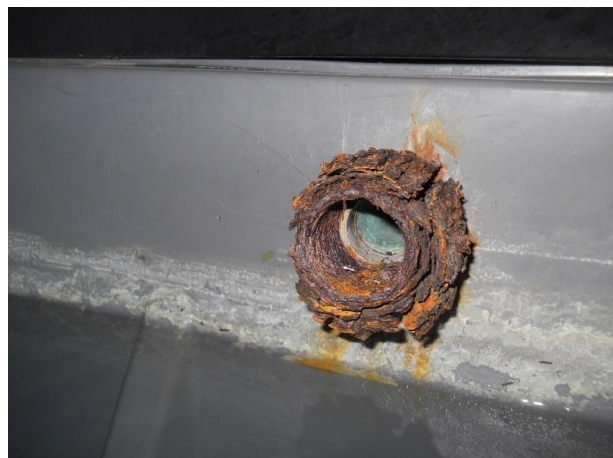
An internal view of the domestic cold water storage tank showing the corroded overflow pipe fitting.

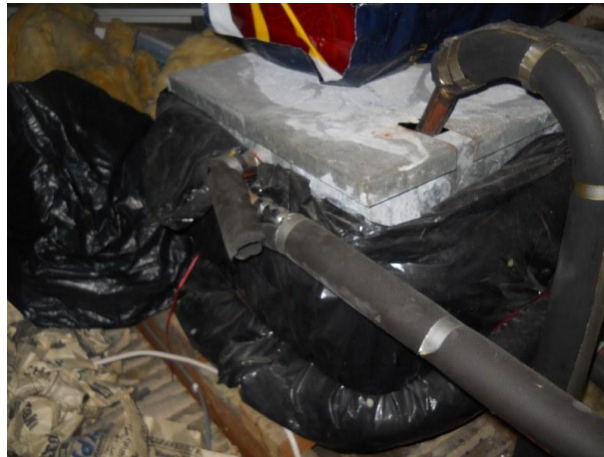
### Roof Space

- Roof Space - The supply pipe to the redundant and drained heating boiler feed and expansion tank is shut at the valve and this pipe has become a dead leg.

The mains cold water dead leg pipe to the redundant and drained central heating boiler feed and expansion tank.

Site Reference/ Address	Remedial/Recommendations	Priority	Date Actioned	Signature
<u>Distribution</u> Fernmount House	Remove dead leg pipe work or put on a weekly flushing regime and record in the logbook when carried out.	5		
	I would recommend Bacteriological and Legionella water samples be taken if the temperatures fall out of the recommended limits.	3		
	Continue <b>weekly</b> flushing of <b>all</b> low use outlets, toilets, showers, outside taps etc and record when carried out.	3		
	Clean and descale showerheads quarterly, or as necessary. Record when carried out.	3		
	Ensure that all TMV's are serviced and maintained regularly.	5
