CONTENTS

Client Address	Hampshire County Council PBR Three Minsters House 76 High Street Winchester Hampshire SO23 8UL
Site Name	Forest Court NCU
Site Address	Forest Way Tatchbury Mount Calmore Hampshire SO40 2PZ
Site contact	Jan Cresdee
Site telephone number	02380 664770
Last risk assessment carried out by	Freeston Water Treatment Limited
Date of risk assessment	May 2011
Date of previous review	N/A
Date of new review	14th March 2012
Review carried out by	Mr Chris Wilson

SITE REVIEW

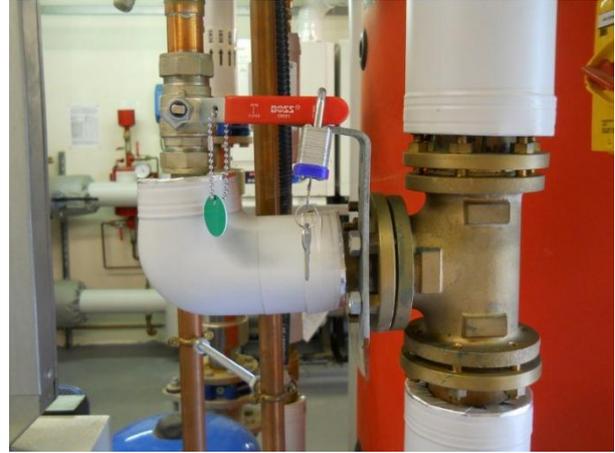
The fill pipe from the booster pumps to the calorifiers has a small dead leg on the supply pipe to the standby calorifier as it is too long and should be shortened as much as possible.

- Boiler Room – The fill pipe from the booster pumps to the calorifiers has a small dead leg on the supply pipe to the standby calorifier as it is too long and should be shortened as much as possible.

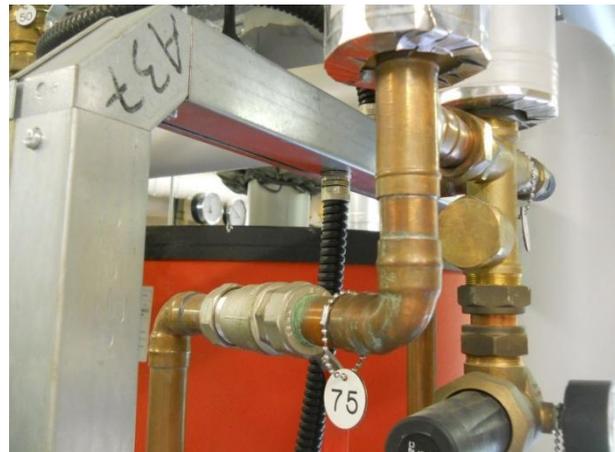
The fill pipe from the booster pumps to the standby calorifiers has a small dead leg on the drain valve as the pipe is too long and should be shortened as much as possible.

- Boiler Room - The fill pipe from the booster pumps to the standby calorifiers has a small dead leg on the drain valve as the pipe is too long and should be shortened as much as possible. **This only applies when the standby calorifier is in service and the pipe is charged, it is currently empty.**

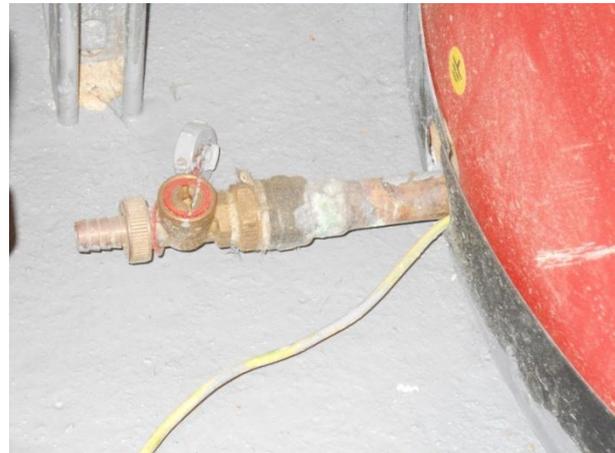
There is a small dead leg on the hot water storage vessel drain as it is too long and should be shortened as much as possible.

- Boiler Room - There is a small dead leg on the hot water storage vessel drain as it is too long and should be shortened as much as possible.
 - Boiler Room - There is a small dead leg on the flow pipe on top of the calorifier.

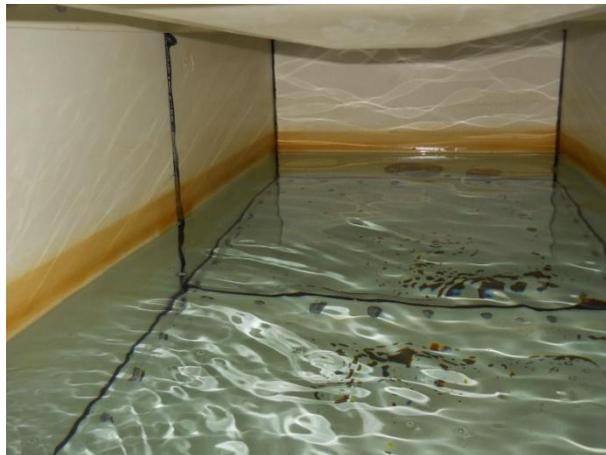
The inside of the tank no. 1 (nearest to the roof space access hatch) showed a medium deposit of sediment on the base and a medium amount of biofilm on the sides.

Sediment, corrosion and biofilm act as nutrients and an ideal environment for the proliferation of bacteria including Legionella.

Internal view of cold water storage tank no. 1.

The vessels were cleaned and disinfected on the 26th May 2011 and I would therefore recommend that it be carried out again.

- Clean and disinfect the domestic cold water storage tanks. Inspect annually and repeat if required.
- Fit extra insulation to the cold water storage tank inlet valve housing lids if needed in hotter months.

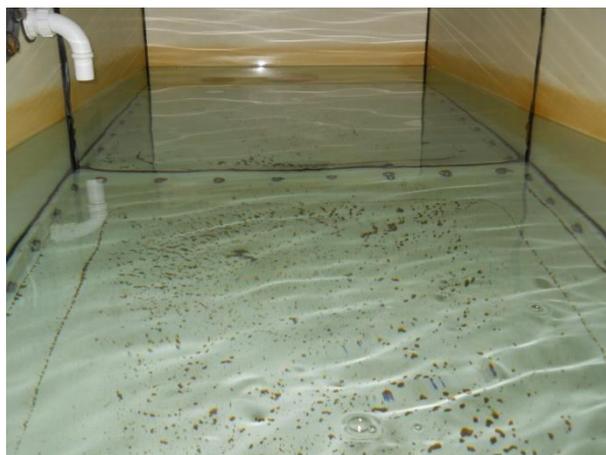
The inside of the tank no. 2 (furthest the roof space access hatch) also showed a medium deposit of sediment on the base and a medium to heavy amount of biofilm on the sides.

Internal view of cold water storage tank no. 2.

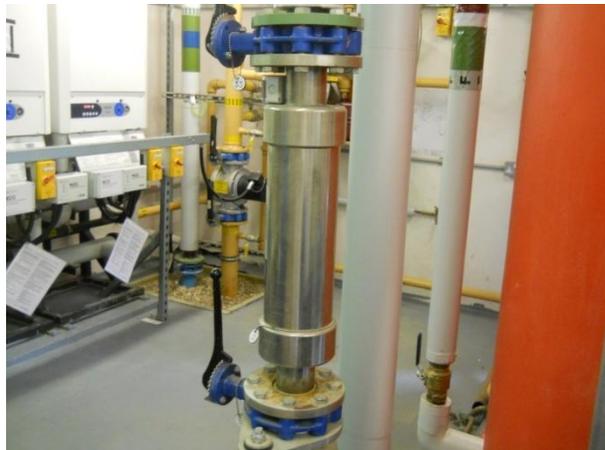
Boiler Room

Scale reducer device.

- Ensure schematic drawings are maintained up to date and file copies within the water systems logbook.
- There is an inline scale reducing device on the inlet of the cold water booster pump set in the boiler room and on the supply pipe to the electric water boiler within the main kitchen. Both should be cleaned / maintained in line with the manufacturer's recommendations. It is not thought that this is being carried out.

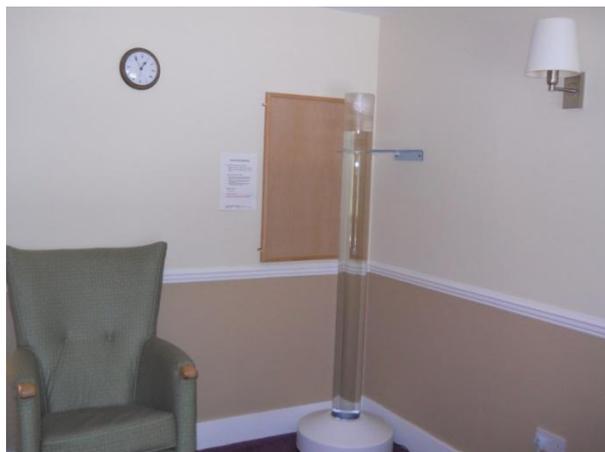
Sensory Room

Bubble tube.

- The bubble tube in the Sensory room should be dosed with an appropriate and safe biocide, cleaned and maintained in line with manufacturer's recommendations. I was informed that it is not known if this being carried out.

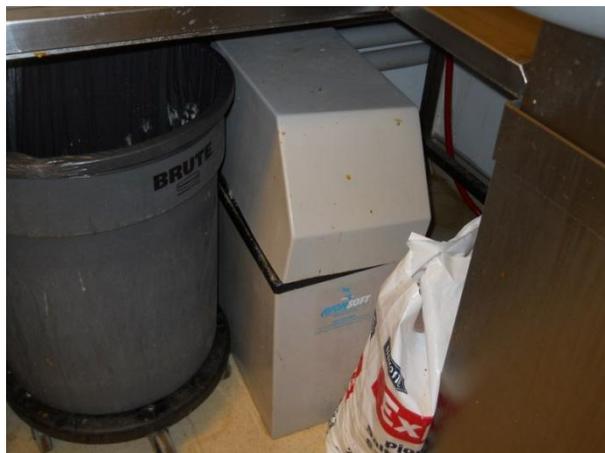
Main kitchen wash up area

Water softener.

- There is a water softener for the dishwashers within the main kitchen wash up area. This should be disinfected and maintained in line with the manufacturer's recommendations. It is unknown if this is being carried out.

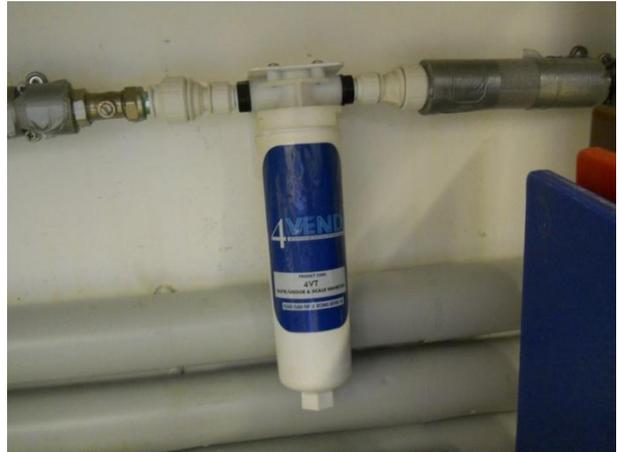
Main Kitchen

Scale inhibitor on electric water boiler.

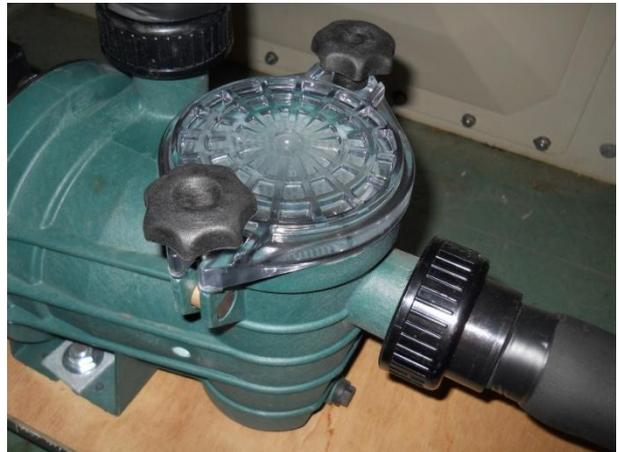
Roof Space

Circulation pump and filter / strainer on the domestic cold water storage tanks.

- I would recommend Bacteriological and Legionella water samples be taken if the temperatures fall out of the recommended limits.
- All tests, servicing and maintenance on the Silver / Copper Ionisation unit (and pump, strainer / filter) should be carried out and at the correct intervals in line with the manufacturers recommendations.

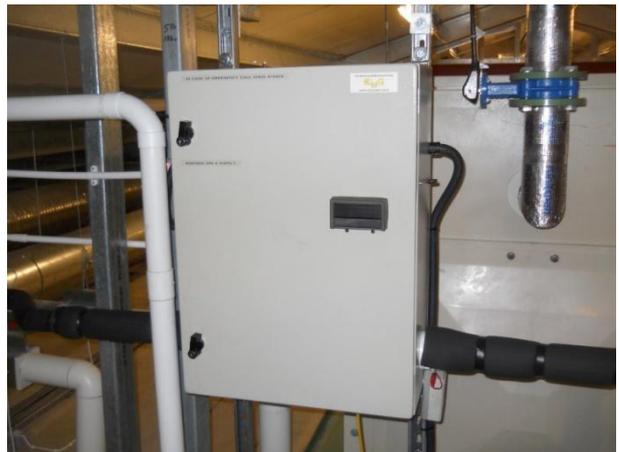
Roof Space

The steel housing containing the Silver / Copper Ionisation unit on the domestic cold water storage tanks circulation system.

Records within a separate logbook (held within the main office) show that the Silver/Copper Ionisation unit is being inspected monthly by the supplier - EMG Water Tech (LM) Ltd. although no work report could be found for January 2012.
