<b>Client Address</b>	<b>Hampshire County Council PBRs Three Minsters House 76 High Street Winchester Hampshire SO23 8UL</b>
<b>Site Name</b>	<b>Hawthorne Court NCU</b>
<b>Site Address</b>	<b>Coldeast way Sarisbury Green Southampton Hampshire SO31 7LX</b>
<b>Site contact</b>	<b>Felicity Dennis</b>
<b>Site telephone number</b>	<b>01489 556720</b>
<b>Last risk assessment carried out by</b>	<b>Freeston Water Treatment Limited</b>
<b>Date of risk assessment</b>	<b>April 2011</b>
<b>Date of previous review</b>	<b>N/A</b>
<b>Date of new review</b>	<b>30th March 2012</b>
<b>Review carried out by</b>	<b>Mr Chris Wilson</b>

This Review has been carried out in accordance with ACoP L8 'The control of Legionella bacteria in water systems' (APPROVED CODE OF PRACTICE & GUIDANCE) and BS 8580 (RISK ASSESSMENTS FOR LEGIONELLA CONTROL-CODE OF PRACTICE).

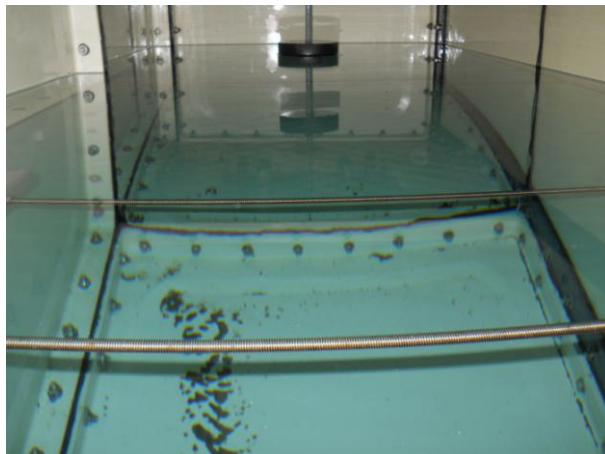
The inside of the tank no. 1 (left side) showed a light deposit of sediment on the base and a slight amount of biofilm on the sides. The inside of the tank no. 2 (right side) showed a light deposit of sediment on the base and a slight amount of biofilm on the sides.

Sediment, corrosion and biofilm act as nutrients and an ideal environment for the proliferation of bacteria including Legionella.

Internal view of cold water storage tank no. 1.

The vessels were last cleaned and disinfected on the 20<sup>th</sup> May 2011 and I would recommend that they be cleaned and disinfected again within the near future.

- Commence six monthly temperature monitoring of the cold water storage tank and record results within the logbook.
- Clean and disinfect the domestic cold water storage tanks within the near future. Inspect the tanks annually and repeat if required.

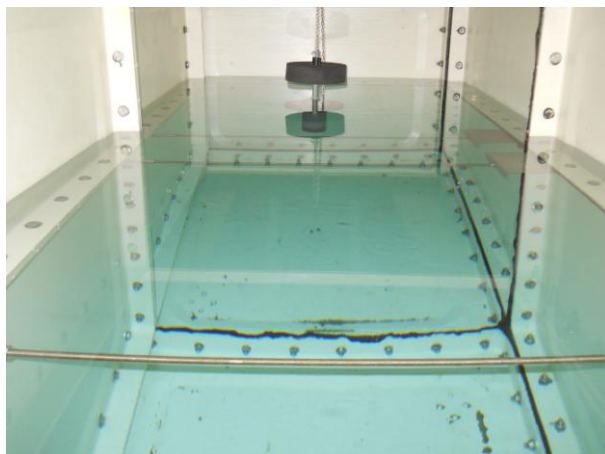
Internal view of cold water storage tank no. 2.

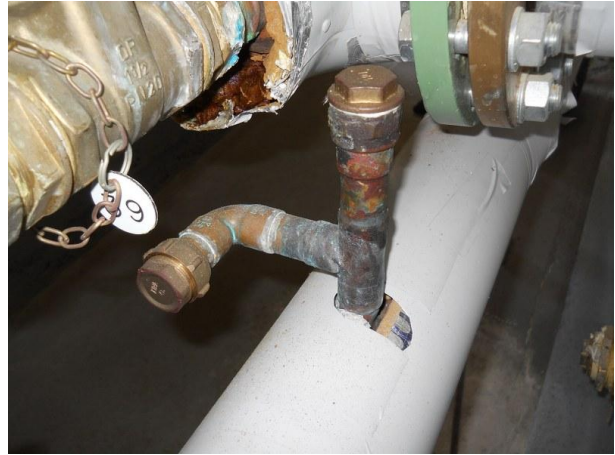
### Boiler Room

There is a dead leg on the boosted cold water supply pipe to the calorifier.

- Dead leg pipework are ideal areas for the proliferation of bacteria and should be removed or put on a weekly flushing regime (without creating an aerosol) and recorded. Dead legs were found in the following areas:-

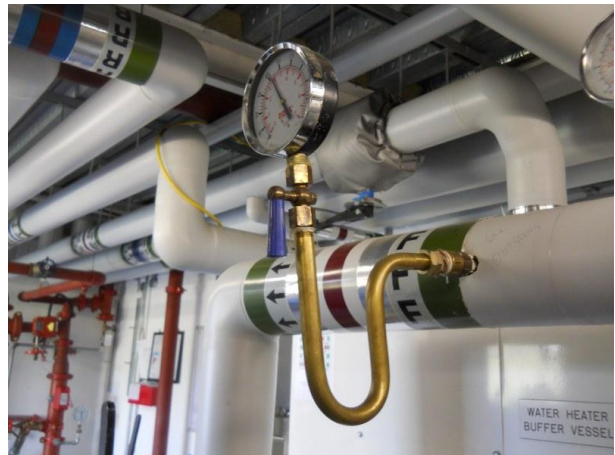
### Boiler Room

There is a swan neck type dead leg pipe to the pressure gauge on the flow pipe of the calorifier to the storage vessel.

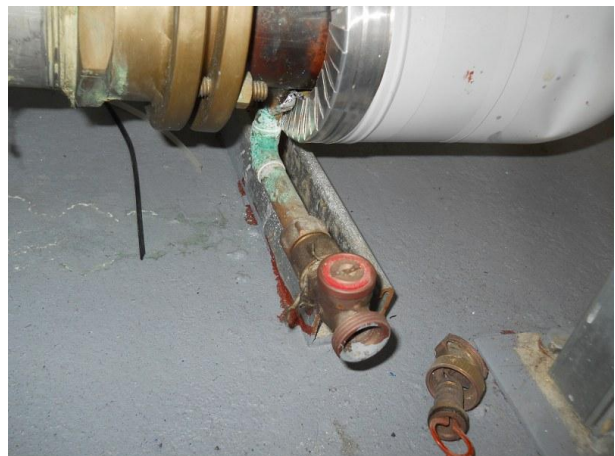
### Boiler Room

Boiler Room – The drain on the outlet pipe of the booster pump set is too long and creating a dead leg

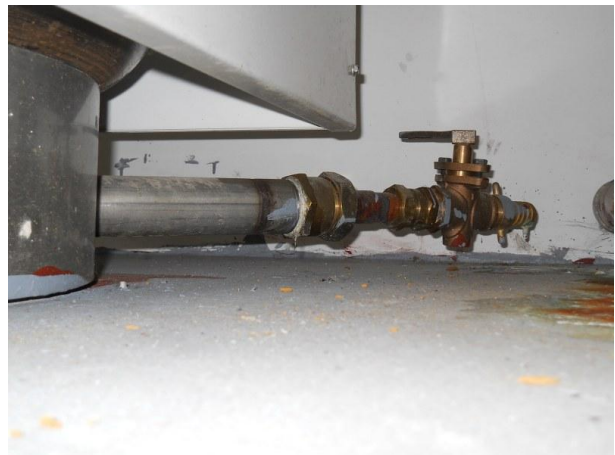
### Boiler Room

The drain on the bottom of the hot water storage vessel is too long and creating a dead leg.

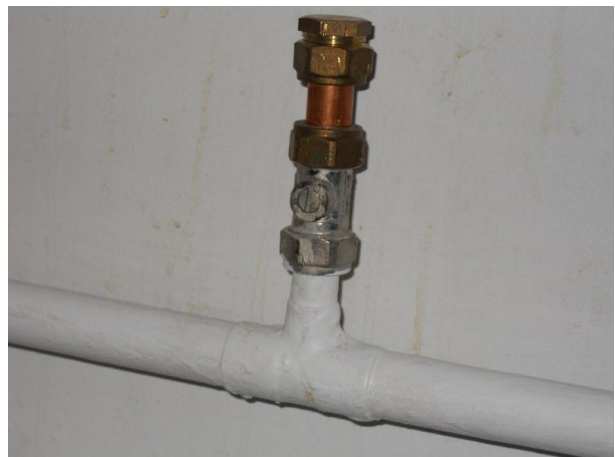
### Main Kitchen

Small dead leg behind the dishwasher.
