Customer: Hampshire County Council

Site: Lakeside School
Winchester Road
Chandlers Ford
Hampshire SO53 2DW

Date of Assessment: 7th June 2010

INTRODUCTION

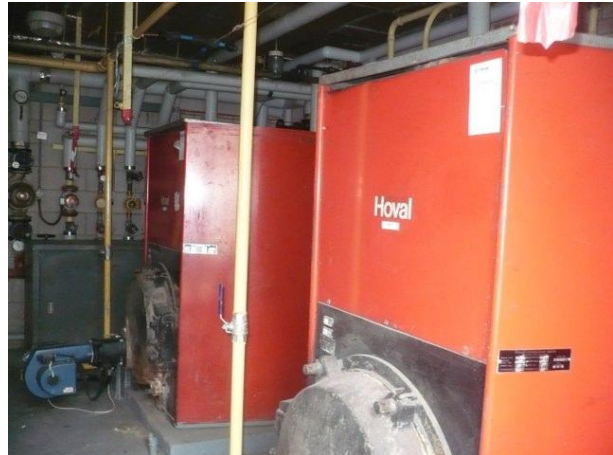
Main Boiler Room

There are no temperature gauges on the calorifiers and I would recommend that gauges are fitted to the flow pipework on each unit for monthly temperature monitoring to be carried out.

Calorifier No 1	Storage	53.4°C	Not Satisfactory
Calorifier No 1	Return		No Return Fitted
Calorifier No 2	Storage	46.0°C	Not Satisfactory
Calorifier No 2	Return		No Return Fitted

The flow temperatures on both units is too low and I would recommend that the calorifiers be adjusted to increase the temperatures to a minimum of 60°C at all times

Combi boiler / calorifier No.'s 1 and 2.

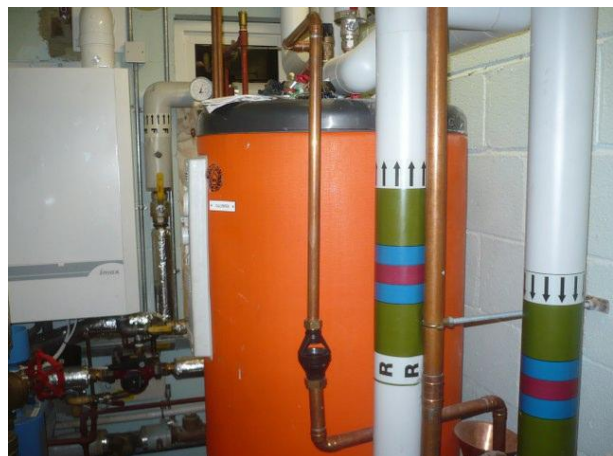
Residential Block Plant Room

There are no temperature gauges on this unit and I would recommend that gauges are fitted to the flow and return pipework for monthly temperature monitoring to be carried out.

Calorifier No 3	Storage	64.1°C	Satisfactory
Calorifier No 3	Return	55.1°C	Satisfactory

Calorifier No. 3.

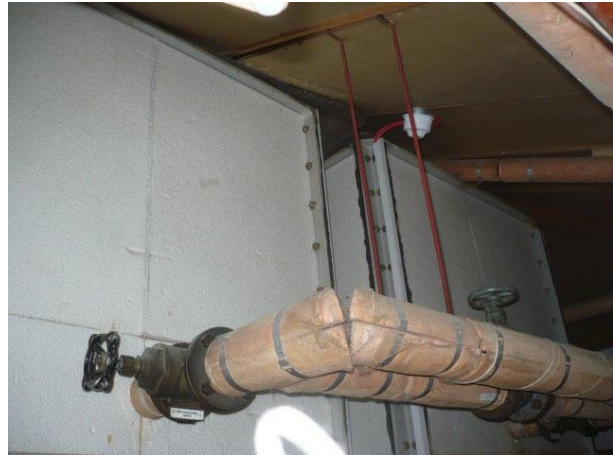
Office Block Roof Space

The domestic cold water storage cisterns are of a sectional GRP construction with polystyrene sheet insulation. The access to the lids of both vessels is so small that I could not survey the lids or internally. I was informed that neither vessel has been cleaned and disinfected in at least 5 years and as the access to carry out this work is so restrictive I feel it is unlikely that a satisfactory result could be achieved and I would therefore recommend that both vessels are disconnected and the outlet pipework be converted to a mains cold water supply. It must be ensured that when carrying out this work that no dead legs are created.

There is a single returning vent pipe into the lid of both cisterns and I would recommend that they are removed and piped to a foul drain via an air gap. There is a valved bypass pipe connecting the two outlet pipes and this is acting as a dead leg and should be opened once a week to flush it.

External view of cold water storage
cisterns No.'s 1 and 2.

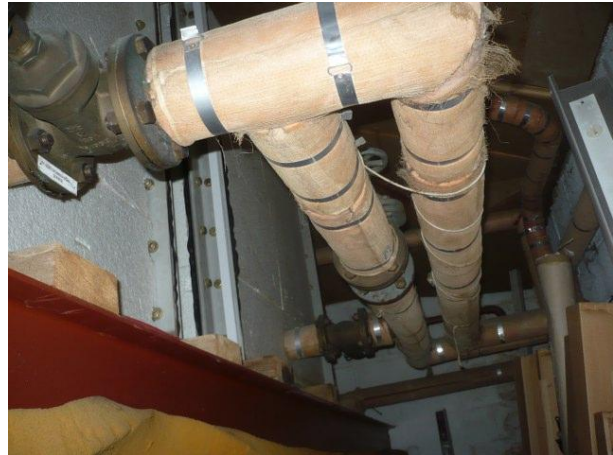
Office Block Roof Space

Dead leg on the valved bypass pipe.

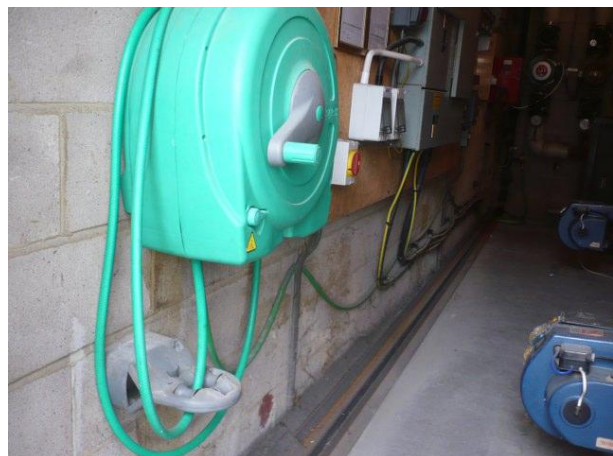
- There is a mains cold water fed bib tap in the Boiler Room on the far wall which has a hose pipe attached to it. The hose pipe feeds a hose pipe reel that is fixed to the wall. The hose is un-insulated and in a warm environment this will create ideal conditions for the proliferation of bacteria including Legionella. I would recommend that the hose pipe is fixed as close to the bib tap as possible and is drained after every use before rolling back onto the reel. The hose must be flushed and drained every week when not used.

Un-insulated feed pipe to hose reel.

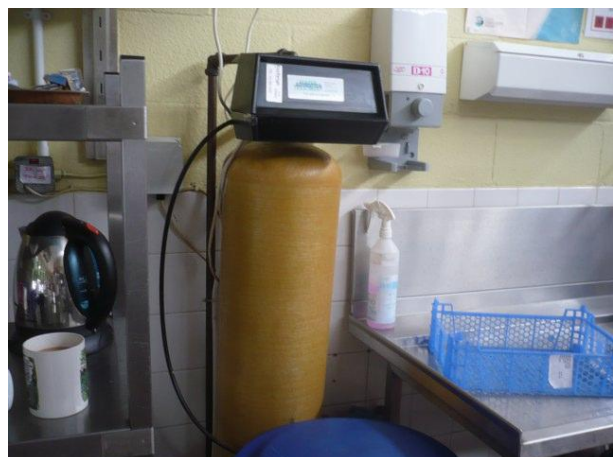
- There is a water softener in the Main Kitchen for the dishwasher and this should be serviced and maintained in-line with the manufacturer's recommendations. I was informed that it is unknown if this is currently being carried out.
- There is an inline water filter on the water cooler in the Dining Area and this should be cleaned / replaced inline with the manufacturer's recommendations. It is unknown if this is being carried out.

Water softener.

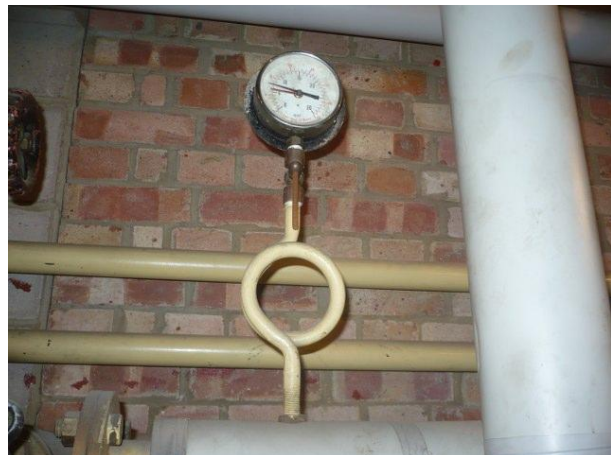
- Main Kitchen on the right side of the dishwasher on the cold pipe
 - Main Boiler Room a pigtail dead leg is on the hot flow pipe.
 - The Headmasters House the water in this building has been isolated but it should be ensured that no dead legs remain from the valve where it has been isolated to the mains cold water underground stop cock.
- The shower heads and hoses must be cleaned and disinfected quarterly and recorded when carried out as recommended in L8. No records could be found and it is unknown if this is being carried out.

Dead leg pigtail pipe on hot flow pipe.

Site Reference/ Address	Remedial/Recommendations	Priority	Date Actioned	Signature
<u>Distribution</u> HCC Lakeside School	Remove dead leg pipe work or put on a weekly flushing regime and record in the logbook when carried out	5		
	I would recommend Bacteriological and Legionella water samples be taken if the temperatures fall out of the recommended limits.	5		
	Continue weekly flushing of any low use outlets etc and record when carried out.	3		
	Clean and descale showerheads at least quarterly. Record when carried out.	3		
	Ensure all domestic hot and cold pipe work is insulated within the building.	4		
	Re-site the hose reel in the Boiler Room next to the bib tap.	5		
	Ensure that the water softener is serviced and maintained in-line with the manufacturer's recommendations.	3		
	Ensure that the filter on the water cooler is cleaned / replaced in-line with the manufacturer's recommendations.	3

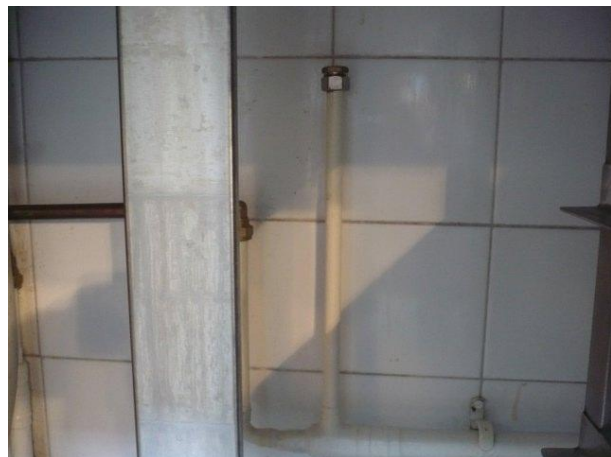
Main Kitchen

Dead leg on the cold pipe on the right
on the dishwasher.

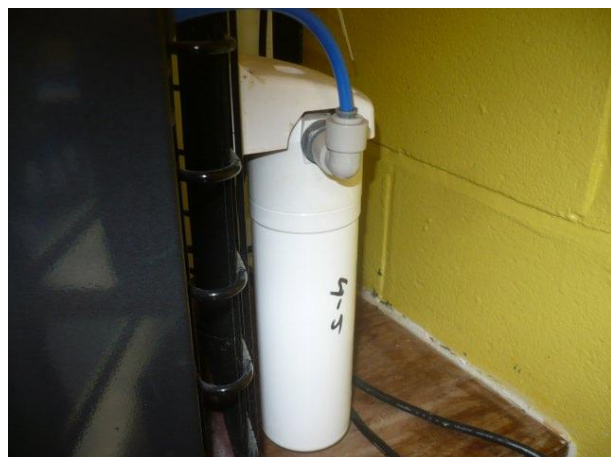
Servery

Water filter on the water cooler.
