Hampshire County Council
Oak Lodge School
DT Block

Risk Assessment Consultant: Mr Chris Wilson MWM Society

Date of Assessment: 26th January 2012

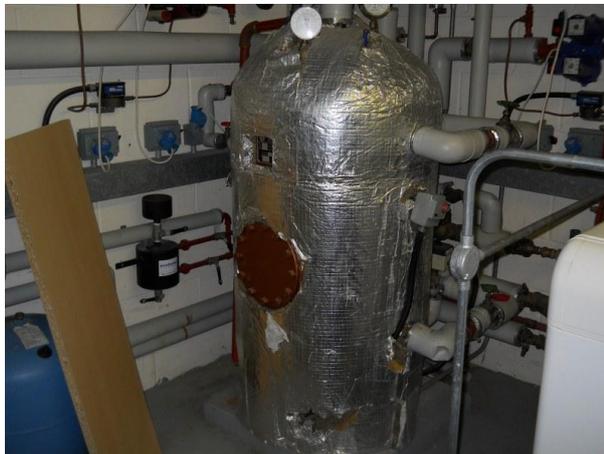
Calorifier	Storage	52.3°C	Not Satisfactory
Calorifier	Return	45.8°C	Not Satisfactory

ACoP L8 recommends hot water storage to be at a minimum of 60°C and the return to be maintained at a minimum of 50°C at all times. I would recommend that the calorifier be adjusted to increase these temperatures.

Boiler Room calorifier.

There is a temperature gauge on the calorifier but not on the hot return pipe work. I would recommend that a temperature gauge be fitted to the return pipework for monthly temperature monitoring to be carried out.

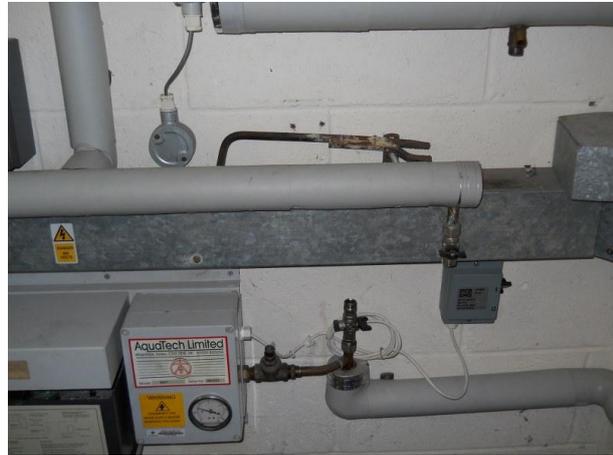
- Boiler Room - The mains cold water pipe to the quick fill line on the heating boiler pressurisation unit is too long and creating a dead leg.
 - Boiler Room - There is a dead leg on the hot return pipe to the calorifier that appears to have once been connected to another dead leg clearly seen near it.

Dead leg on the mains cold water pipe to heating boiler pressurisation unit quick fill line.

- Dead leg pipework are ideal areas for the proliferation of bacteria and should be removed or put on a twice weekly flushing regime (without creating an aerosol) and recorded. Dead legs were found in the following areas:-

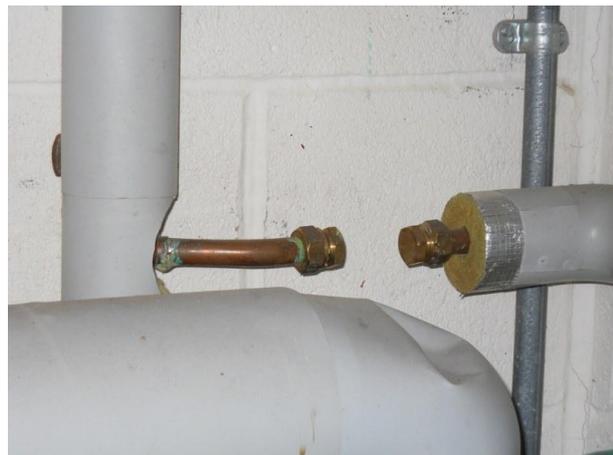
Boiler Room

There is a dead leg on the hot return pipe to the calorifier that appears to have once been connected to another dead leg clearly seen near it.

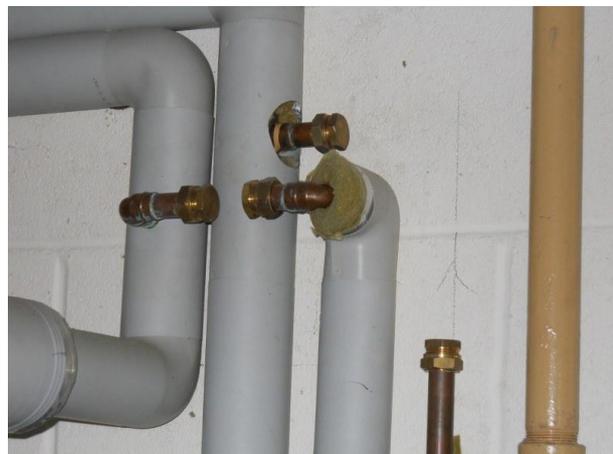
- Boiler Room - There is a dead leg on the mains cold water pipe behind the calorifier (that supplies the heating boiler pressurisation unit) that appears to have once been connected to another dead leg clearly seen near it.

- Boiler Room - There is a dead leg on the hot flow pipe from the calorifier that appears to have once been connected to another dead leg clearly seen near it.

There is a dead leg on the mains cold water pipe behind the calorifier (that supplies the heating boiler pressurisation unit) that appears to have once been connected to another dead leg clearly seen near it. There is also a dead leg on the hot flow pipe from the calorifier that appears to have once been connected to another dead leg clearly seen near it.
