**Site:** Oak Lodge School  
Roman Road  
Dibden Purlieu  
Hampshire SO45 4RQ

**Date of Assessment:** 7th June 2010

This report relates to a water source Risk Assessment carried out by Mr Chris Wilson of Freeston Water Treatment Ltd on the 7<sup>th</sup> June 2010 on behalf of Hampshire County Council. The survey was carried out at Oak Lodge School, Roman Road, Dibden Purlieu, Hampshire SO45 4RQ. During the course of the survey water systems within the properties were risk assessed. These sources were chosen as being fully representative of the overall domestic water systems and outlets within the buildings.

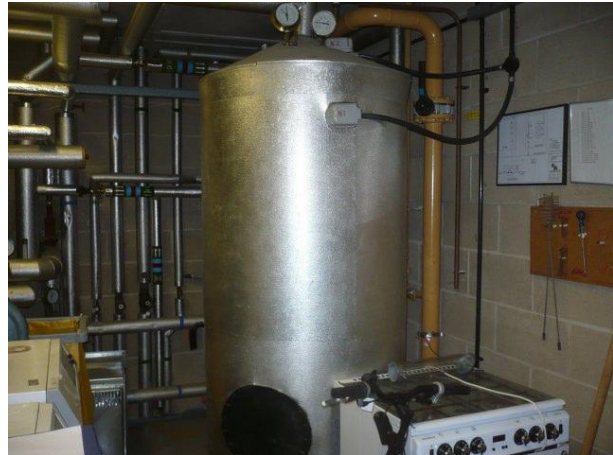
Hot water storage at Oak Lodge School is by two calorifiers. The Calorifier No. 1 is located within the main boiler Room. The calorifier was manufactured by Rycroft (Calorifiers) Ltd. It is of a steel construction and is indirectly heated by an internal coil from the heating boilers. It has fibre type insulation under a metal outer casing. There is a return system fitted to the calorifier that has a two circulating pumps which at the time of the survey they both appeared to be working correctly when switched over. I was informed that the pumps are alternated monthly but this will now be carried out weekly. I was informed by maintenance staff that the calorifier is fed from the mains cold water supply. I would recommend that the calorifier be purged to drain to check the water quality on at least a six monthly period and recorded within a water systems logbook when carried out, I was informed that it is unknown if this is being carried out. There is an old temperature gauge on the calorifier but not on the hot return pipe work. I would recommend that new temperature gauges are fitted to the flow and return pipework for monthly temperature monitoring to be carried out.

Calorifier No 1	Storage	62.0°C	Satisfactory
Calorifier No 1	Return	27.8°C	Not Satisfactory

The return temperature is too low and this must be investigated further. Firstly I would recommend that the calorifier is adjusted to increase the temperature. Secondly, much of the domestic pipe work is uninsulated and this is likely to be contributing to the problem and should be rectified. Further investigation should be carried out if adjusting the calorifier and insulating the pipes does not fully rectify the problem.

Site Reference/ Address	Remedial/Recommendations	Priority	Date Actioned	Signature
<u>Hot Water Storage &amp; System</u> HCC Oak Lodge School	Commence monthly temperature monitoring of the domestic hot water systems; sentinel outlets. Record within a logbook.	5		
	Commence monthly temperature monitoring of the hot water calorifier flow water temperature. Record within a logbook.	5		
	Purge calorifiers to drain on at least a six monthly basis and record when carried out.	3		
	If access allows, visually inspect the calorifiers internally for scale and sludge on an annual basis.	3		
	Adjust Calorifier No. 1 to achieve a minimum storage temperature of 60°C and a minimum return temperature of 50°C.	5		
	Adjust electric local water heaters to achieve a minimum of 50°C at the hot outlet or inlet to TMV within one minute.	5		
	Fit temperature gauges to flow and return pipes on Calorifier No. 1.	3		
	Fit temperature gauges to return pipe on Calorifier No. 2.	3

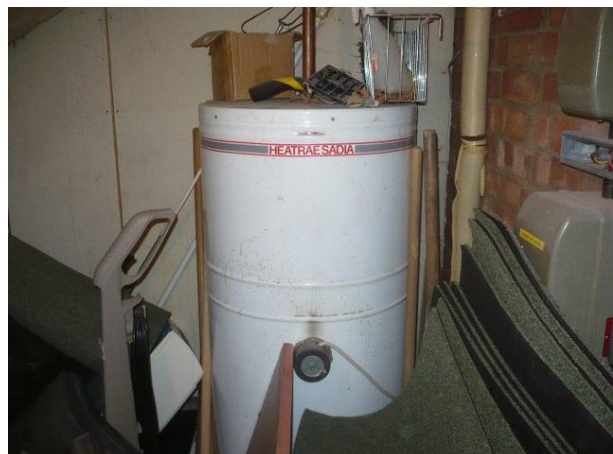
Calorifier No. 2.

Calorifier No 2 is located within Room 34 and supplies all the hot outlets within Room 34 and Room 87. The calorifier was manufactured by Heatrae Sadia. It is of a copper construction and is directly heated by one electrical element. It has fibre type insulation under a metal outer casing which is damaged in places and should be repaired. The calorifier is fed from the mains cold water system and there is no return system fitted. I would recommend that the calorifier be purged to drain to check the water quality on at least a six monthly period and recorded within a water systems logbook when carried out, I was informed that it is unknown if this is being carried out. There is no temperature gauge on this unit and I would recommend that one is fitted to the flow pipework for monthly temperature monitoring to be carried out.

Calorifier No. 2	Storage	64.6°C	Satisfactory
Calorifier No. 2	Return		No Return Fitted

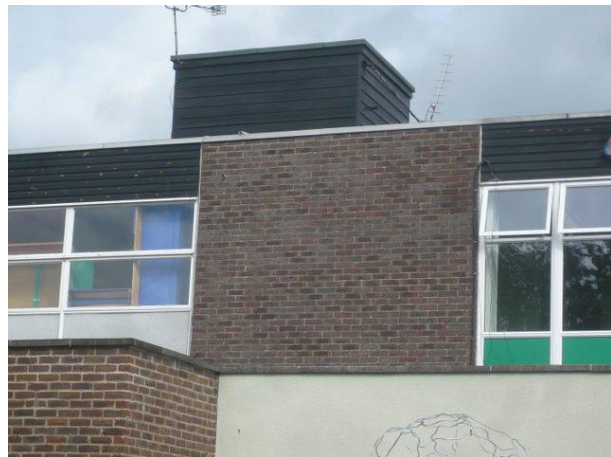
Cold water storage cistern housing.

Domestic cold water storage at Oak Lodge School consists of one domestic cold water storage cistern located at height on the roof. At the time of the survey there was found to be no safe access to this vessel.

I was informed by maintenance staff that it is believed that this cistern only now feeds the first floor boys toilets. If this is the case then the cistern is likely to be over capacity and taking it out of service and converting the boy's toilet outlets to mains cold water should be considered. It must be ensured that no dead legs are created when this work is carried out.

**I would recommend that safe access is made available for maintenance, cleaning and disinfecting and for a risk assessment to be carried out as soon as is practicable.**

Site Reference/ Address	Remedial/Recommendations	Priority	Date Actioned	Signature
<u>Cold Water Storage</u> HCC Oak Lodge School	Commence monthly temperature monitoring of the domestic cold water systems; sentinel outlets. Record within a logbook.	5		
	Make safe access available to the cold water storage cistern.	5		
	Clean and disinfect the cold water storage cistern as soon as is practicable. Inspect annually and repeat if required.	5

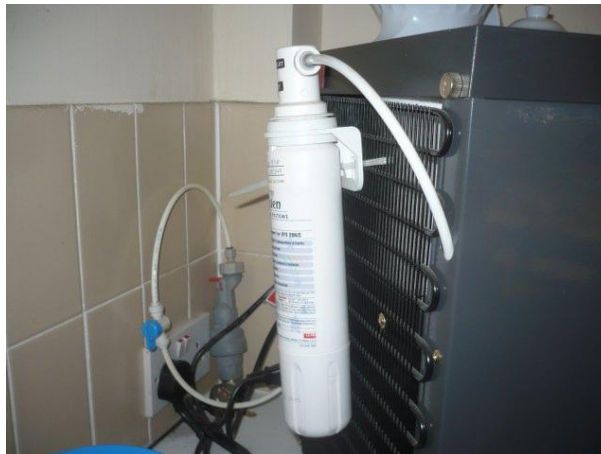
- There is a filter on the drinking water cooler and it should be ensured that this is cleaned / replaced in-line with the manufacturer's recommendations.

Filter on the drinking water cooler.
