Client Address	Hampshire County Council PBRS Three Minsters House 76 High Street Winchester Hampshire SO23 8UL
Site Name	Oakridge House OPH
Site Address	Jefferson Road Basingstoke Hampshire RG21 5QS
Site contact	Maxine Dyer
Site telephone number	01256 324357
Last risk assessment carried out by	Freeston Water Treatment Limited
Date of risk assessment	June 2011
Date of previous review	N/A
Date of new review	26th April 2012
Review carried out by	Mr Chris Wilson

This Review has been carried out in accordance with ACoP L8 'The control of Legionella bacteria in water systems' (APPROVED CODE OF PRACTICE & GUIDANCE) and BS 8580 (RISK ASSESSMENTS FOR LEGIONELLA CONTROL-CODE OF PRACTICE).

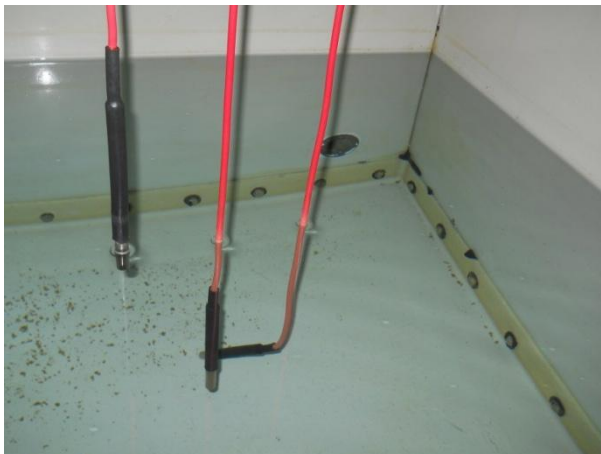
The inside of the tank showed a light deposit of sediment on the base and a slight amount of biofilm on the sides. Sediment and biofilm act as nutrients and an ideal environment for the proliferation of bacteria including legionella.

An internal view of domestic cold water storage tank no. 1.

This vessel was last cleaned and disinfected on the 7th July 2011 and I would recommend that this be carried out again within the near future.

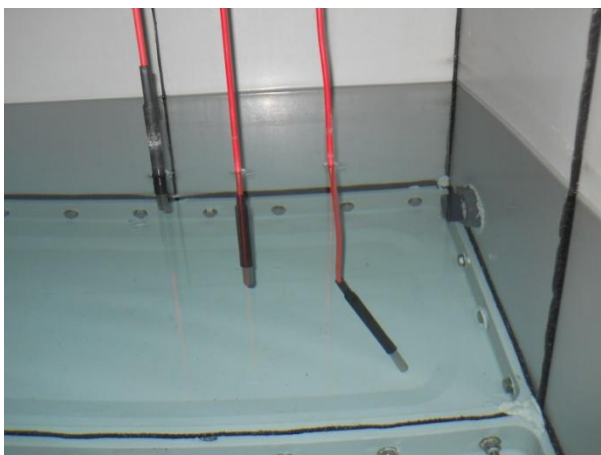
The inside of the tank showed a slight deposit of sediment on the base and a slight amount of biofilm on the sides. Sediment and biofilm act as nutrients and an ideal environment for the proliferation of bacteria including Legionella.

An internal view of domestic cold water storage tank no. 2.

This vessel was last cleaned and disinfected on the 7th July 2011 and I would recommend that this be carried out again within the near future.

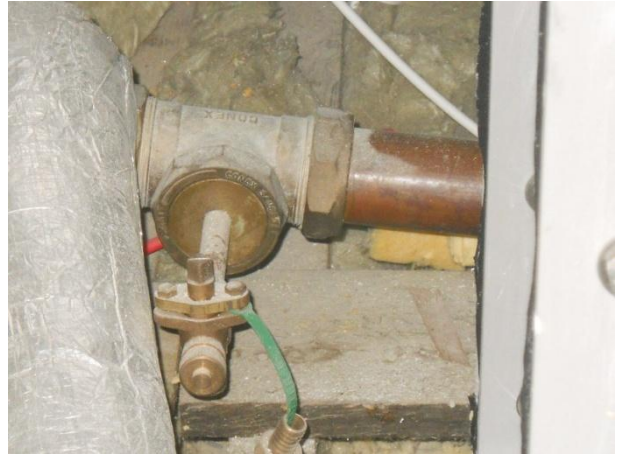
Roof Space (in the long wing)

The pipe of the drain on tank no. 1 is too long and is creating a dead leg.

- Dead leg pipework are ideal areas for the proliferation of bacteria and should be removed or put on a weekly flushing regime (without creating an aerosol) and recorded. Dead legs were found in the following areas:-

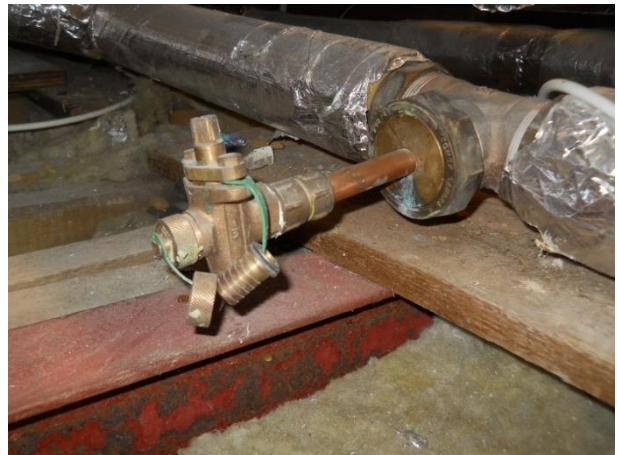
Roof Space (in the long wing)

The pipe of the drain on tank no. 2 is too long and is creating a dead leg.

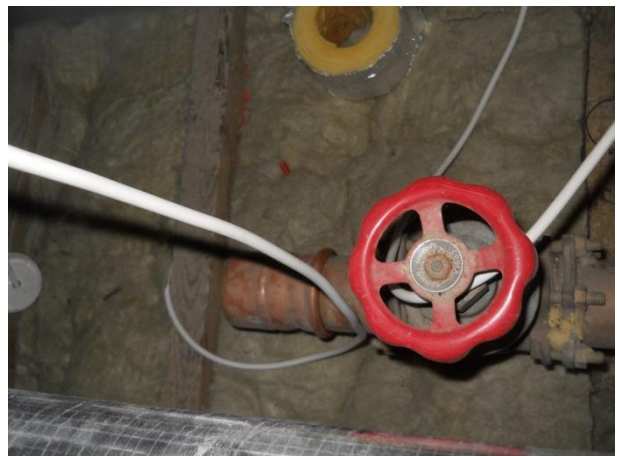
Roof Space (in the long wing)

There is a dead leg pipe on the outlet pipe of tank no. 1.

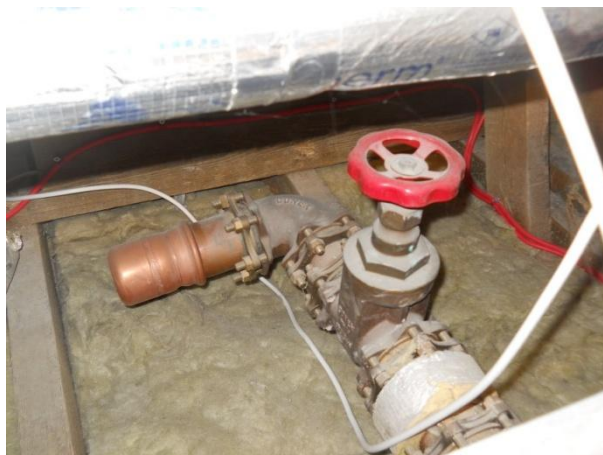
Roof Space (in the long wing)

There is a dead leg pipe on the outlet pipe of tank no. 2.

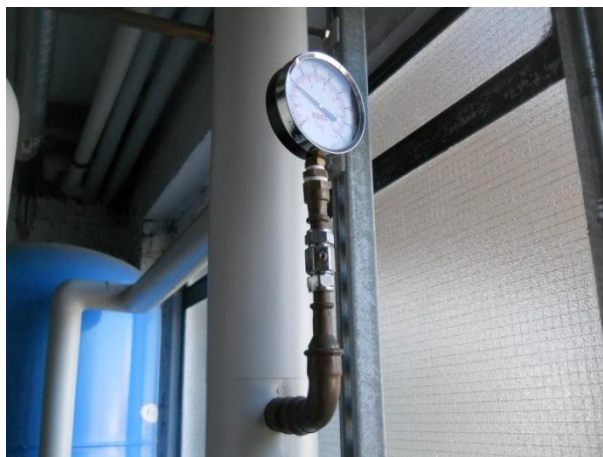
Boiler Room

The pipe to the pressure gauge on the outlet pipe of the booster pump set is too long and creating a dead leg.

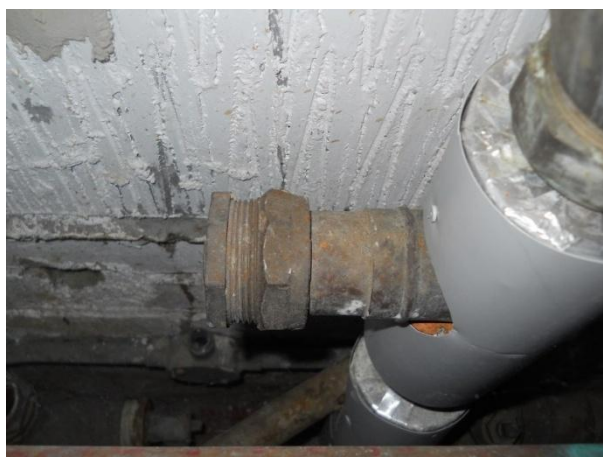
Boiler Room

There is a dead leg on the lower level of the cold water rising main.

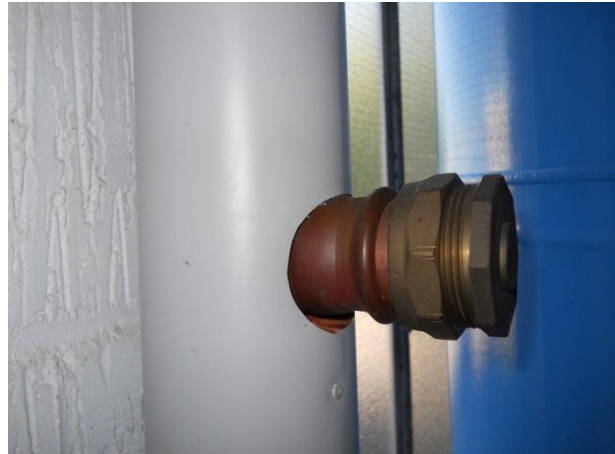
Boiler Room

There is a dead leg on the mid level of the cold water rising main.

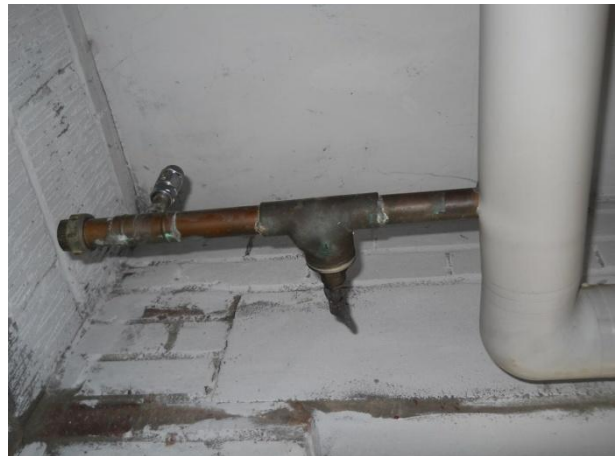
Boiler Room

There is a dead leg on the mains cold water pipe at height.

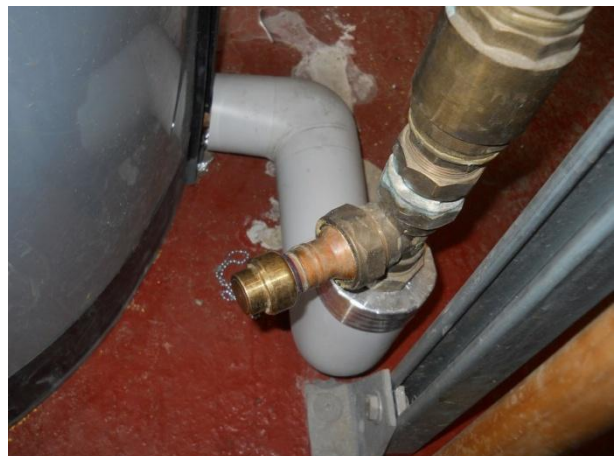
Boiler Room

There is a dead leg on the hot return pipe just as it enters calorifier no. 2. Although this has been shortened since the Risk Assessment, ideally it should be removed completely.

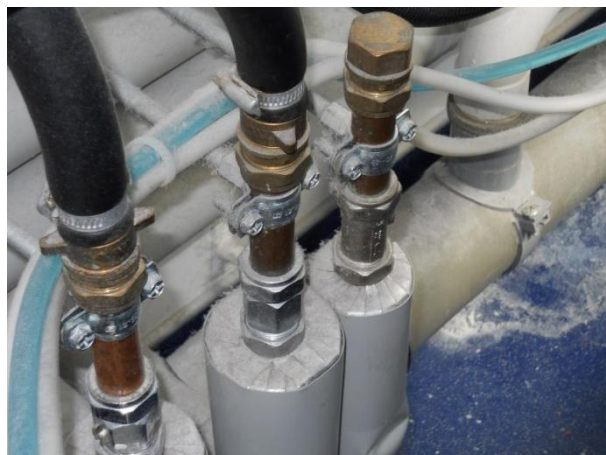
Laundry

There is a dead leg behind the washing machine near the wash basin.

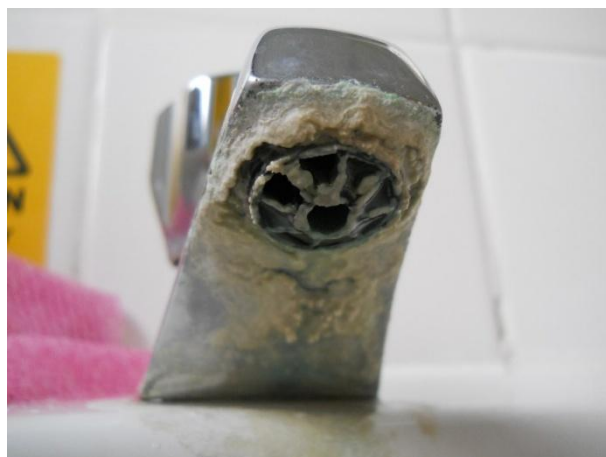
Main Kitchen Toilet

Scaled outlet seen in many areas of site.

- Ensure the new maintenance operative on site is competent and adequately trained in Legionella management.
- Clean and disinfect domestic cold water storage tank no. 1 and no. 2 within the near future and repeat annually if required.
- Descale tap outlets as often as needed.
- Fit overflow warning pipes to both tanks along with WRAS approved insect screens.
- Adjust calorifier no. 2 to achieve a minimum storage temperature of 60°C at all times and a minimum of 50°C on the return at all times.
