**Site:** Osborne School  
Athelstan Road  
Winchester  
Hampshire SO23 7GA

**Risk Assessment Consultant:** Mr Chris Wilson MWM Society

**Date of Assessment:** 9<sup>th</sup> June 2010

## INTRODUCTION

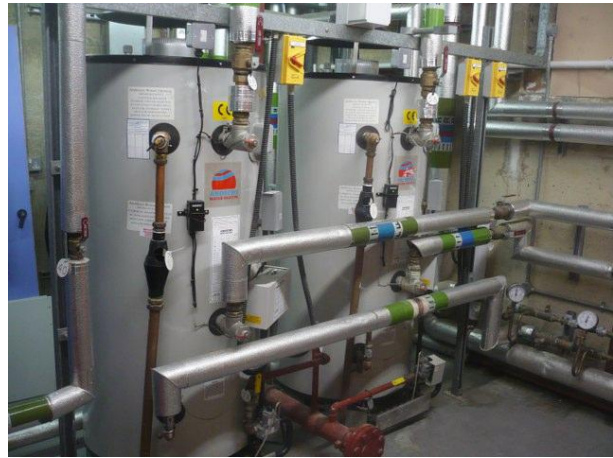
Calorifiers No's. 1 & 2.

Calorifiers No.'s 1 and 2 are identical units and were manufactured by Andrews Water Heaters. They are gas fired units and are fed by the mains cold water supply. The calorifiers have insulation under the metal outer casings. There is a common return system fitted to the calorifiers that has a circulating pump which at the time of the survey appeared to be working correctly.

Calorifier No 1	Storage	62.8°C	Satisfactory
Calorifier No 1	Return	53.1°C	Satisfactory
Calorifier No 2	Storage	60.0°C	Satisfactory
Calorifier No 2	Return	53.1°C	Satisfactory

I would recommend that the calorifiers be purged to drain to check the water quality on at least a six monthly period and recorded within a water systems logbook when carried out, I was informed that it is unknown if this is being carried out.

There is a temperature gauge on the common hot return pipe work but not on the flow. I would recommend that temperature gauges are fitted to the individual flow pipes for monthly temperature monitoring to be carried out.

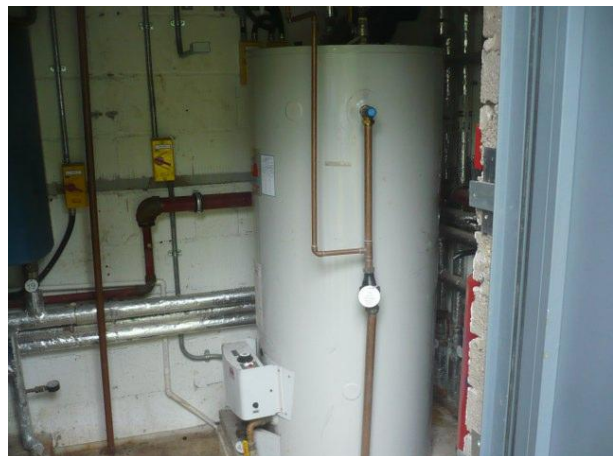
Calorifier No. 3.

Calorifier No. 3 was manufactured by Andrews Water Heaters. It is a gas fired unit and is fed by the mains cold water supply. The calorifier has insulation under the metal outer casings. There is a return system fitted to the calorifier that has a circulating pump which at the time of the survey appeared to be working correctly.

Calorifier No 3	Storage	60.1°C	Satisfactory
Calorifier No 3	Return	51.8°C	Satisfactory

I would recommend that the calorifier be purged to drain to check the water quality on at least a six monthly period and recorded within a water systems logbook when carried out. I was informed that it is unknown if this is being carried out.

There are no temperature gauges on the calorifier and I would recommend that temperature gauges are fitted to the flow and the return pipework for monthly temperature monitoring to be carried out.

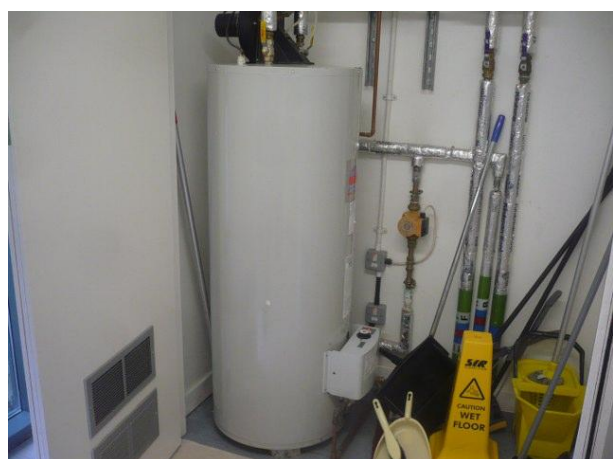
Calorifier No. 4.

Calorifier No. 4 was manufactured by Andrews Water Heaters. It is a gas fired unit and is fed by the mains cold water supply. The calorifier has insulation under the metal outer casings. There is a return system fitted to the calorifier that has a circulating pump which at the time of the survey appeared to be working correctly.

Calorifier No 4	Storage	63.5°C	Satisfactory
Calorifier No 4	Return	63.1°C	Satisfactory

I would recommend that the calorifier be purged to drain to check the water quality on at least a six monthly period and recorded within a water systems logbook when carried out. I was informed that it is unknown if this is being carried out.

There are no temperature gauges on the calorifier and I would recommend that temperature gauges are fitted to the flow and the return pipework for monthly temperature monitoring to be carried out.

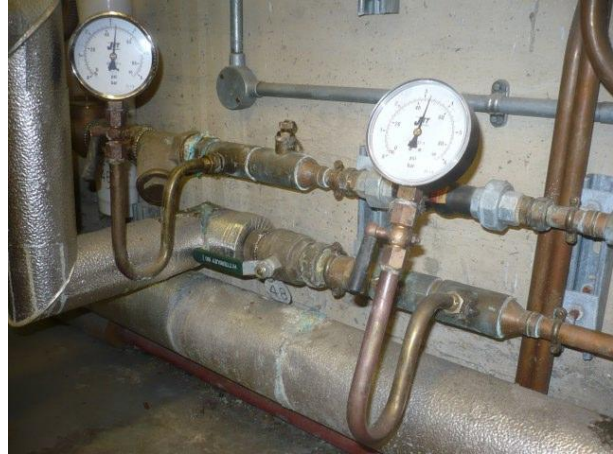
### Boiler room

- Boiler Room two swan neck type dead leg pipes are on the hot water return pipe.
- Science Prep Room two dead legs were found under the worktop.
- Room 16GY Hygiene Area the WC Sluice has been removed and the pipe work to the taps is still in place albeit with open ends. This should be investigated behind the panels to ensure that no dead legs have been left.
- Hygiene Room adjacent to Room 8WF the shower has no hose, rendering it a dead leg.
- Outside tap near ASD Class this outlet is never used.
- Ground Floor Hygiene Room next to room 7JS there was no water from the sink possibly rendering it a dead leg. This should be investigated further.

Swan-neck dead legs on hot return pipe.

Site Reference/ Address	Remedial/Recommendations	Priority	Date Actioned	Signature
<u>Distribution</u> HCC Osborne School	Remove dead leg pipe work or put on a weekly flushing regime and record in the logbook when carried out	5		
	I would recommend Bacteriological and Legionella water samples be taken if the temperatures fall out of the recommended limits.	5		
	Commence <b>weekly</b> flushing of any low use outlets etc and record when carried out.	5		
	Clean and descale showerheads at least quarterly. Record when carried out.	3		
	Ensure all domestic hot and cold pipe work is insulated within the building.	2		
	Commence monthly temperature monitoring of the domestic cold water systems; sentinel outlets. Record within a logbook.	5

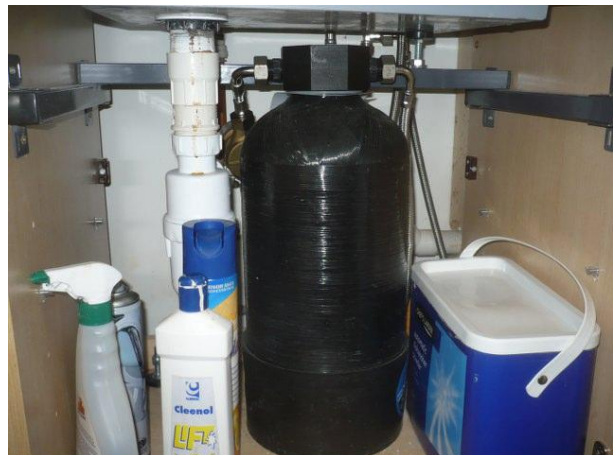
### Staff Room

Water softener.

- There is a water softener within the Staff Room for the hot water boiler and another in the Main Kitchen for the dishwasher. These should be cleaned and replaced in-line with the manufacturer's recommendations. I was informed that it is unknown if this is being carried out.

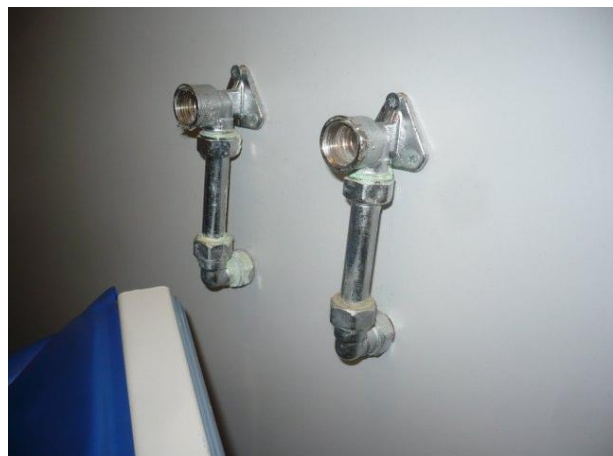
### Room 16GY Hygiene Area

Ensure no dead legs are left behind the panels.

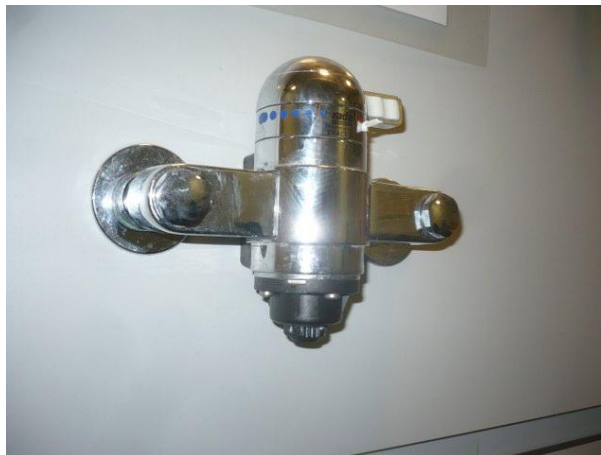
**Hygiene Area adjacent Room 8WF**

Shower with no hoses is rendered a  
dead leg.

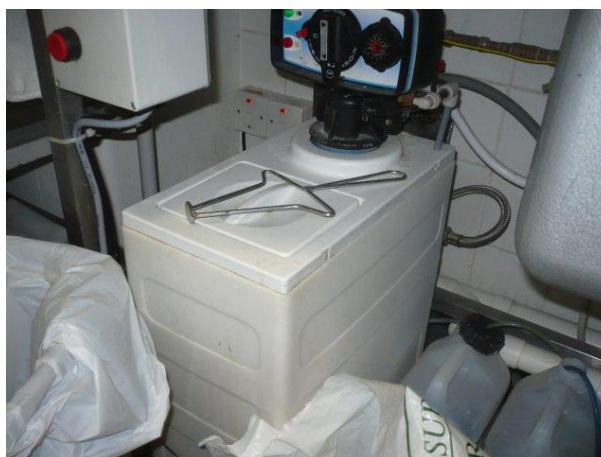
**Main Kitchen**

Water softener.

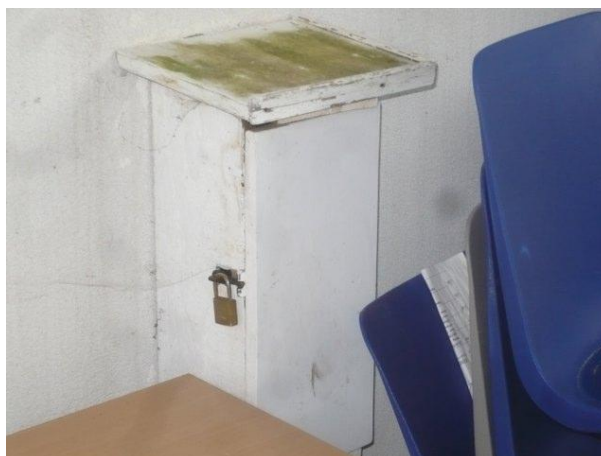
**Outside Tap near ASD Class**

Not used.
