CONTENTS

INTRODUCTION

Client Address	Hampshire County Council PBRS Three Minsters House 76 High Street Winchester Hampshire SO23 8UL
Site Name	Westholme NCU
Site Address	55 Harestock Road Winchester Hampshire SO22 6NT
Site contact	Marion Wilson
Site telephone number	01962 881481
Last risk assessment carried out by	Freeston Water Treatment Limited
Date of risk assessment	June 2011
Date of previous review	N/A
Date of new review	10th April 2012
Review carried out by	Mr Chris Wilson

This Review has been carried out in accordance with ACoP L8 'The control of Legionella bacteria in water systems' (APPROVED CODE OF PRACTICE & GUIDANCE) and BS 8580 (RISK ASSESSMENTS FOR LEGIONELLA CONTROL-CODE OF PRACTICE).

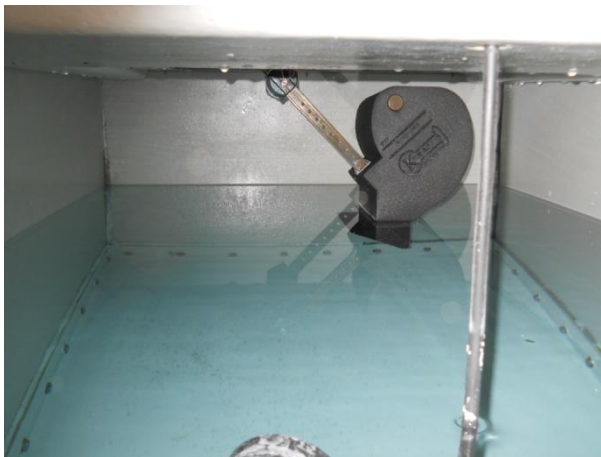
The inside of the tank showed a light deposit of sediment on the base and a light amount of biofilm on the sides. Sediment and biofilm act as nutrients and an ideal environment for the proliferation of bacteria including Legionella.

An internal view of domestic cold water storage tank no 1.

It is unknown when this vessel was last cleaned and disinfected and I would recommend that this be carried out within the near future.

- Clean and disinfect domestic cold water storage tank no. 1 as soon as is practicable and repeat annually if required.
- Clean and disinfect domestic cold water storage tank no. 2 if brought back into service.

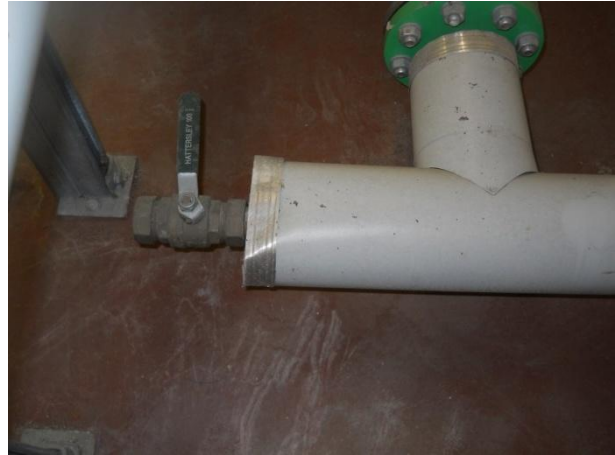
Boiler Room

The drain on the inlet pipe to the booster pumps from the tanks is too long and creating a dead leg.

- Dead leg pipework are ideal areas for the proliferation of bacteria and should be removed or put on a weekly flushing regime (without creating an aerosol) and recorded. Dead legs were found in the following areas:-

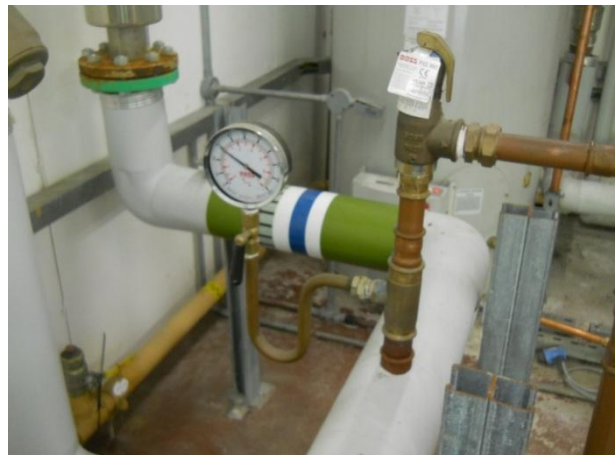
Boiler Room

There is a swan neck type dead leg pipe to the pressure gauge on the outlet pipe of the booster pump set. The pipe that it is on is to the pressure relief valve, this pipe is too long and also creating a dead leg and should be shortened as far as possible.

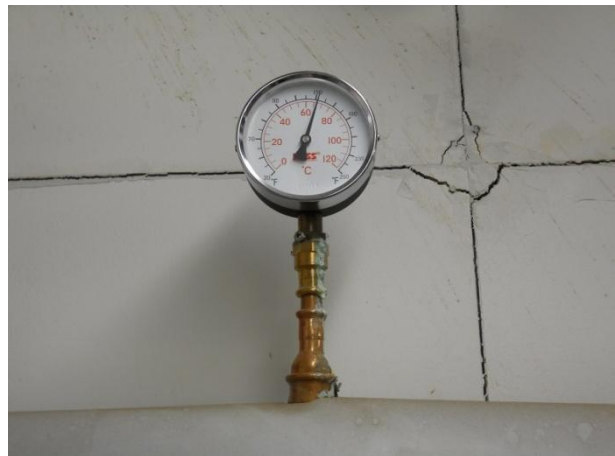
Boiler Room

The pipe to the temperature gauge on the flow pipe of the calorifier is too long and creating a dead leg.

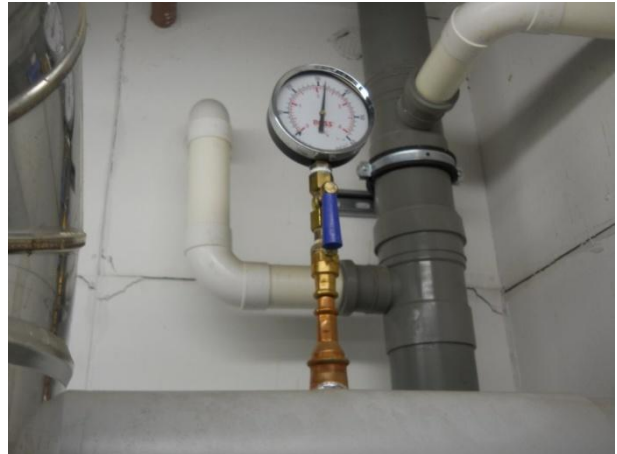
Boiler Room

The pipe to the pressure gauge on the flow pipe of the calorifier is too long and creating a dead leg.

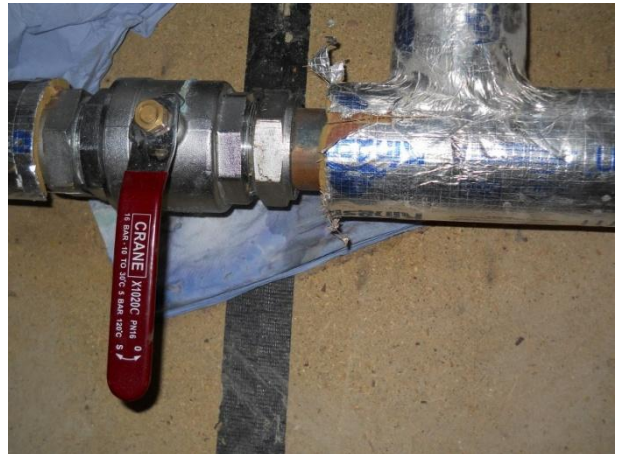
Roof Space above Jay Wing

The valve on the mains cold water pipe to the inlet of tank no. 2 is shut and creating a dead leg.

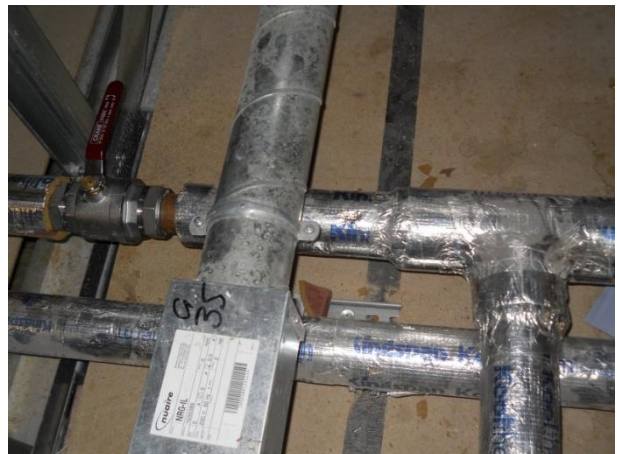
Roof Space above Jay Wing

The valve on the outlet pipe of tank no. 2 is shut and creating a dead leg on the outlet header pipe.
