<b>Client Address</b>	<b>Hampshire County Council PBRs Three Minsters House 76 High Street Winchester Hampshire SO23 8UL</b>
<b>Site Name</b>	<b>Willow Court NCU</b>
<b>Site Address</b>	<b>Willow Way Charlton Road Andover Hampshire SP10 3JY</b>
<b>Site contact</b>	<b>Jo Badby</b>
<b>Site telephone number</b>	<b>01264 325620</b>
<b>Last risk assessment carried out by</b>	<b>Freeston Water Treatment Limited</b>
<b>Date of risk assessment</b>	<b>May 2011</b>
<b>Date of previous review</b>	<b>N/A</b>
<b>Date of new review</b>	<b>28<sup>th</sup> March 2012</b>
<b>Review carried out by</b>	<b>Mr Chris Wilson</b>

This Review has been carried out in accordance with ACoP L8 'The control of Legionella bacteria in water systems' (APPROVED CODE OF PRACTICE & GUIDANCE) and BS 8580 (RISK ASSESSMENTS FOR LEGIONELLA CONTROL-CODE OF PRACTICE).

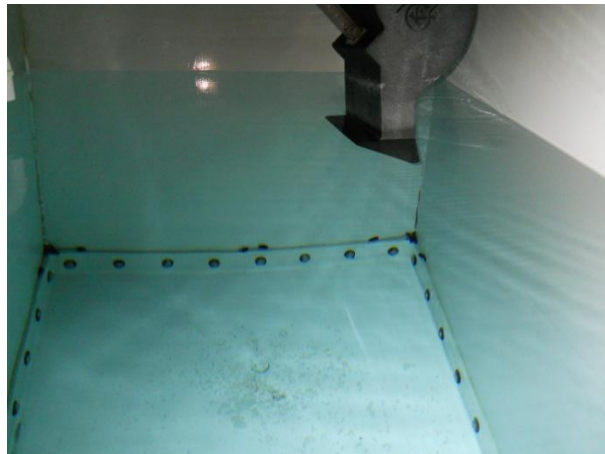
The inside of the tank no. 1 (nearest to the roof space access hatch) showed a very slight deposit of sediment on the base and had no evidence of biofilm on the sides. The inside of the tank no. 2 was empty and clean.

Internal view of cold water storage tank no. 1.

I was informed that it is not thought that the vessels have been cleaned and disinfected since the building was opened but I would not consider it necessary to clean and disinfect them. Tank no. 2 should be cleaned and disinfected before being brought back into service.

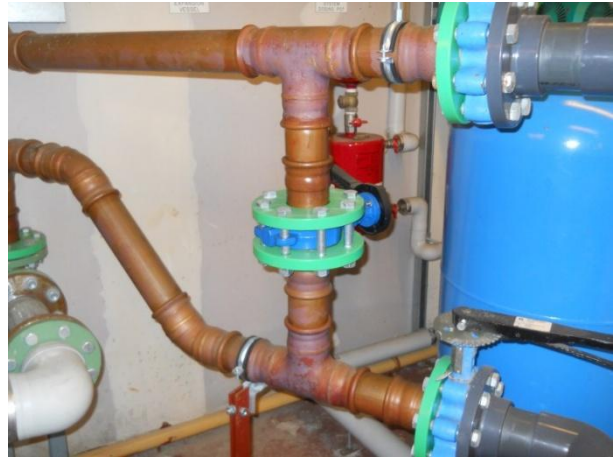
### Boiler Room

The closed valve on the bypass pipe to the water filtration unit on the boosted cold water outlet pipe. This is creating dead legs either side of the valve.

- Dead leg pipework are ideal areas for the proliferation of bacteria and should be removed or put on a weekly flushing regime (without creating an aerosol) and recorded. Dead legs were found in the following areas:-

- Boiler Room - There is a closed valve on the bypass pipe to the water filtration unit on the boosted cold water outlet pipe. This is creating dead legs either side of the valve

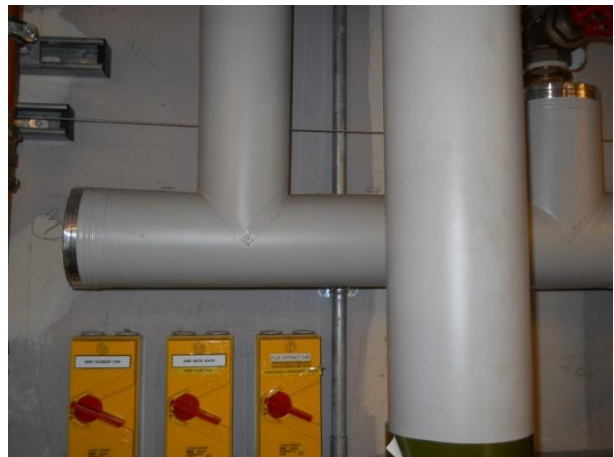
### Boiler Room

There is a dead leg on the outlet pipe of the cold water booster pump.

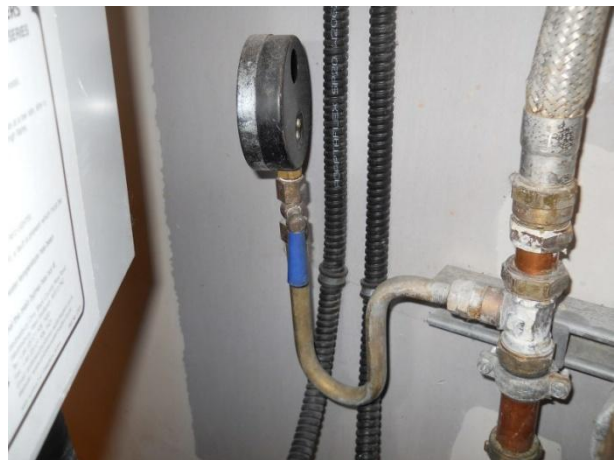
### Boiler Room

There is a swan neck type dead leg pipe to the pressure gauge on the return pipe of the building to the calorifier.

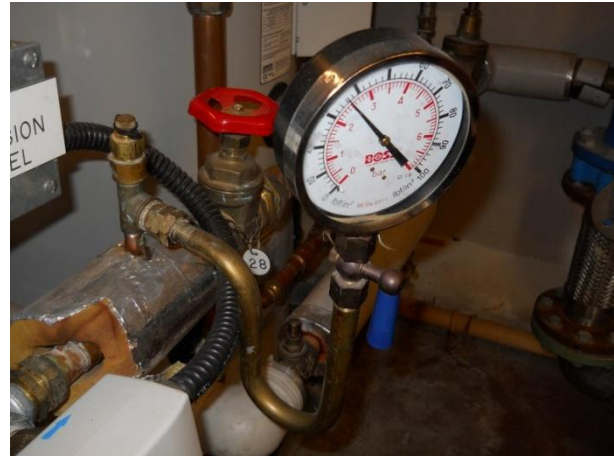
### Boiler Room

There is a swan neck type dead leg pipe to the pressure gauge on the return pipe of the storage vessel to the calorifier.

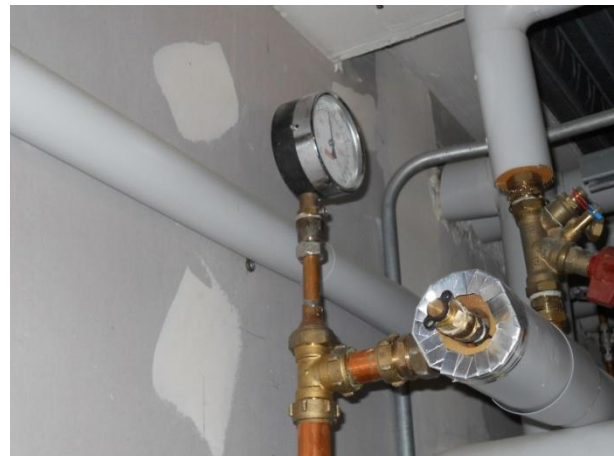
### Boiler Room

The pipe to the temperature gauge on the top of the return pipe from the building to the calorifier is too long and creating a dead leg.

- Boiler Room – The pipe to the temperature gauge on the top of the return pipe from the building to the calorifier is too long and creating a dead leg.

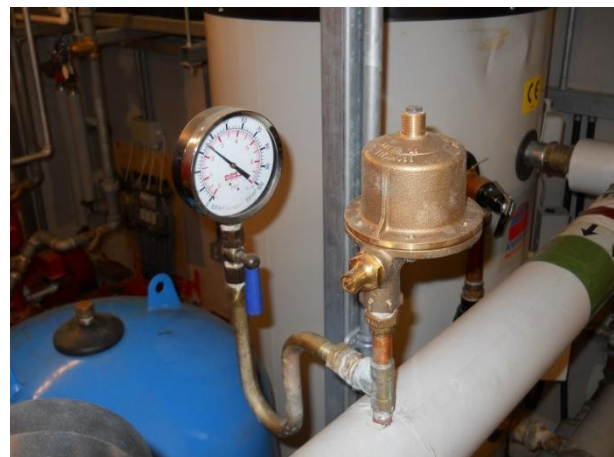
### Boiler Room

There is a swan neck type dead leg pipe to the pressure gauge on the flow pipe of the calorifier to the storage vessel.

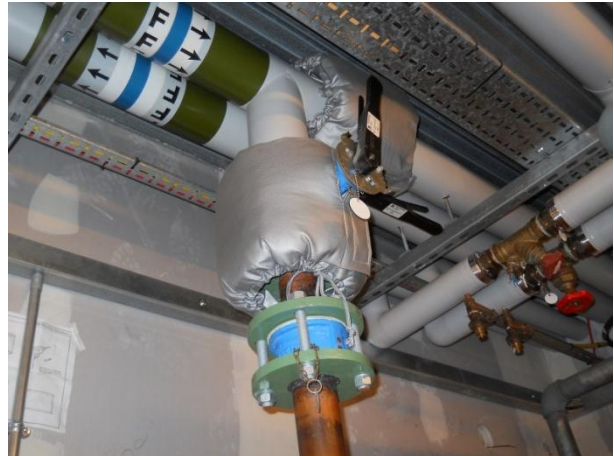
### Boiler Room

There is 500mm of pipe between the mains cold water header and the check valve on the supply pipe to the underground sprinkler tank. This is too long and creating a dead leg as the supply to the sprinkler tank is never flushed.

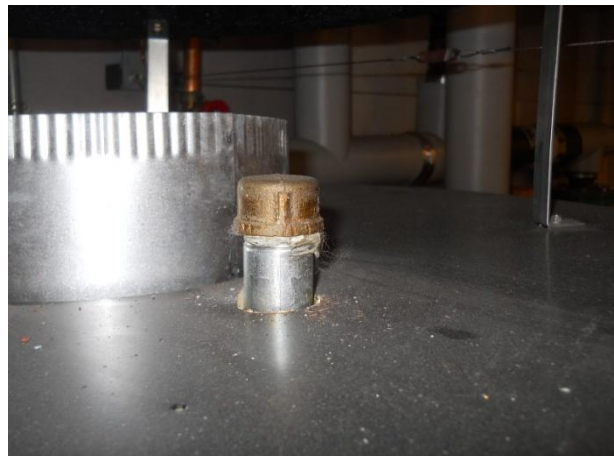
### Boiler Room

There is a small dead leg on the top of the calorifier.

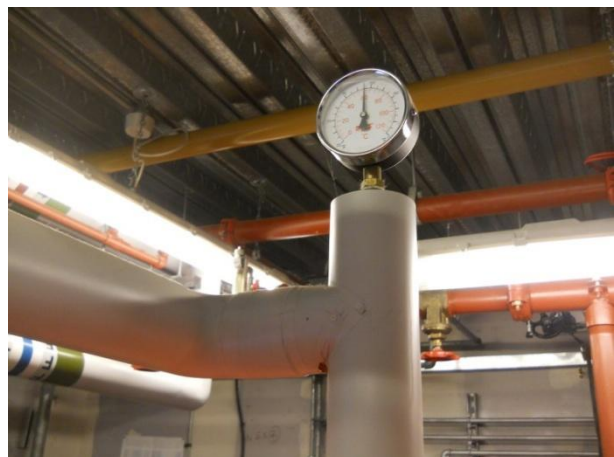
### Boiler Room

The pipe to the temperature gauge on the top of the flow pipe of the hot water storage vessel is too long and creating a dead leg.
