Homewood

INTRODUCTION

This report relates to a **Review** of the Legionella Risk Assessment that was carried out by Freeston Water Treatment in April 2009; this is the latest Risk Assessment for this building. The Review Survey was carried out at Homewood, Enham Lane, Charlton, Andover, Hampshire SP10 4AN. The Review of Recommendations highlighted in the previous Risk Assessment was undertaken in order to comply with the Health and Safety Executive requirements on the control and prevention of Legionellosis. This Review has been carried out as asked for by Hampshire County Council in accordance with ACoP L8 'The control of Legionella bacteria in water systems' (APPROVED CODE OF PRACTICE & GUIDANCE) only:

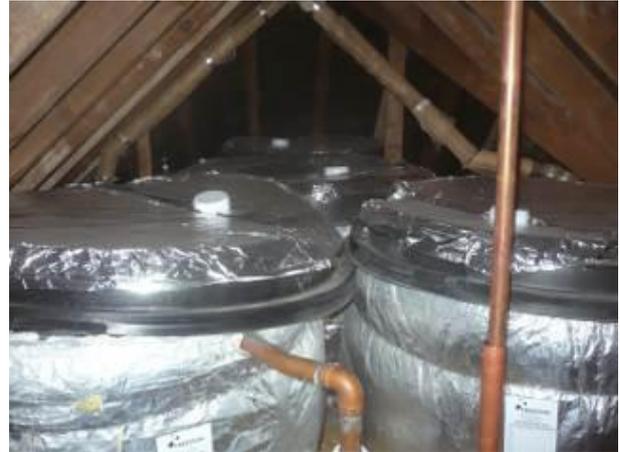
Internal view of no.1 water storage tank at time of Review. Slight sediment seen continue to clean and disinfect annually if required.

All four water storage tanks were last cleaned and disinfected in November 2010; at the time of this Review there was seen to be slight sediment build up within the tanks; I would recommend that all storage tanks are cleaned and disinfected annually if required. Some tank lids still do not fit properly due to the roof beams being in the way; I would recommend this is addressed to prevent the ingress of contaminants.

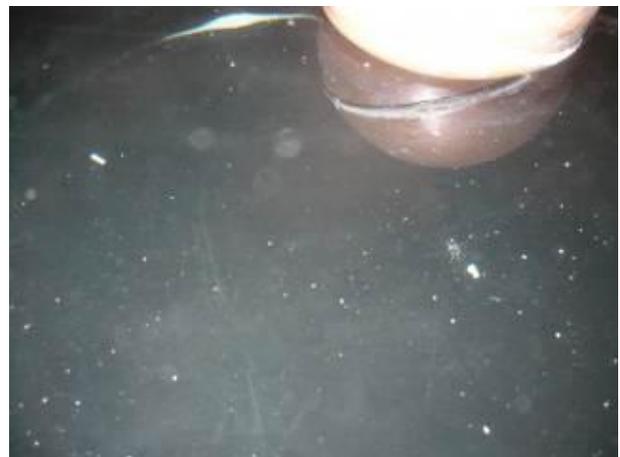
At the time of this Review there was seen to be some surface stagnation within two of the water storage tanks possibly due to the lack of water turn over; it appears that the storage tanks are linked.

Internal view no.2 water storage tank at time of Review. Surface stagnation occurring possibly due to lack of water turn over or plumbing arrangement of tanks; recommend this is addressed and continue to clean and disinfect annually if required.

This does not appear to have been carried out as surface stagnation is occurring in two of the storage tanks.

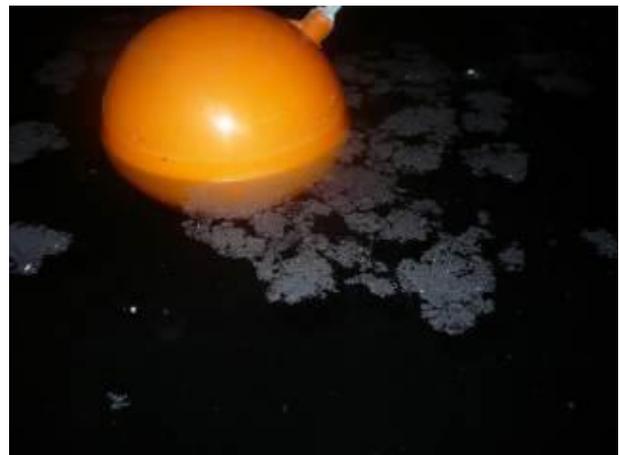
Internal view no.3 water storage tank at time of Review. Surface stagnation occurring possibly due to lack of water turn over or plumbing arrangement of tanks; recommend this is addressed and continue to clean and disinfect annually if required.

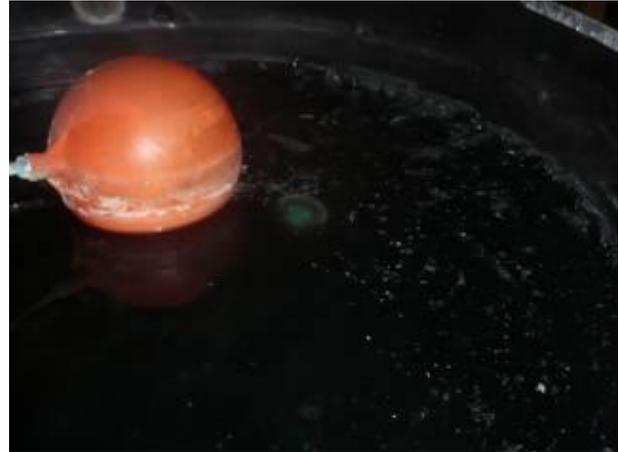
Internal view of no.4 water storage tank at time of Review. Slight sediment seen continue to clean and disinfect annually if required.

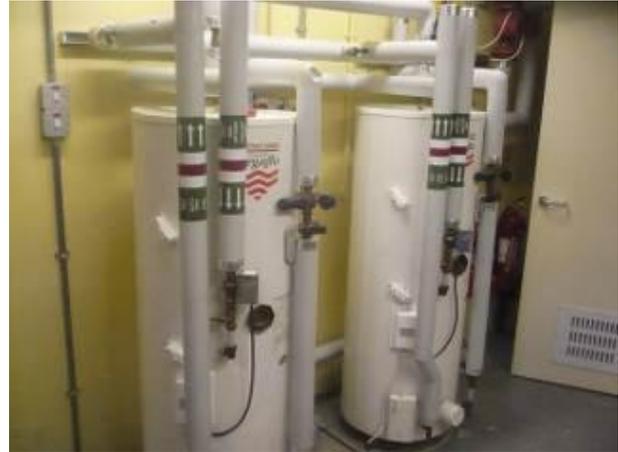
Calorifier hot water circulating / return pump. Good return temperatures recorded at the time of this Review.

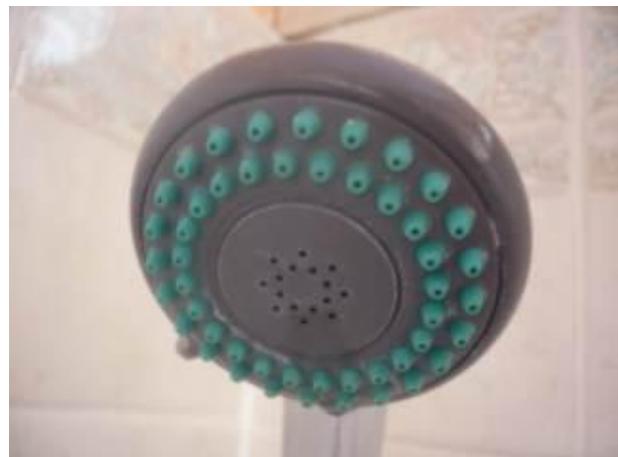
This has not been carried out.

Ensure all showerheads are changed to the non adjustable type as recommended in the Risk Assessment.

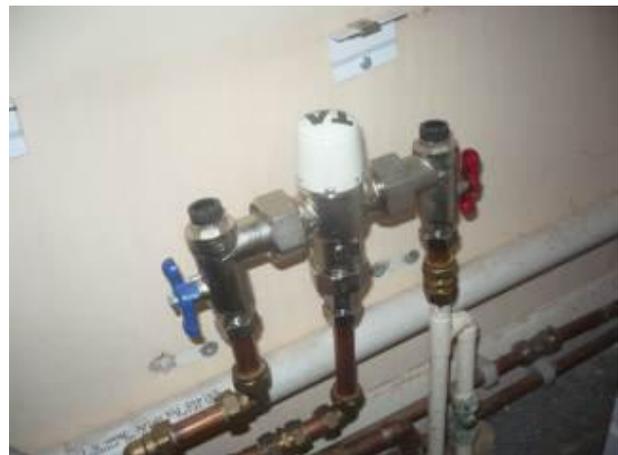
This is assumed being carried out on a six monthly basis by contractors EMCOR; no records seen for the last service of TMV's as certification could not be found in the files.

Continue to service, maintain and adjust if required all TMV's on a six monthly basis; record when carried out.

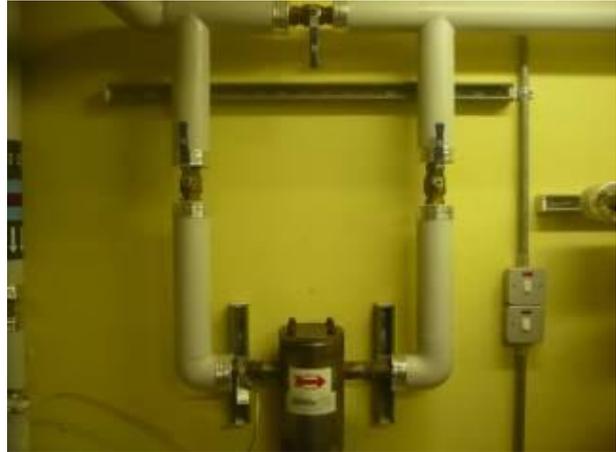
Ensure inline vessel is in use; the by-pass for this vessel is shut off creating deadleg pipe work. Recommend by-pass is opened weekly to flush deadleg area.

The mains water flows through this vessel as the by-pass is shut off creating deadleg pipe work. I would recommend the by-pass is opened on a weekly basis to flush the deadleg area. If this vessel is not being used it should be removed from the water services along with associated pipe work.

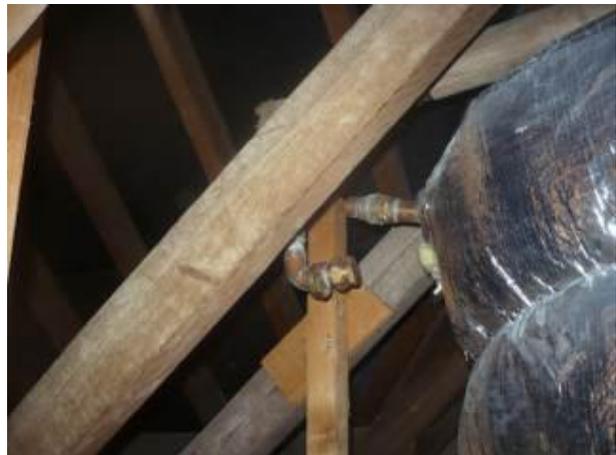
The F&E Tank also located within the roof void has been removed from service and the mains water supply to this tank has just been capped off creating deadleg pipe work on the mains water service which should be removed.

Capped off mains water pipe work to old F&E tank has made deadleg pipe work on the mains water service; recommend this is removed.

The F&E storage tank has been removed from service and the mains water supply has been capped off creating deadleg pipe work; I would recommend this deadleg this should be removed.

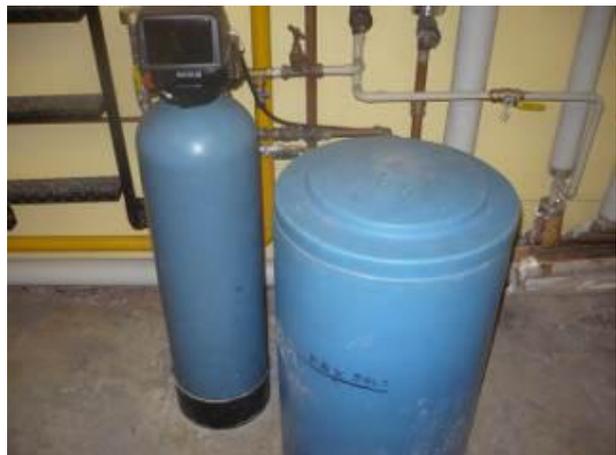
No records seen for this being carried out.

Ensure water softener is serviced and maintained to manufacturer's recommendations.
