**Merry Oak
Community Centre
&
Pre- School
Review Photographs
21st January 2015**

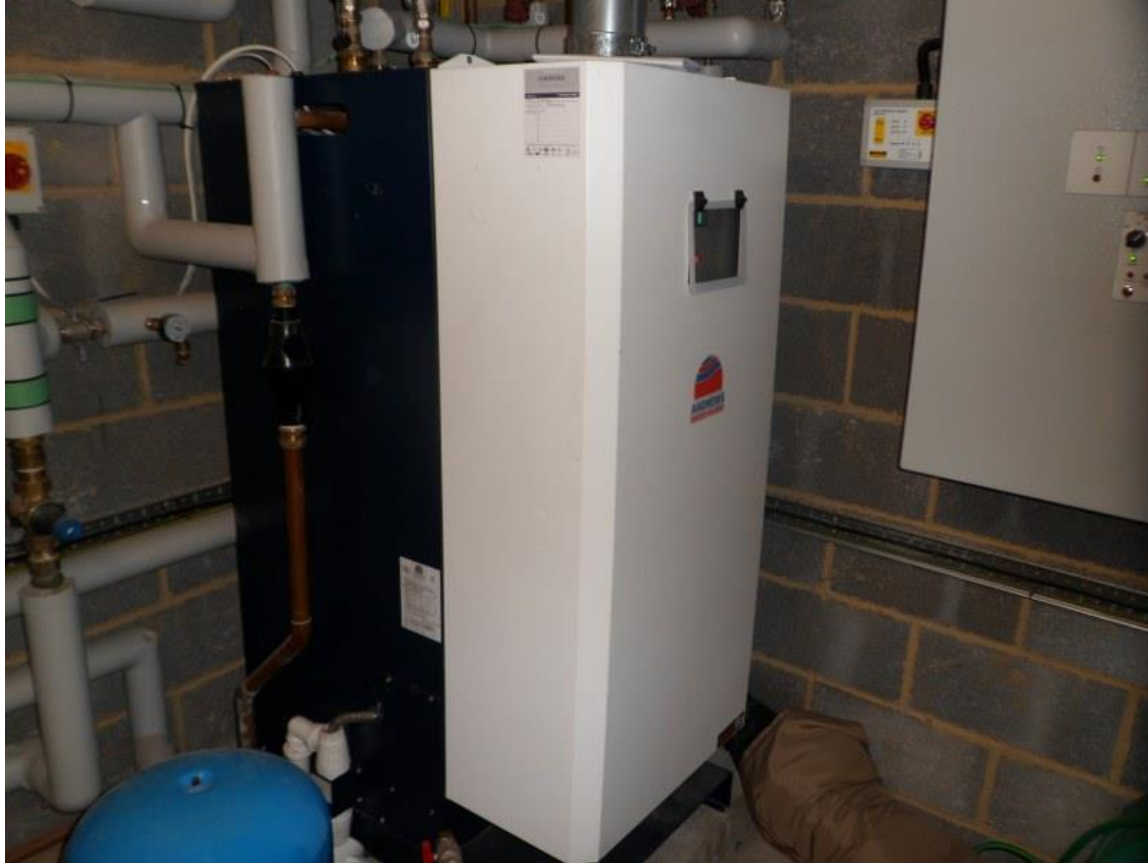
Hot Water Calorifier

The community centre hot water calorifier had a good storage temperature at the time of this review; records indicate this is normally satisfactory.

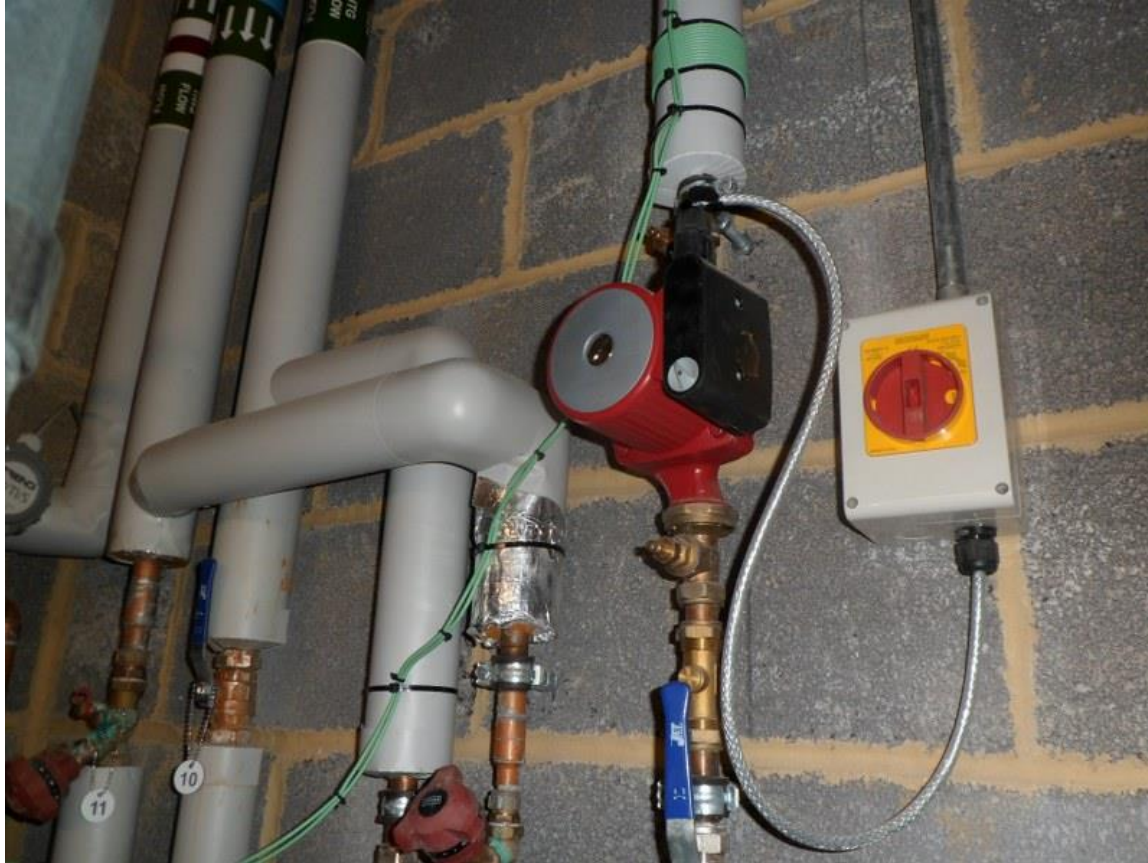
Hot Water Return Pump

The community centre hot water return pump was found to have a low return temperature of 22.0c at the time of this review; I would recommend investigation be carried out to determine if working correctly and rectify to achieve 50.0c or more.

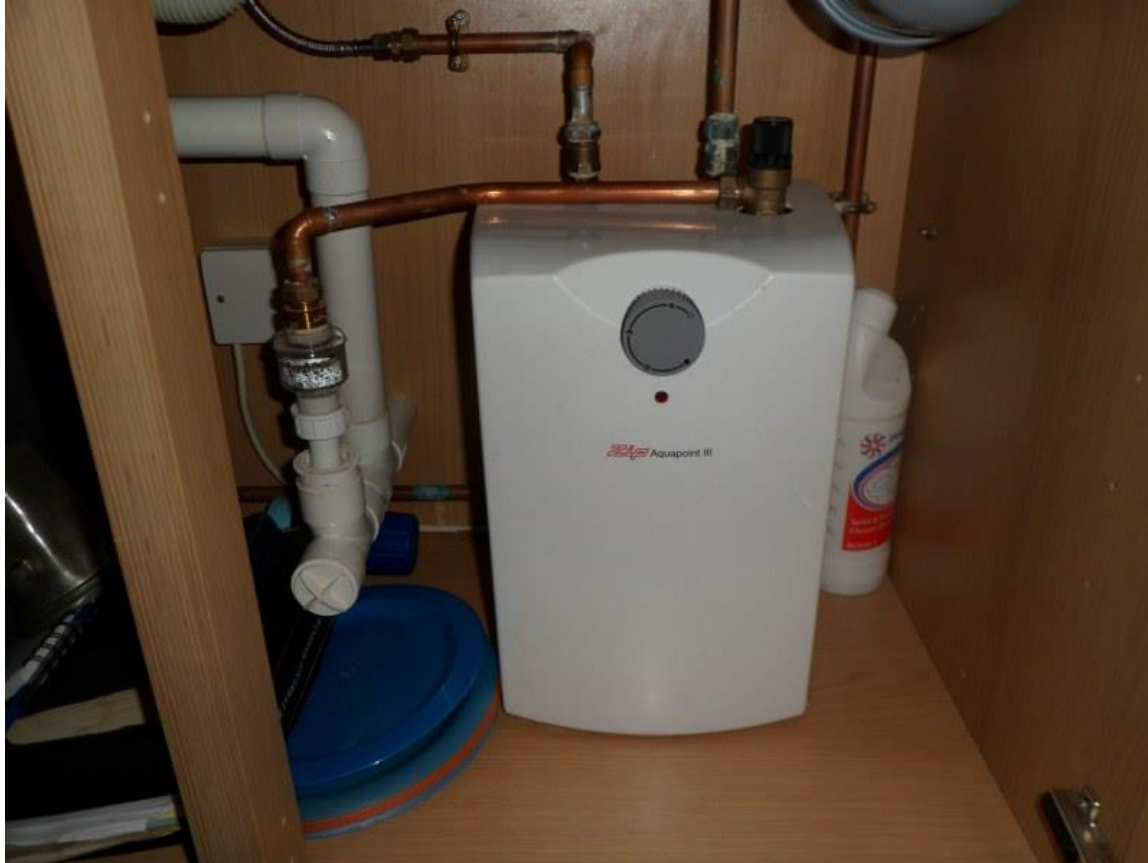
Local Water Heaters

Local water heaters are fitted in the community centre kitchen areas; these should be set to operate at 50.0 – 60.0c as they hold less than 15 litres.

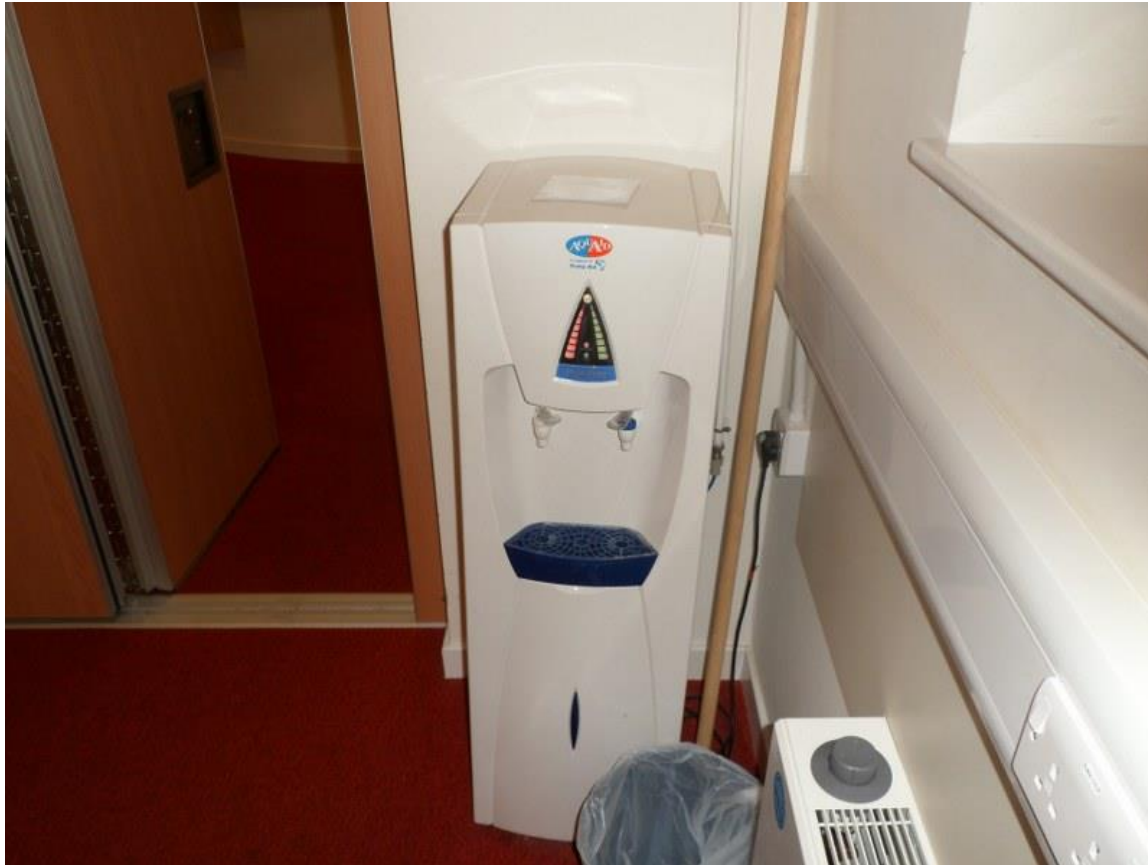
Water Cooler

A water cooler has now been fitted to the highlighted deadleg pipe work in the day services room; ensure good water turnover at the cooler as it is fitted on long pipe run.

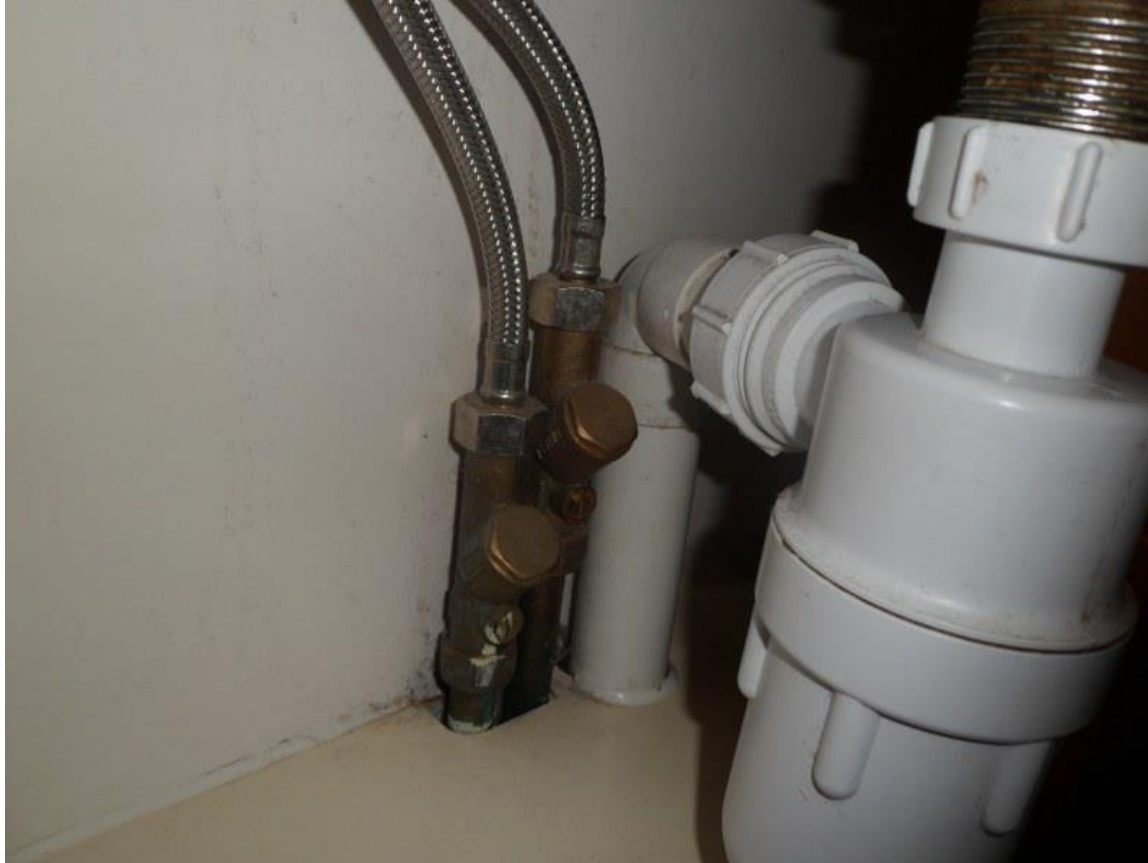
Strainers

Inline strainers are fitted prior to TMV tap outlets within the community centre; ensure these are cleaned on a regular basis or as part of TMV servicing as ideal areas for bacteria proliferation.

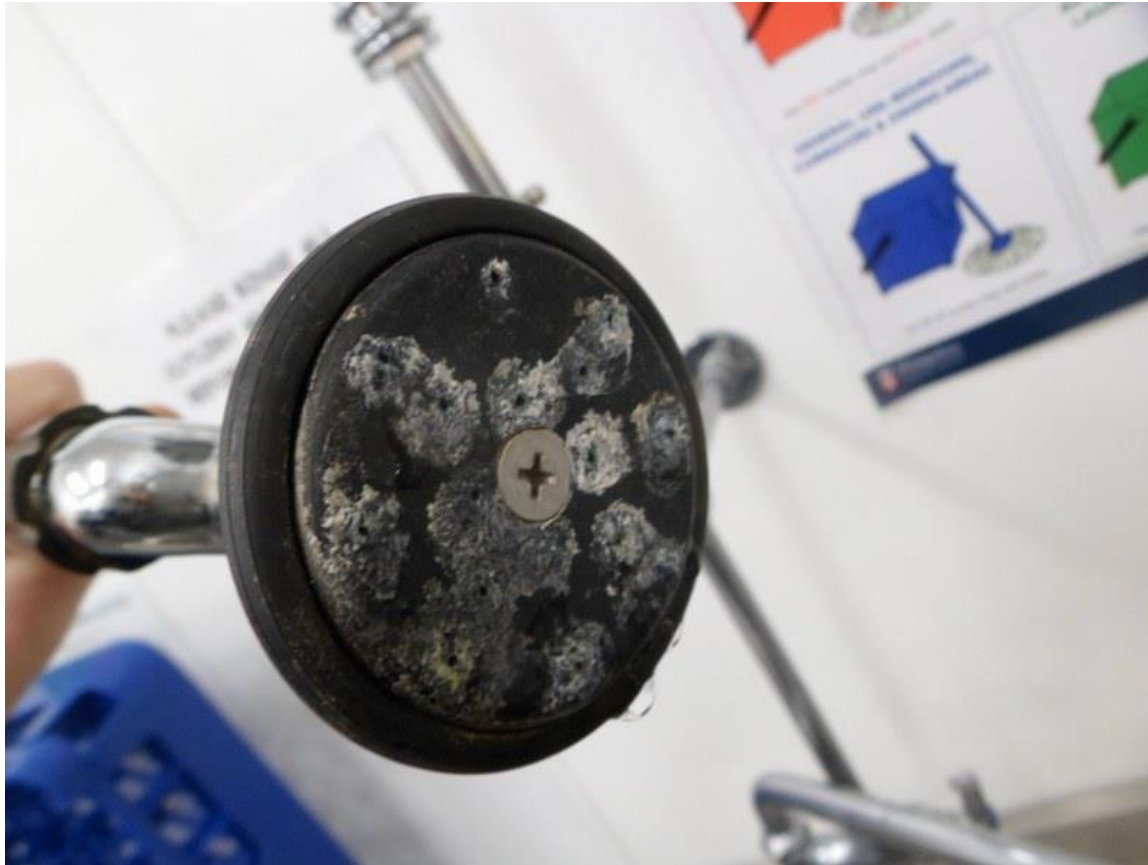
Spray Head

The spray head in the community centre main kitchen within the community centre should be cleaned and descaled quarterly as aerosols are created when operated; records indicate this was last carried out in May 2013.

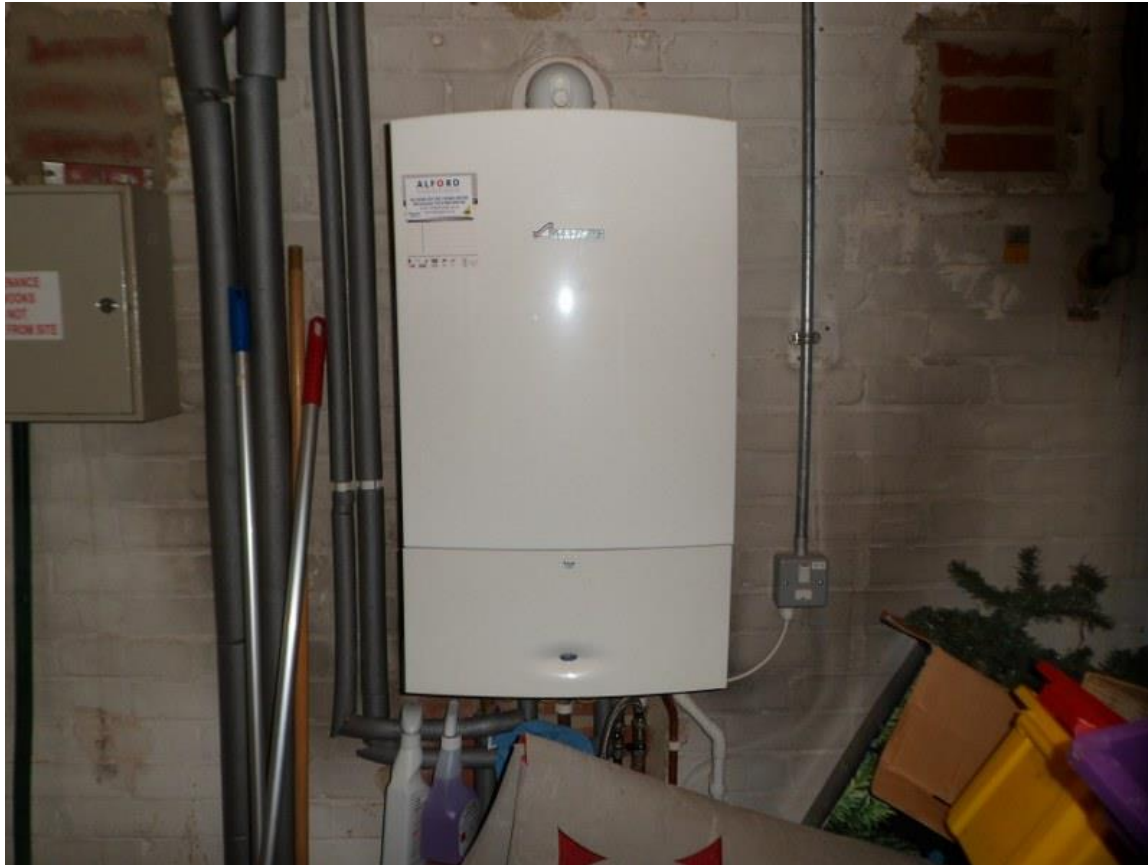
Combination Boiler

The combination boiler located within the pre-school plant room area serves all hot water within the building; good temperatures recorded at the time of this review.

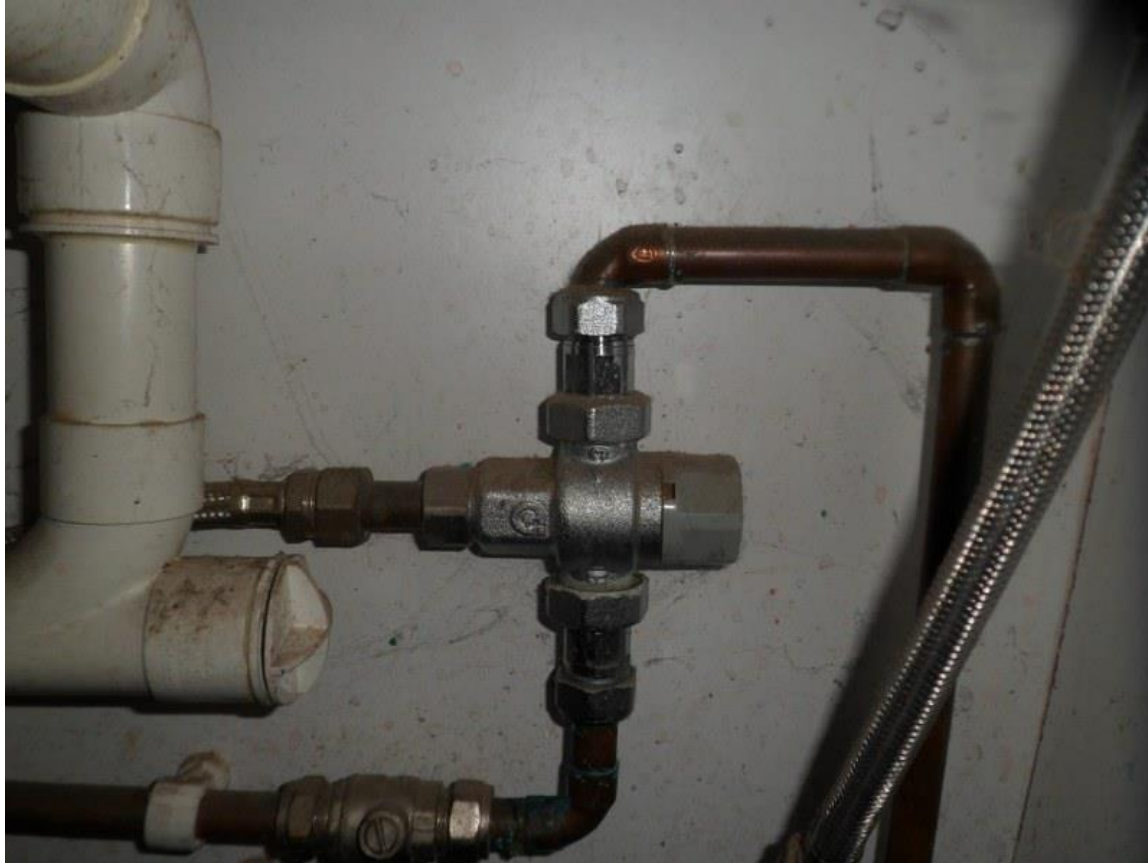
TMVs fitted within the community centre and pre-school should be serviced and maintained to the manufacturers recommendations; no records were seen to indicate this is being carried out.
