Ashby Youth & Community Centre

Review Photographs

23rd January 2017

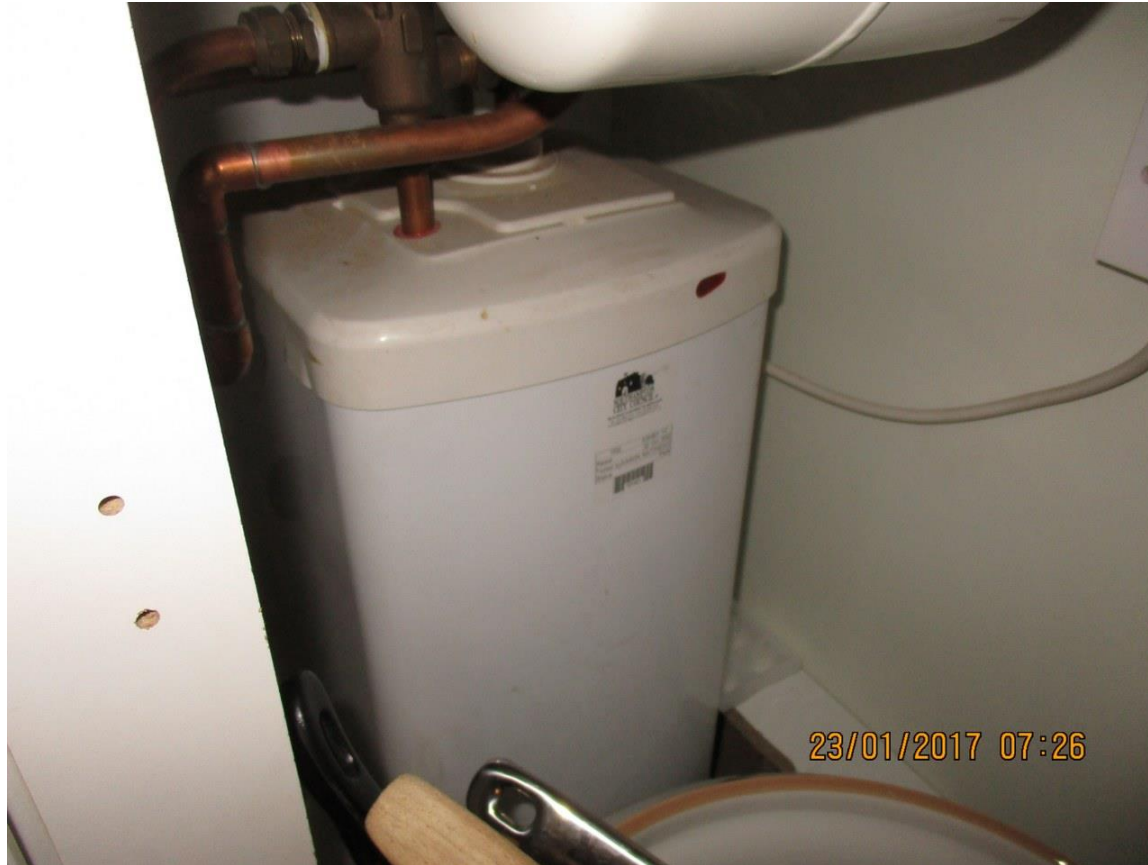
Ground Floor Kitchen Water Heater

Local water heater serving the kitchen area was found to have slightly low storage temperature at the time of this 2017 review; records seen indicate this is normally satisfactory.

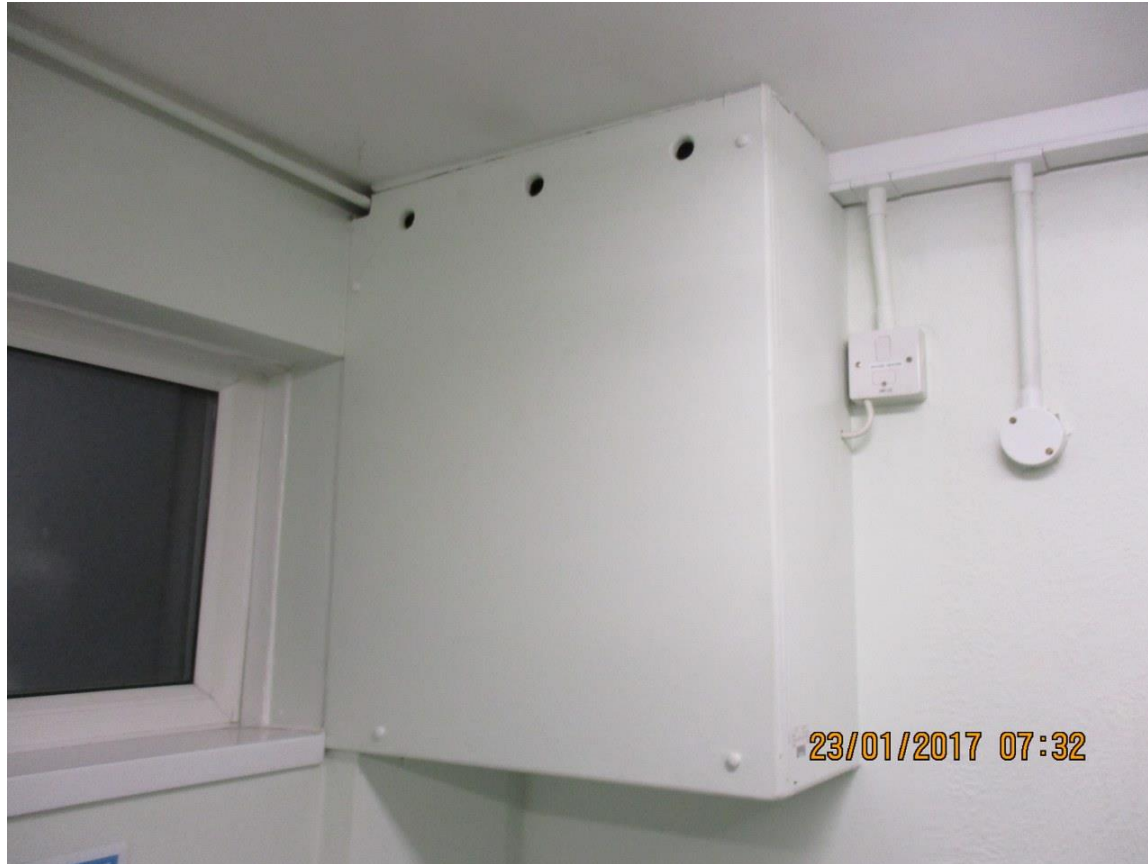
Toilet Area Water Heaters

The ladies and gents toilet water heaters are located behind paneling; the ladies toilet water heater was found to have low storage temperature at the time of this 2017 review; records seen indicate this is normally satisfactory

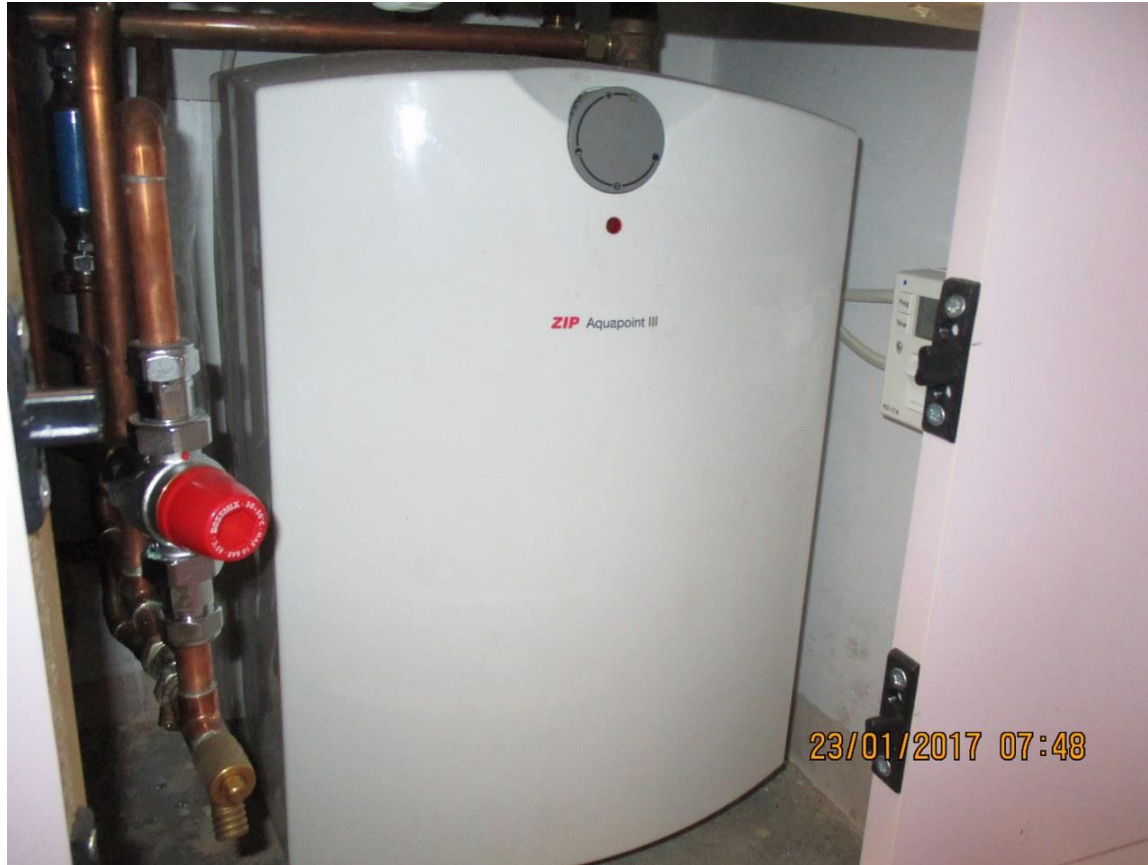
Sure Start Typical Water Heater

Typical water heater seen within the sure start boys toilet area; records seen indicate water heater temperatures within the sure start area normally satisfactory.

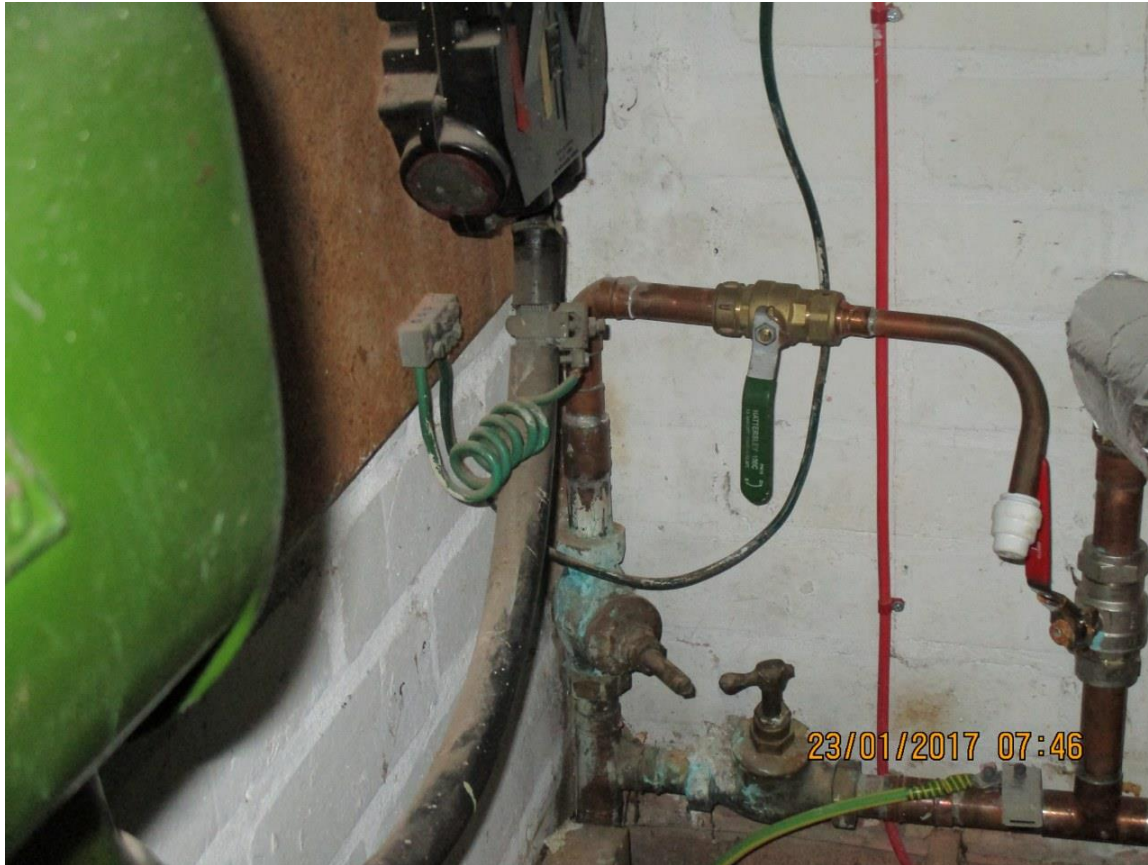
Deadleg Pipe Work

The deadleg pipe work highlighted on the rising main was still seen to be in place; I would recommend removal or flushed through at least on a weekly basis.

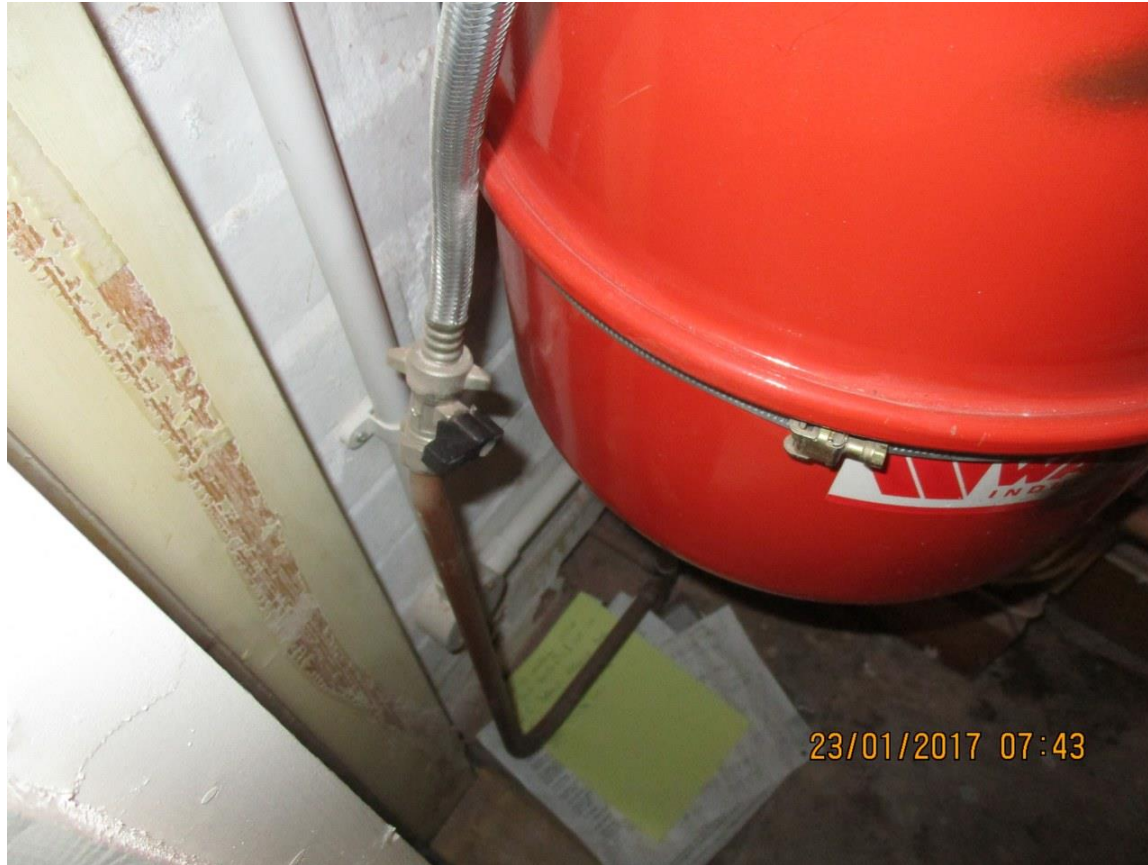
Heating Quick Fill

The heating quick fill can act as deadleg pipe work; I would recommend this is flushed through on a regular basis and recorded when carried out.

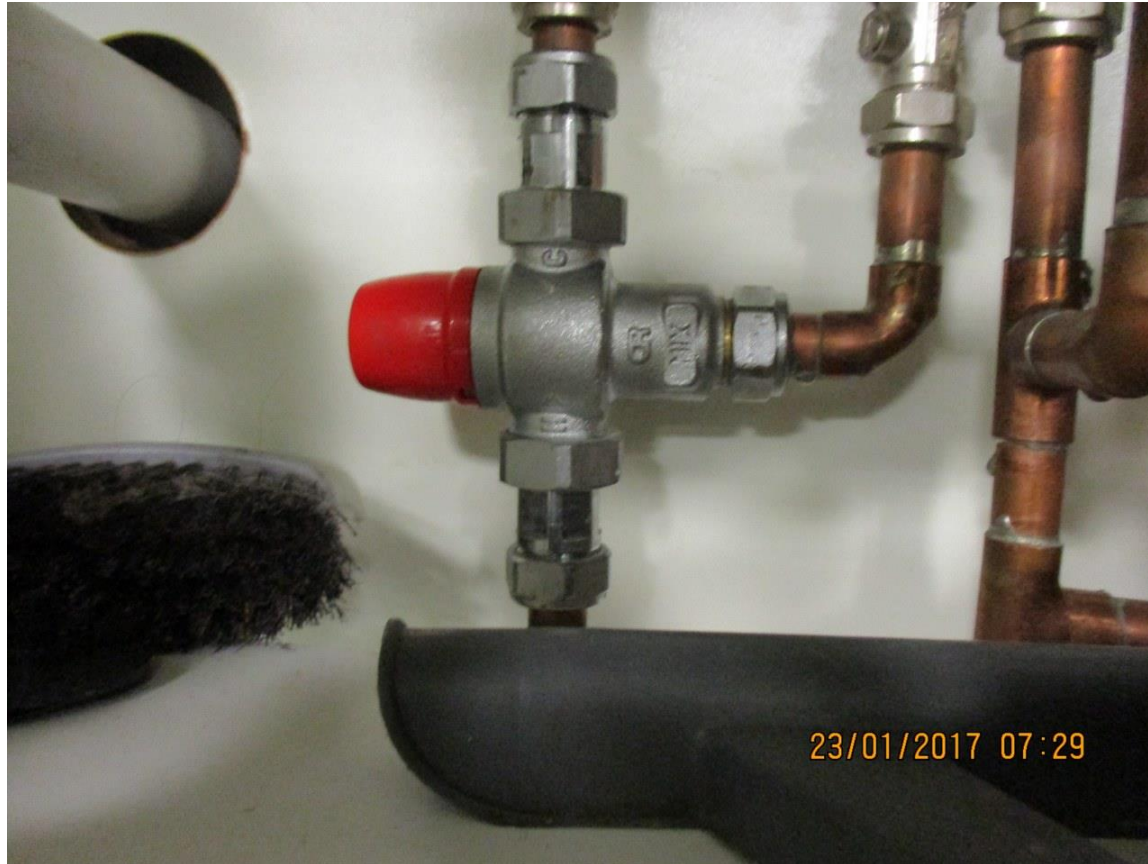
TMVs are fitted within the community centre; no records were seen to indicate these are being serviced and maintained as recommended by the manufacturers.

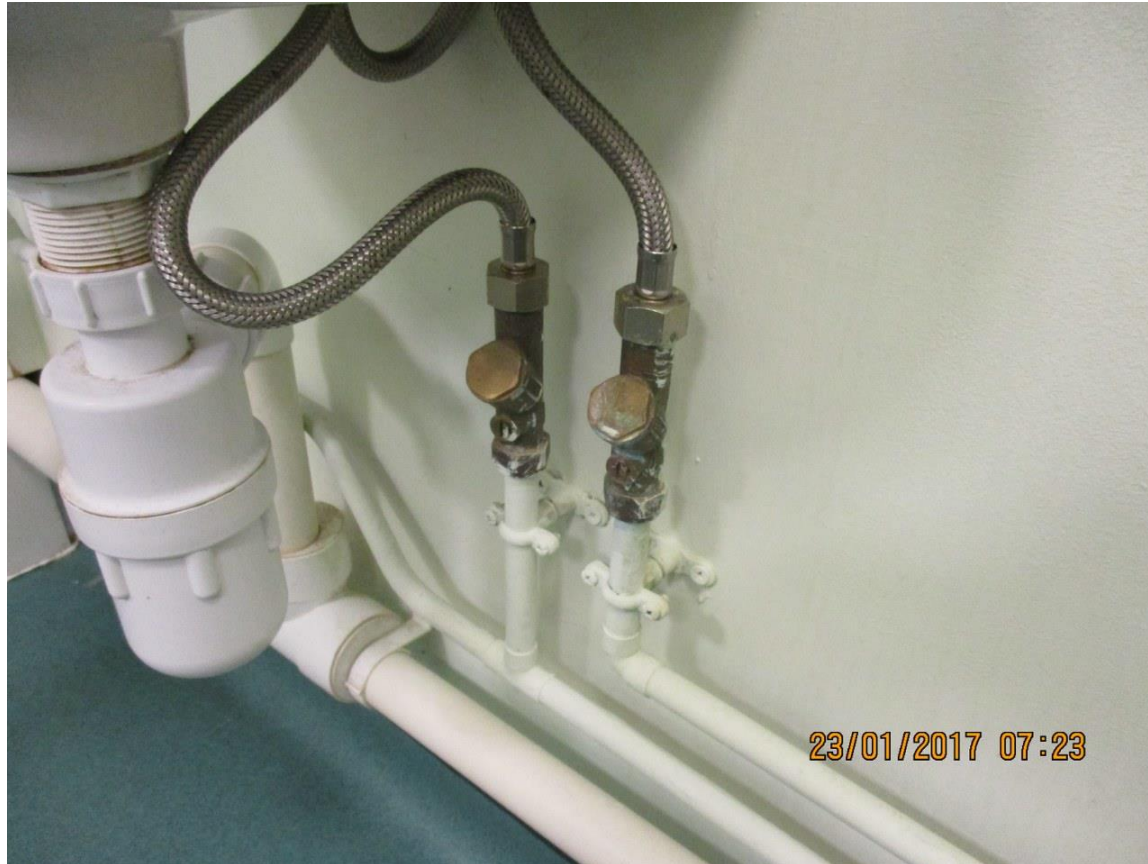
Strainers

Inline strainers are fitted prior to the TMV tap outlets in the toilet areas; I would recommend these strainers are cleaned on a regular basis or as part of a servicing schedule as ideal areas for bacteria proliferation.

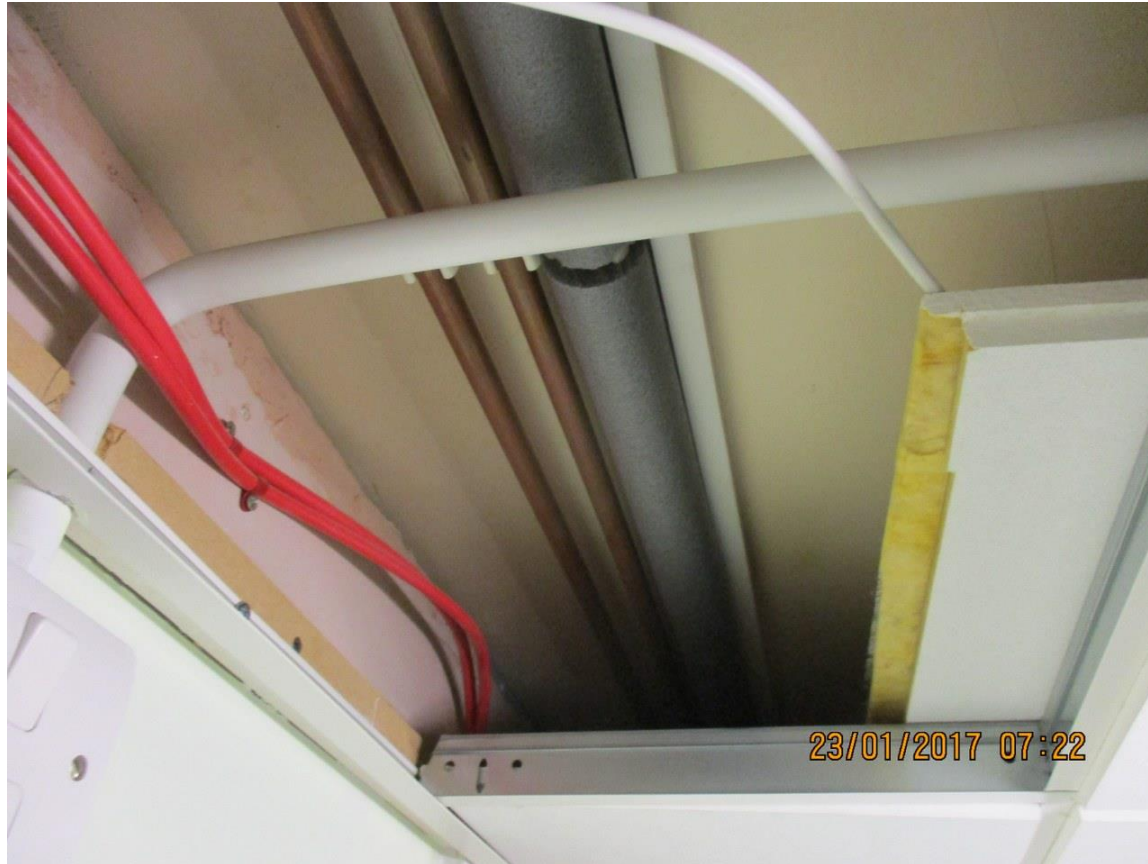
Insulated

The mains water pipe work running with heating pipe work in the disabled toilet ceiling space has now been insulated to help prevent heat gain.
