Clovelly Centre Sure Start

Review Photographs

8th March 2017

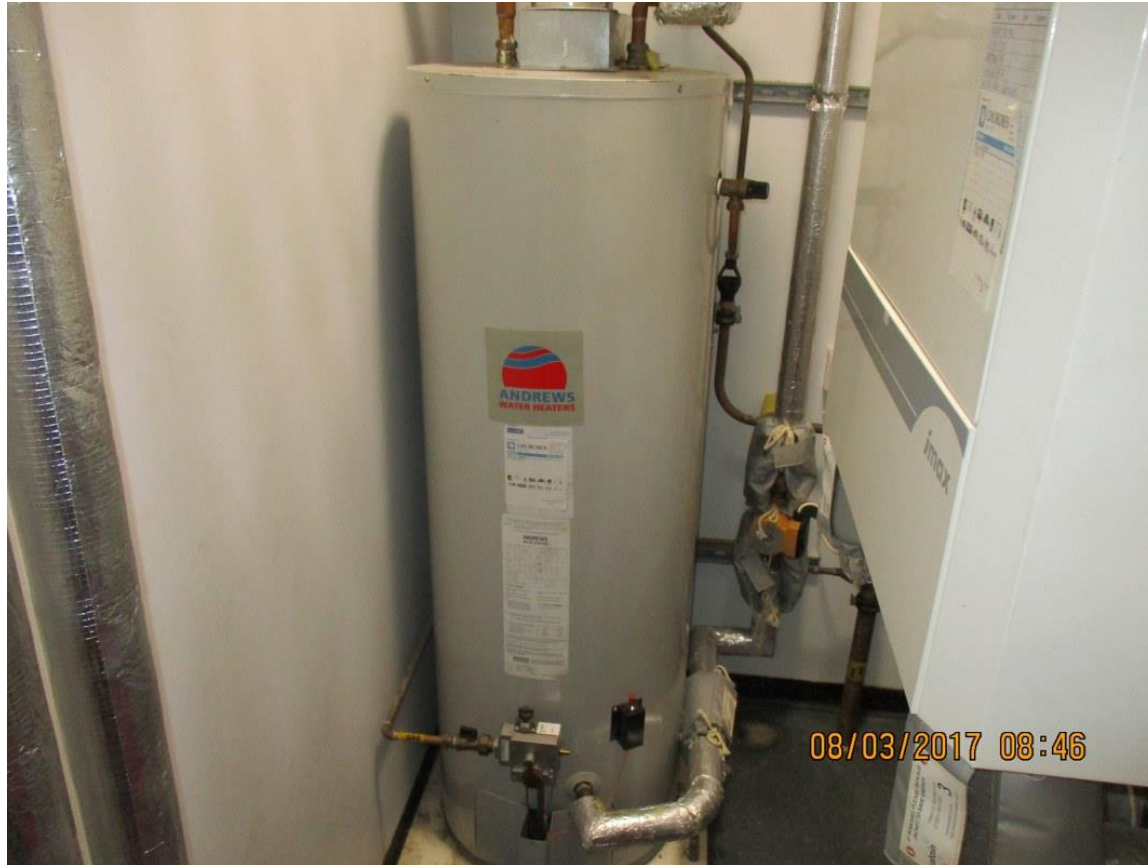
Hot Water Calorifier

The hot water calorifier was found to have low storage temperature at the time of this 2017 review; records seen indicate this has been reported ten times since February 2016. This must be addressed at the earliest opportunity.

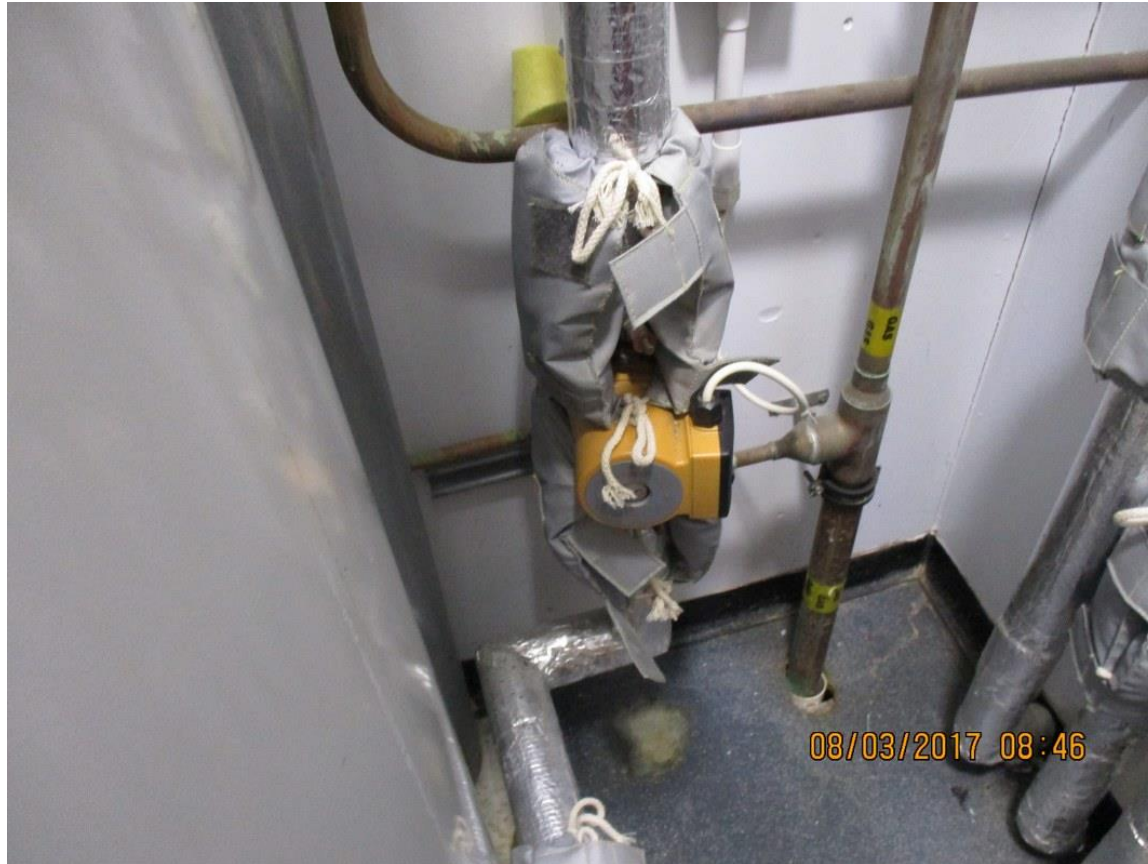
Hot Water Return Circulating Pump

The hot water calorifier return pump was found to have low return temperature at the time of this 2017 review; records seen indicate this has been reported ten times since February 2016. This must be addressed at the earliest opportunity.

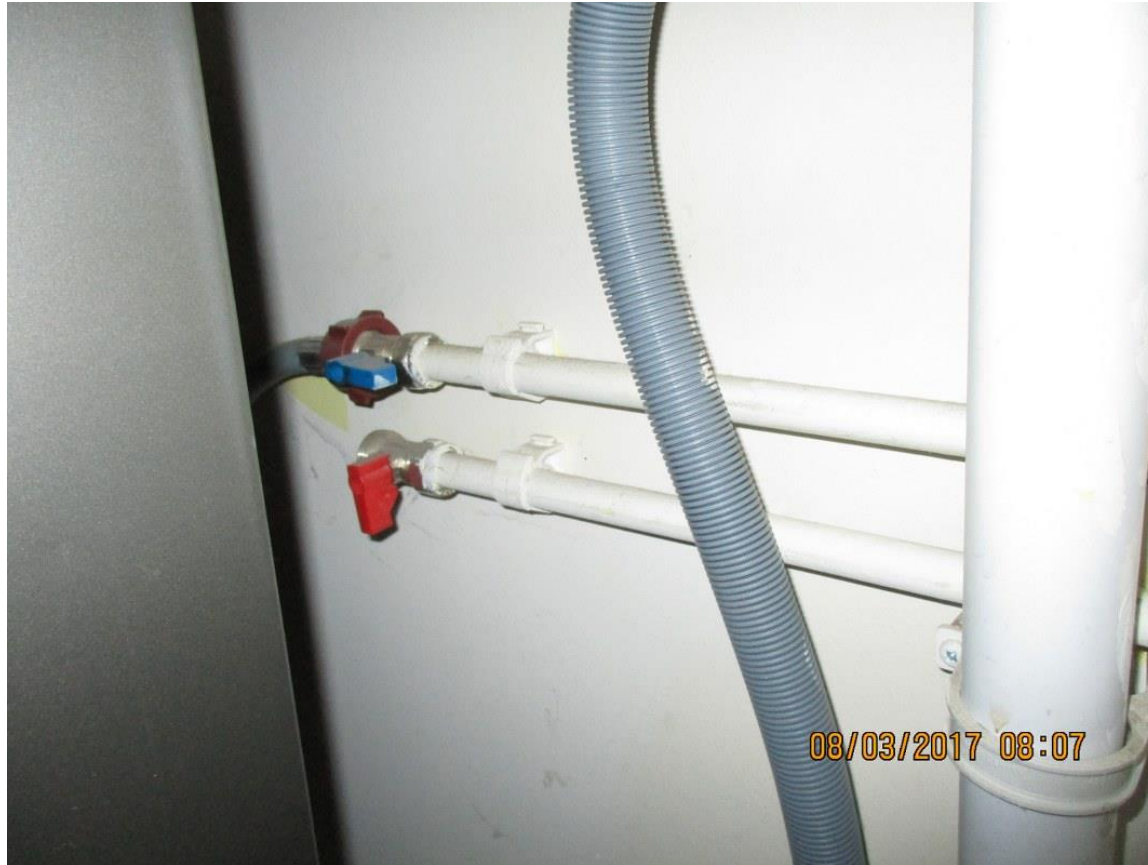
Deadleg Pipe work

Deadleg pipe work was seen on the hot water pipe work at the rear of the dishwasher in the crèche area kitchen; recommend removal.

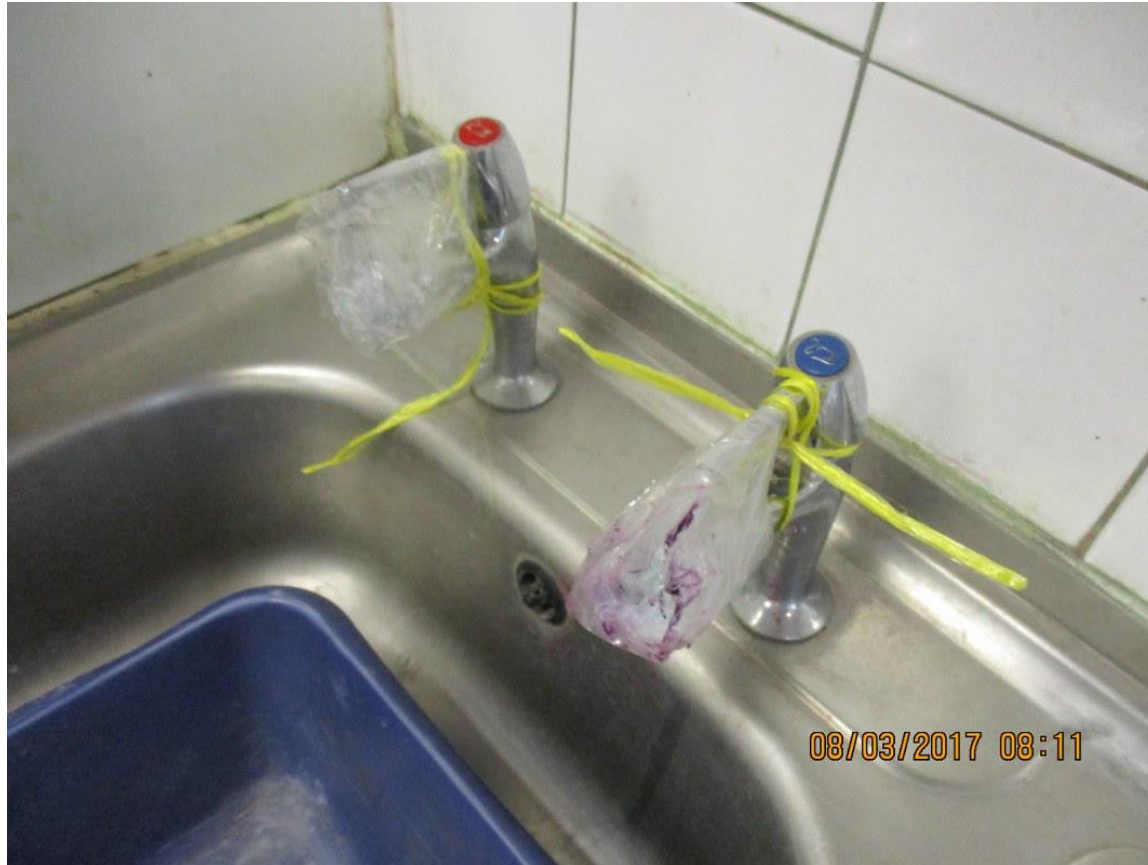
Deadleg Area

The tap outlets in the crèche area have been tapped off to prevent use; this creates deadleg pipe work and should be removed.

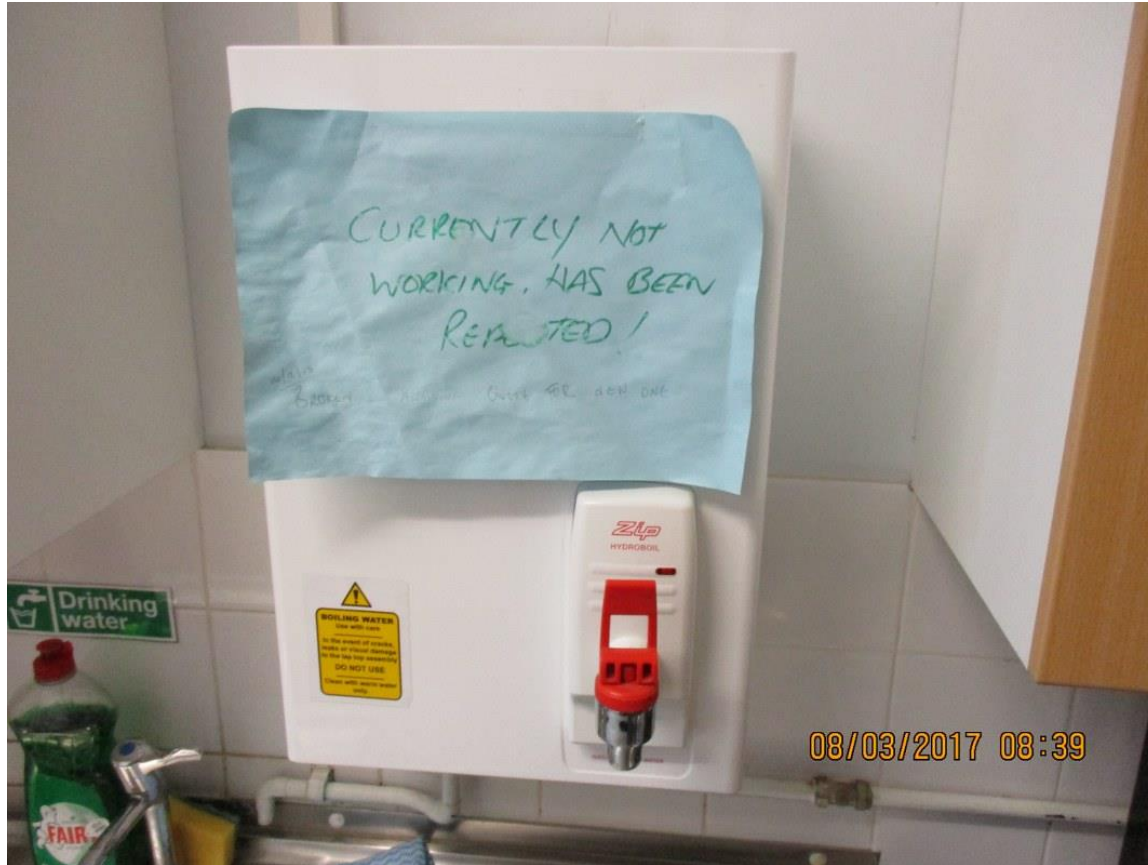
Deadleg Pipe work

The hot water boiler in the first floor kitchen has been isolated for some considerable time creating deadleg pipe work; this should be replaced or removed along with all associated pipe work at the earliest opportunity.

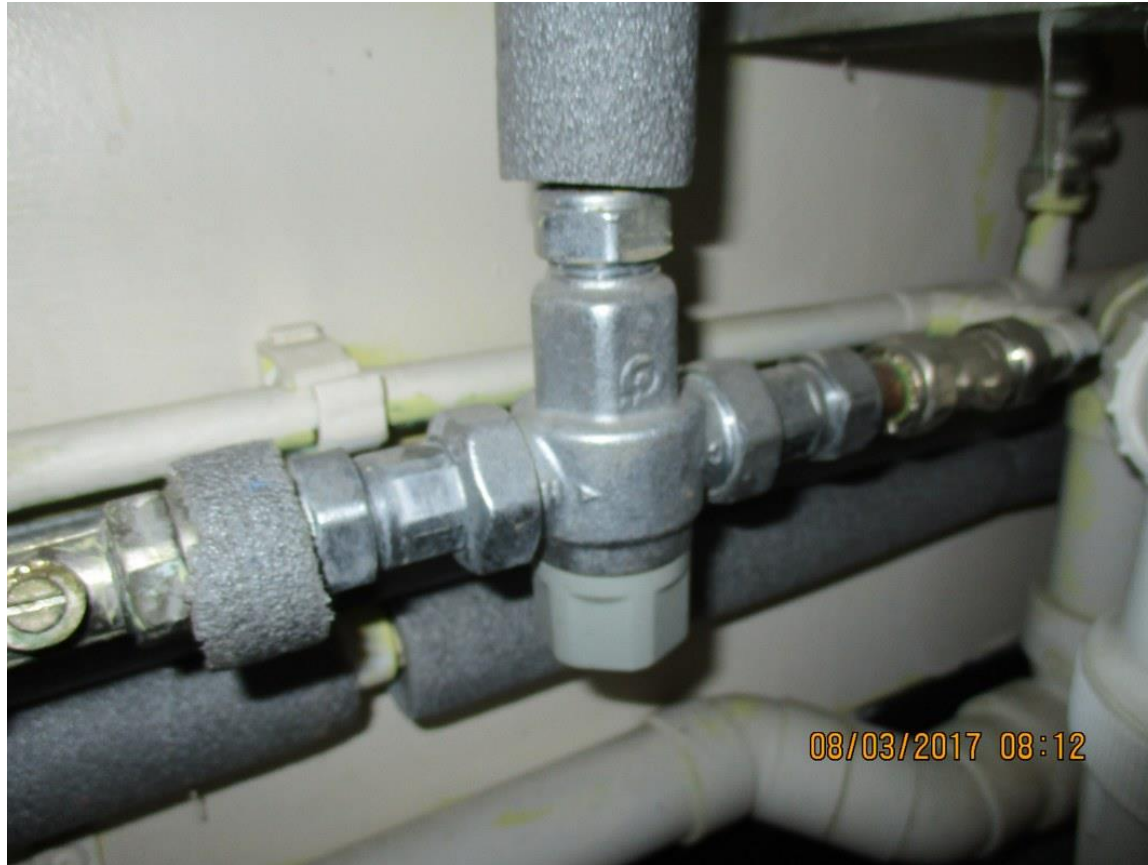
The TMVs appear to be being serviced on a six monthly basis; records seen indicate this was last carried out in January 2017.
