Swaythling Community Centre

Review Photographs

1st February 2017

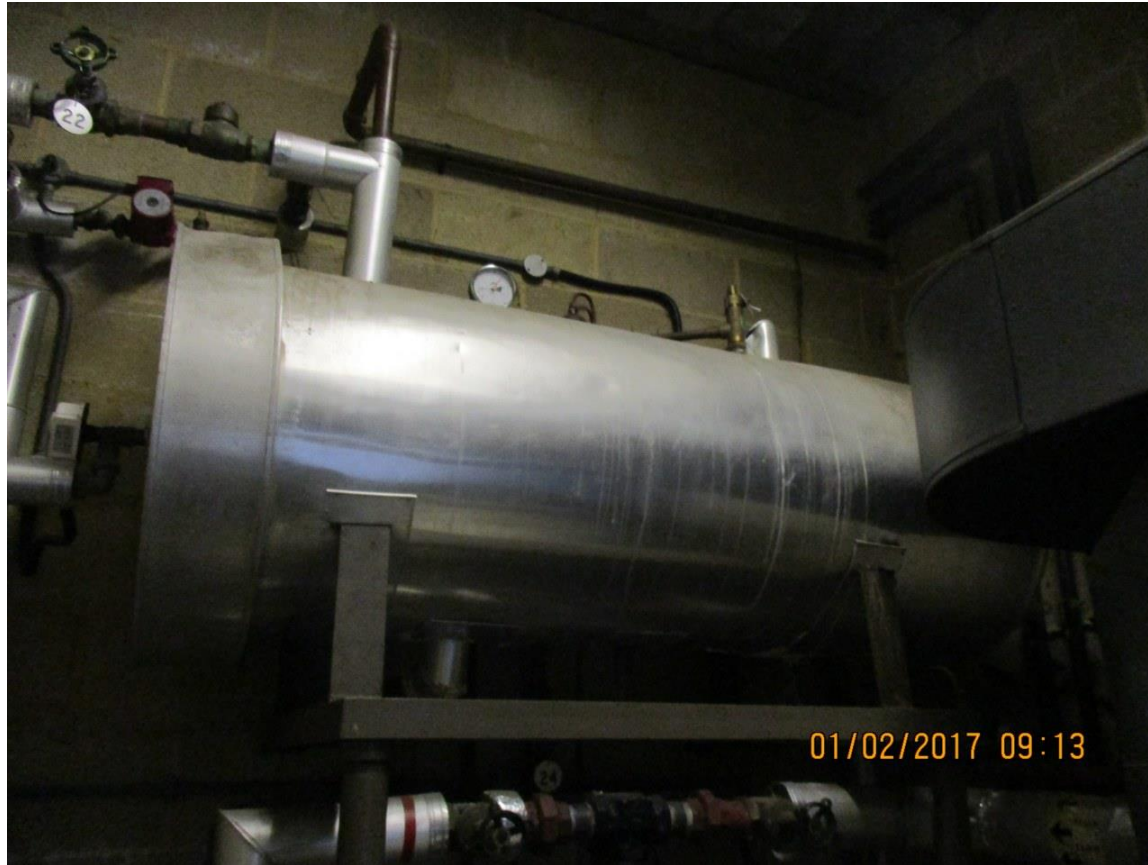
Hot Water Calorifier

Hot water calorifier serving the community centre; slightly low storage temperature at the time of this 2017 review; records seen indicate normally satisfactory.

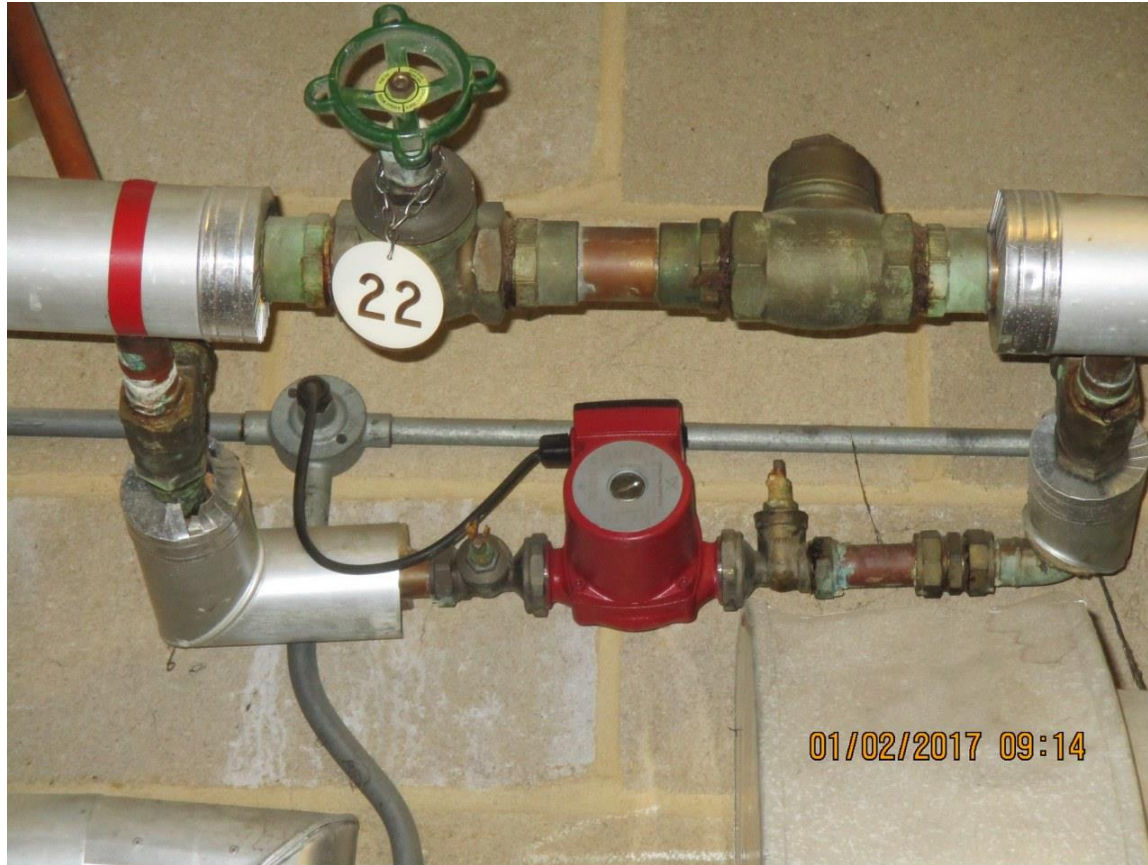
Calorifier Return Pump

Calorifier circulating / return pump good temperature recorded at the time of this 2017 review.

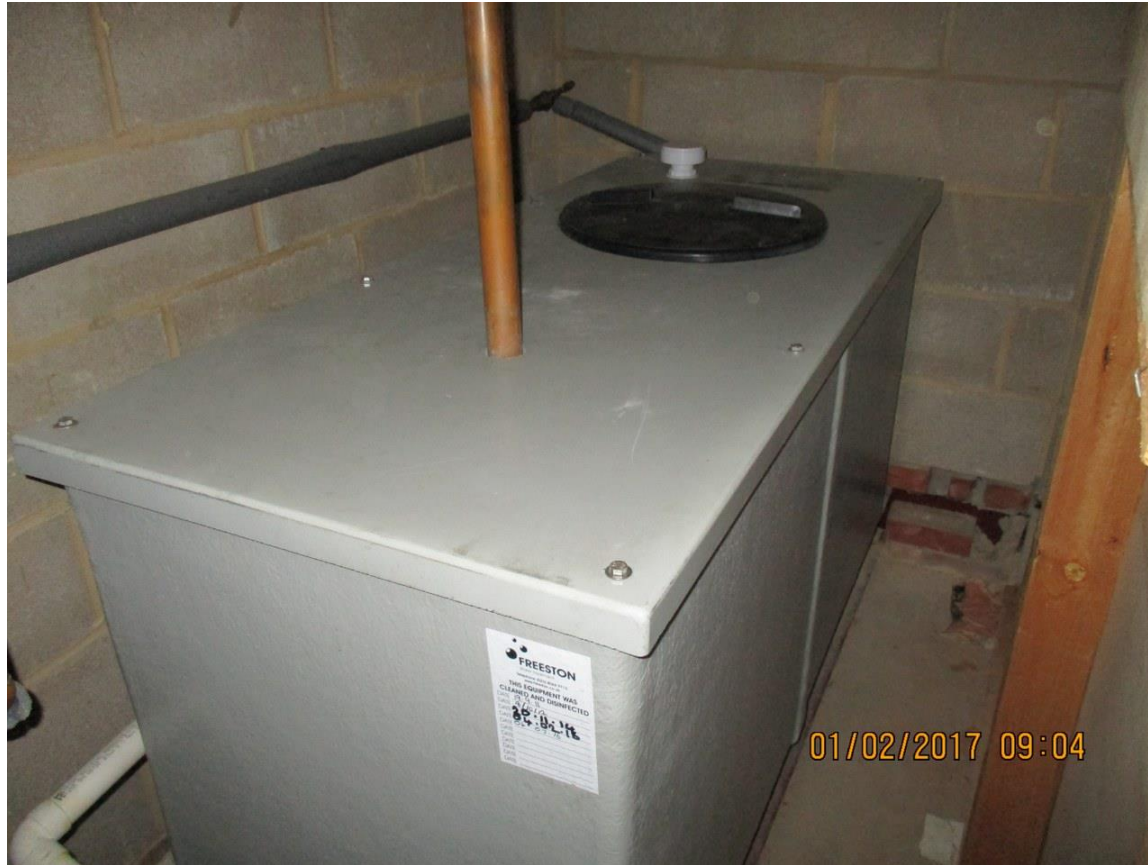
Cold Water Storage Tank

The cold water storage tank still has the open vent pipe returning to the tank; I would again recommend that this be re-routed to a drain via a tundish.

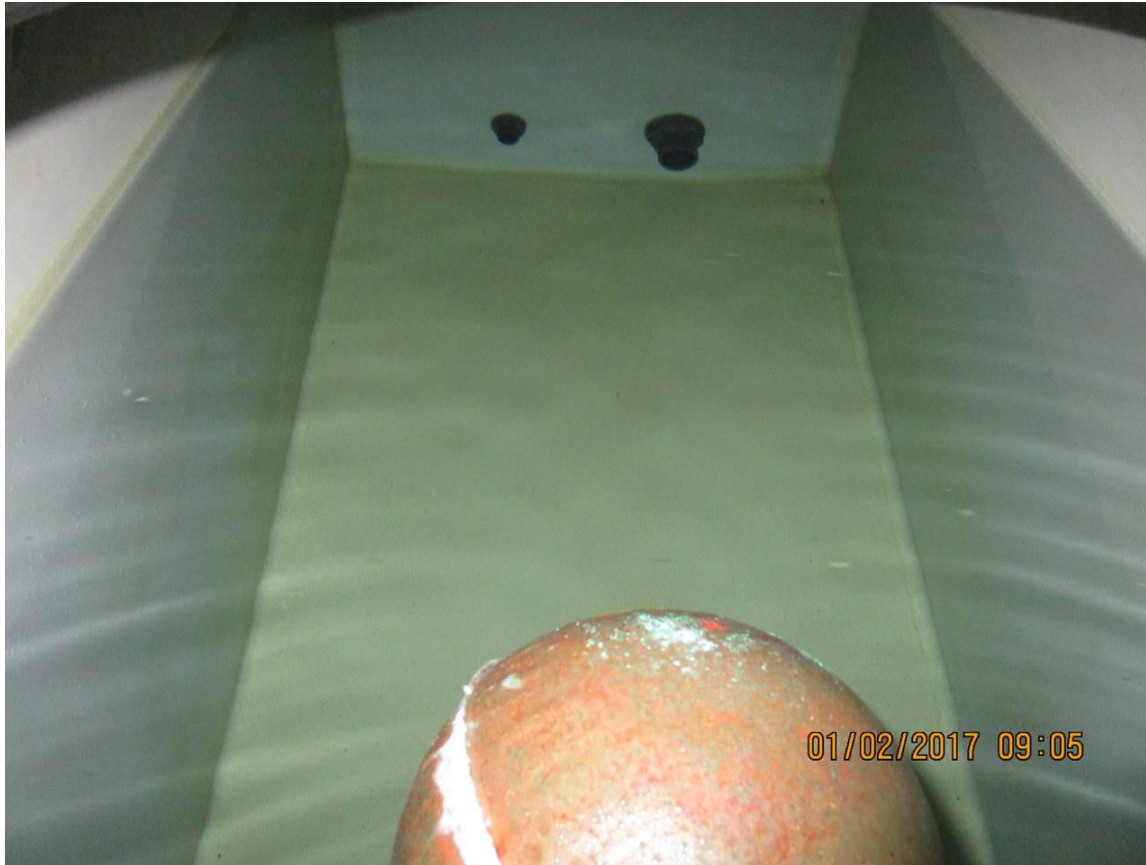
Internal View of Water Storage Tank

Internal view of the cold water storage tank proved it to be in a clean condition; very slight sediment on base; this tank was last cleaned and disinfected in July 2016.

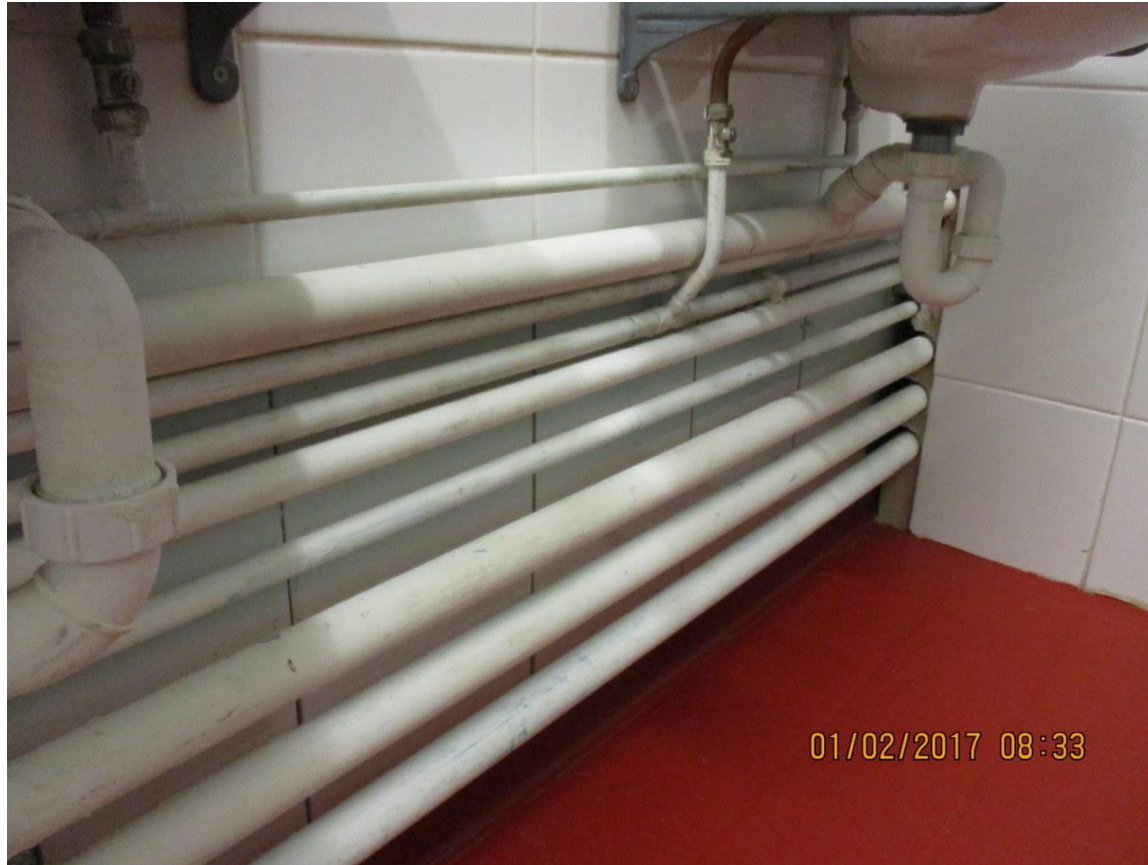
Insulation Missing Ladies Toilet

The domestic water pipe work is running with and above heating pipe work; this can create elevated cold water; I would again recommend this domestic water pipe work be insulated to help prevent heat gain.

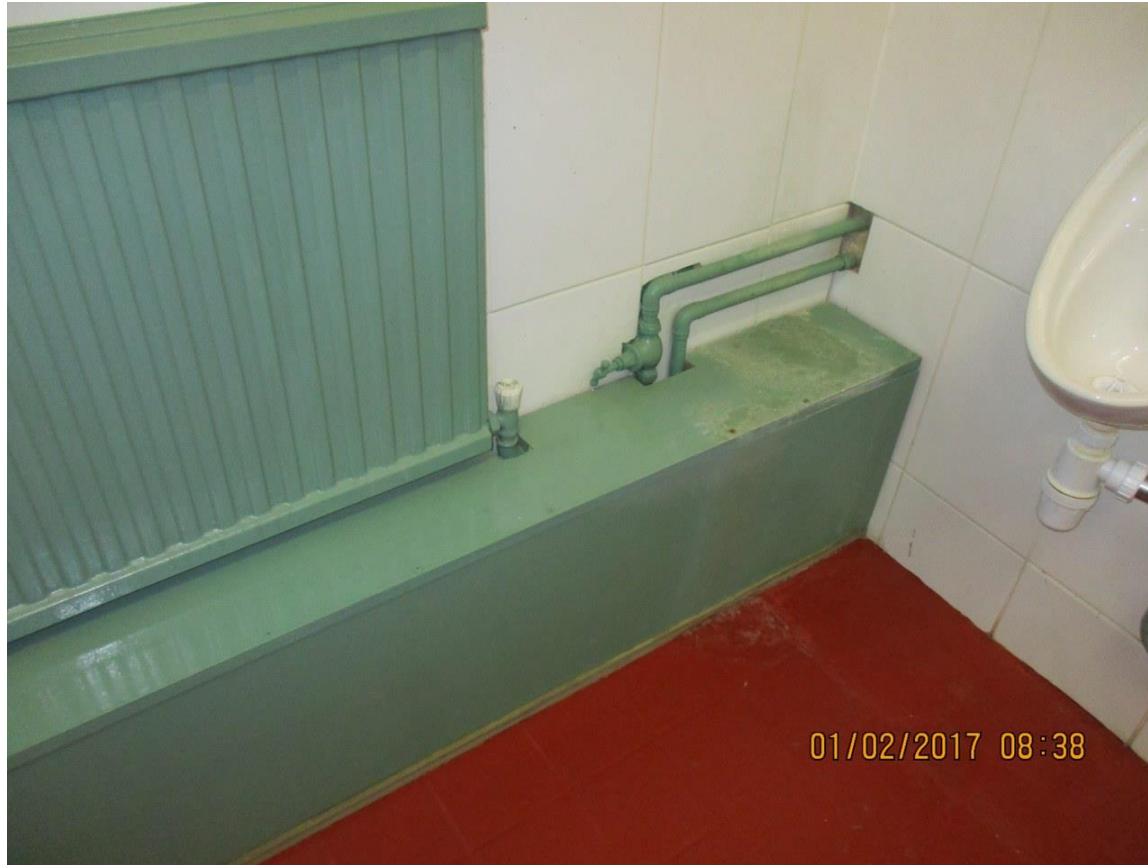
Insulation Missing Gents Toilet

The domestic water pipe work is running with heating pipe work and is boxed in within the ground floor gents toilet; this could create elevated cold water temperatures; I would again recommend domestic water pipe work be insulated to help prevent heat gain.

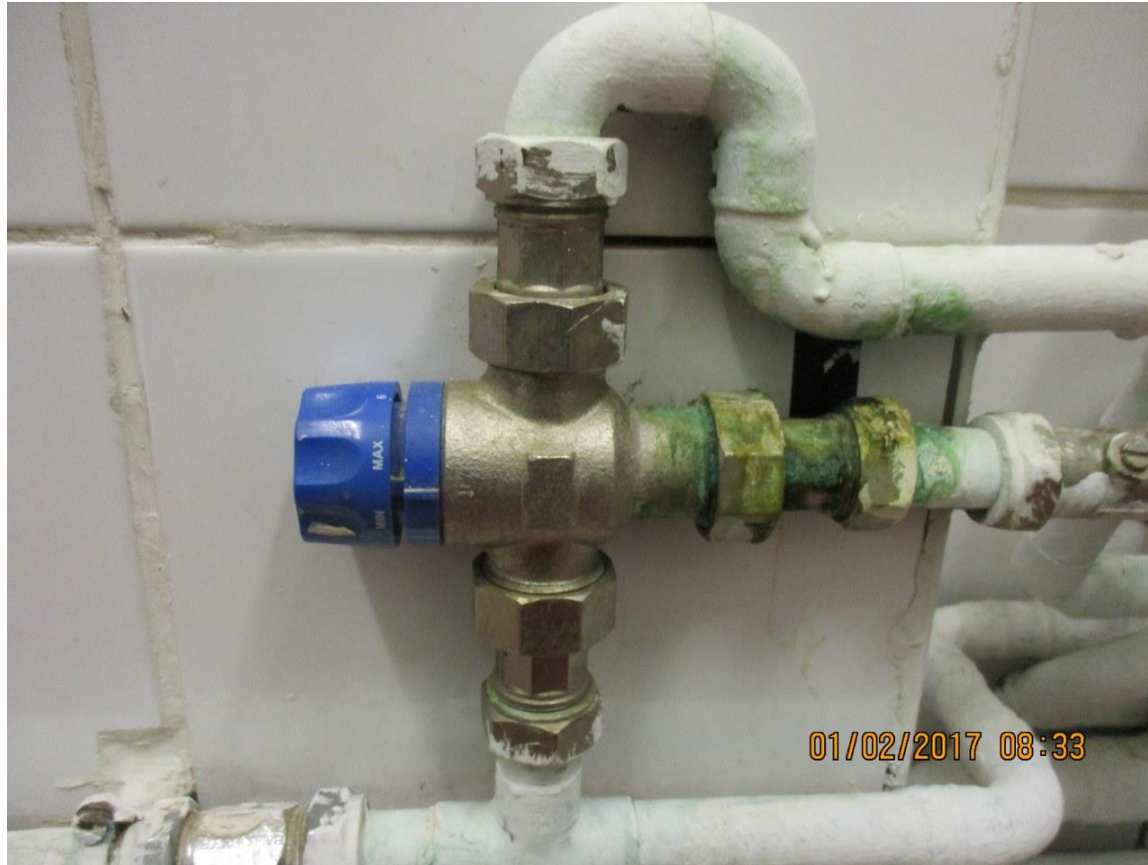
TMVs are fitted within the community centre; no records were seen at the time of this 2017 review to indicate servicing and adjustment is being carried out. I would recommend these are serviced and maintained as recommended by the manufacturers.

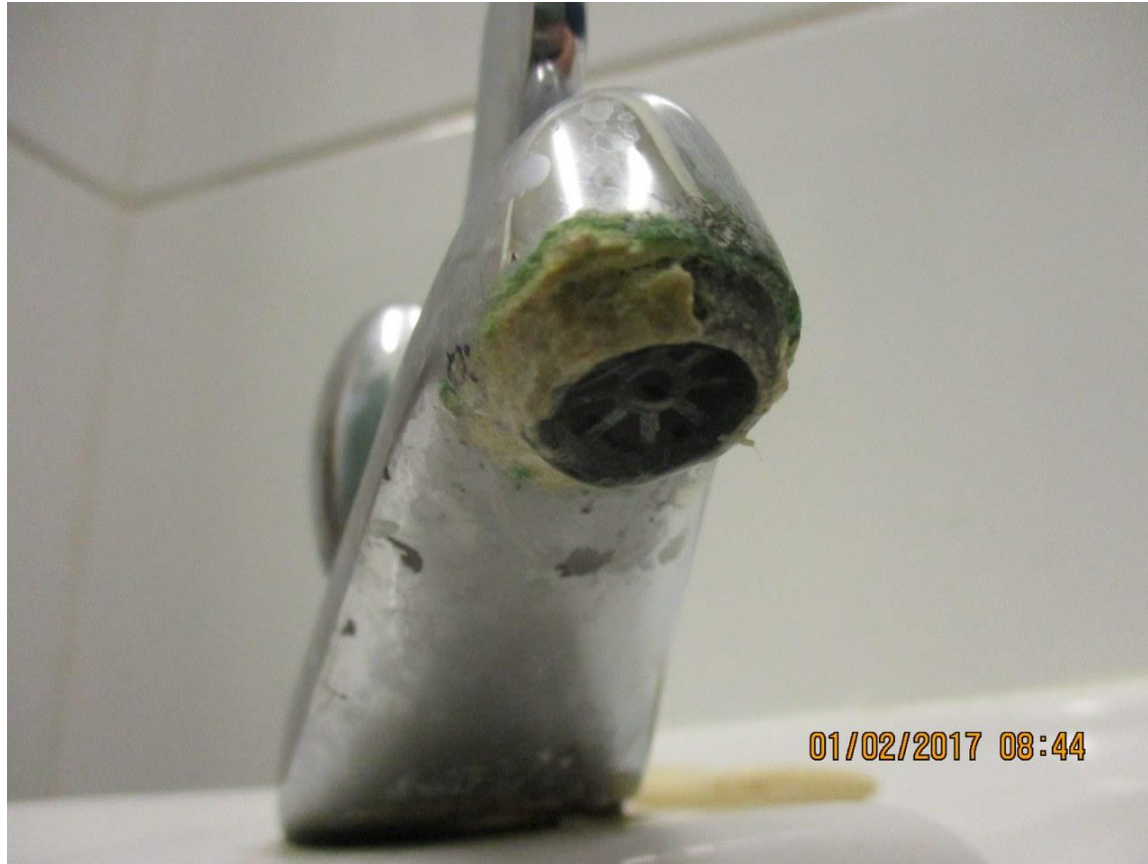
Scale Build Up on Tap Outlets

I would recommend all tap outlets be cleaned and descaled on a regular basis. This will also help the flow of water and prevent aerosol creation.
