32A Kentish Road
Review Photographs
12th July 2018

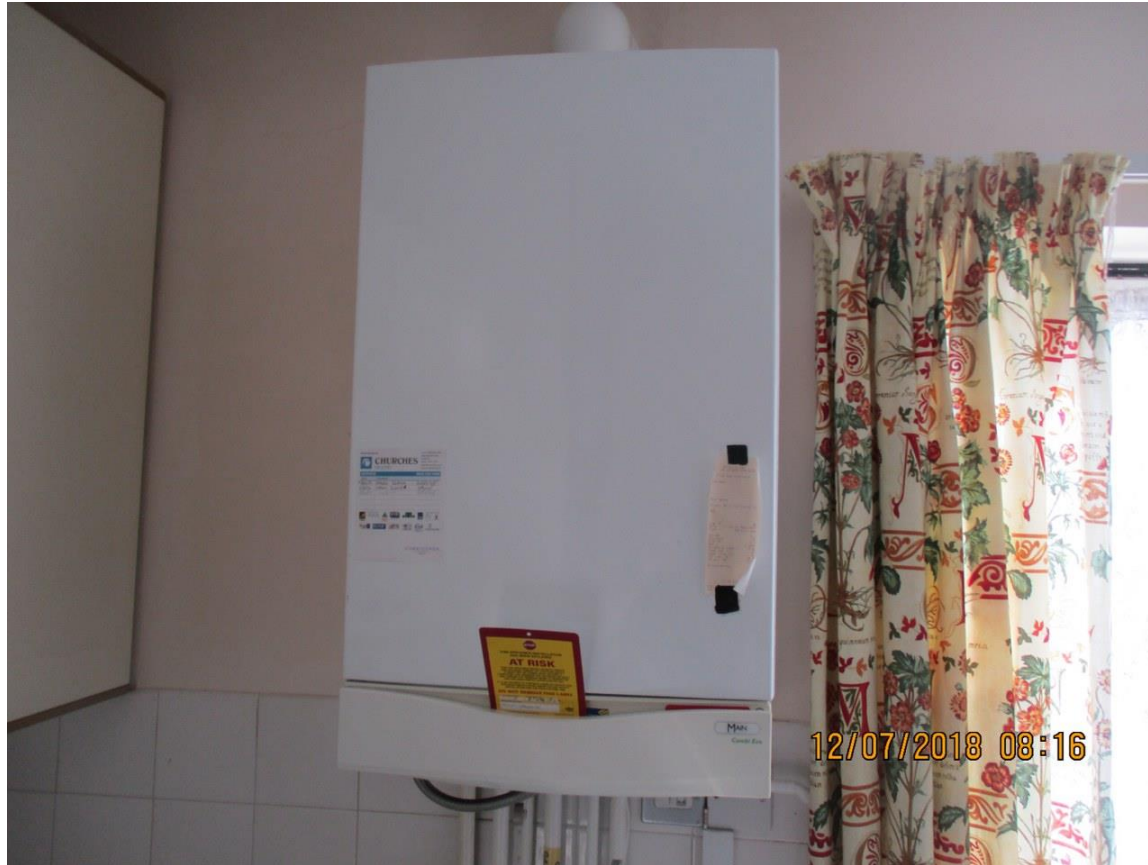
Combination Boiler

The combination boiler serving hot water to 32A has been isolated gas and electrically due to it being faulty; no hot water available at the time of this 2018 review.

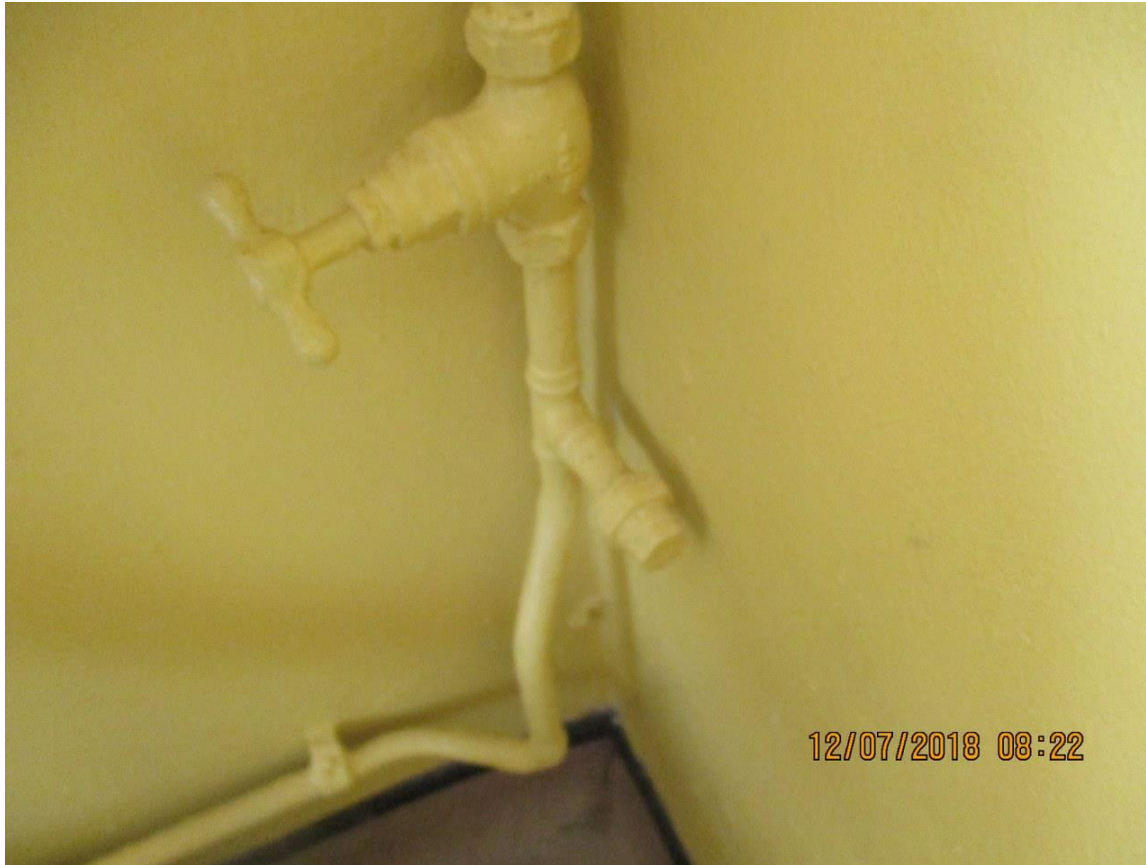
Small Dadleg

A small deadleg was seen on the cold water service to the ground floor toilet cistern; recommend removal.

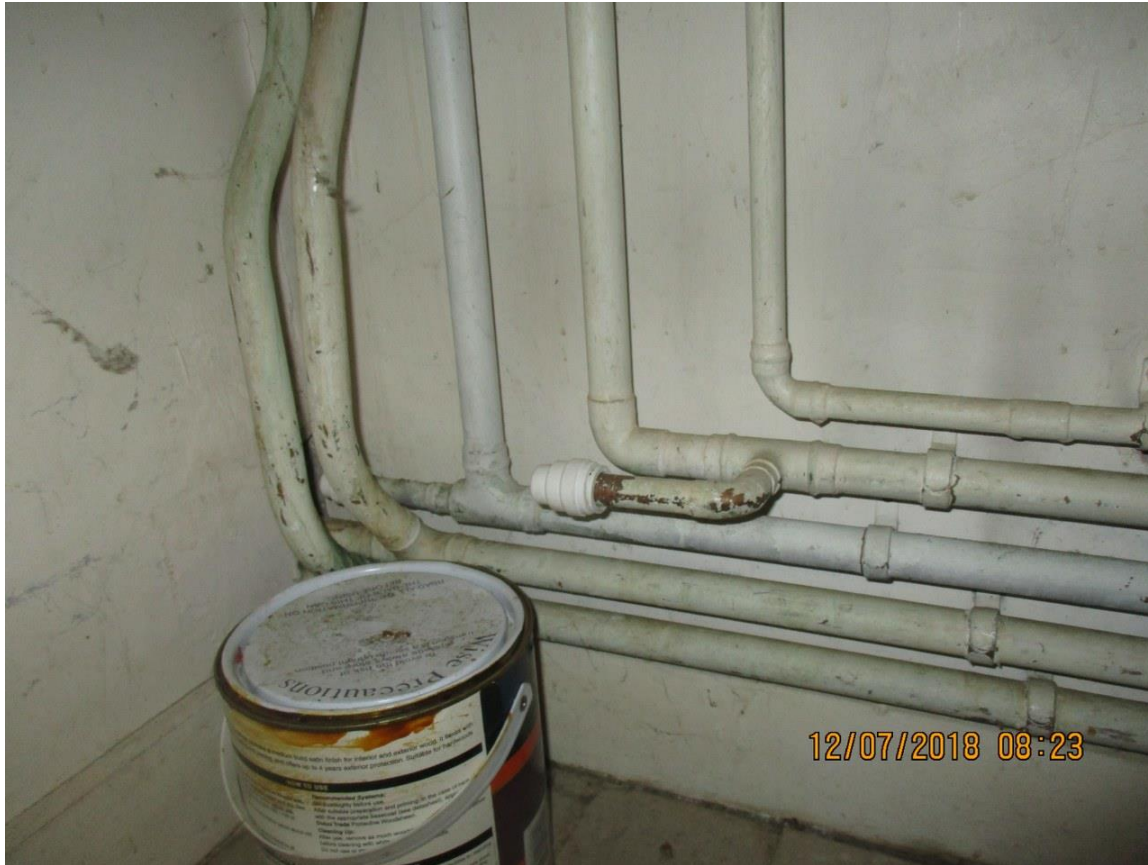
Deadleg Pipe Work

Capped off pipe work seen on the domestic water systems in the ground floor cupboard space create deadleg pipe work; recommend removal.

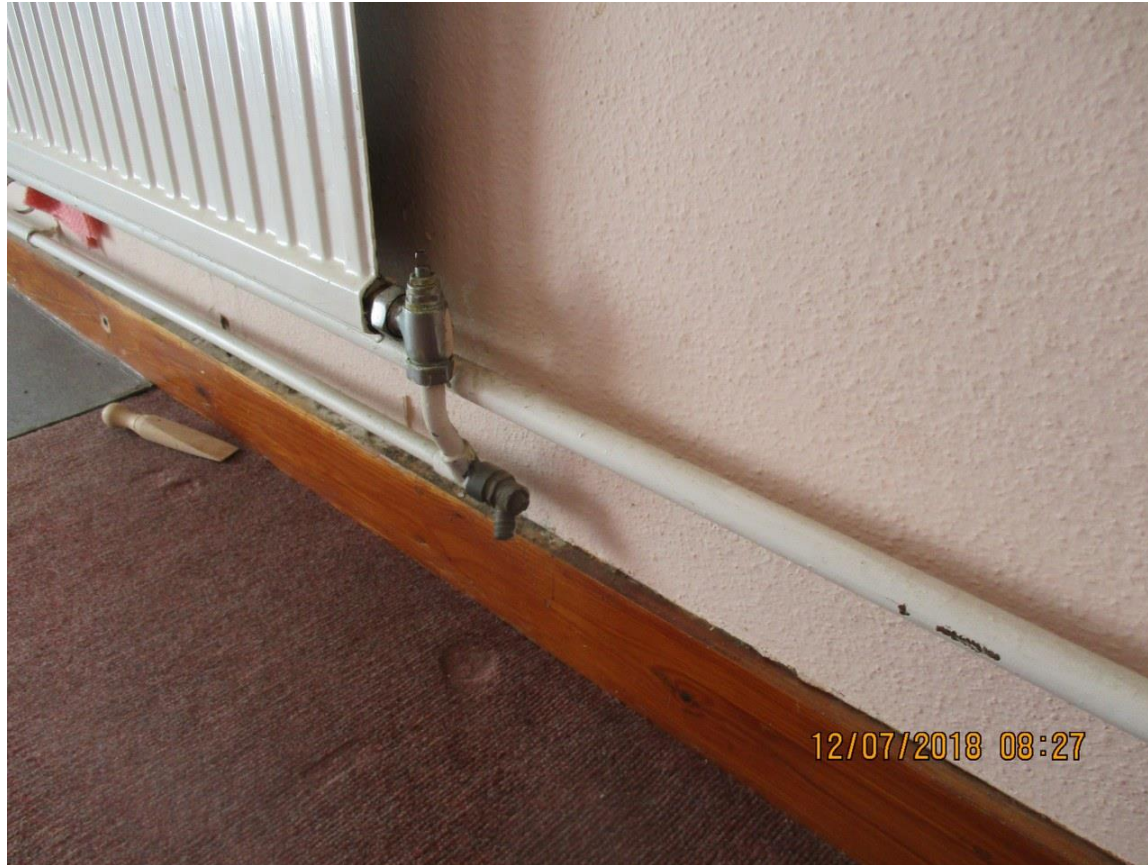
Domestic Water Pipe

The domestic water pipe work was still seen to be running behind the heating radiator in the first floor kitchen area; recommend re-routed or at least insulated.

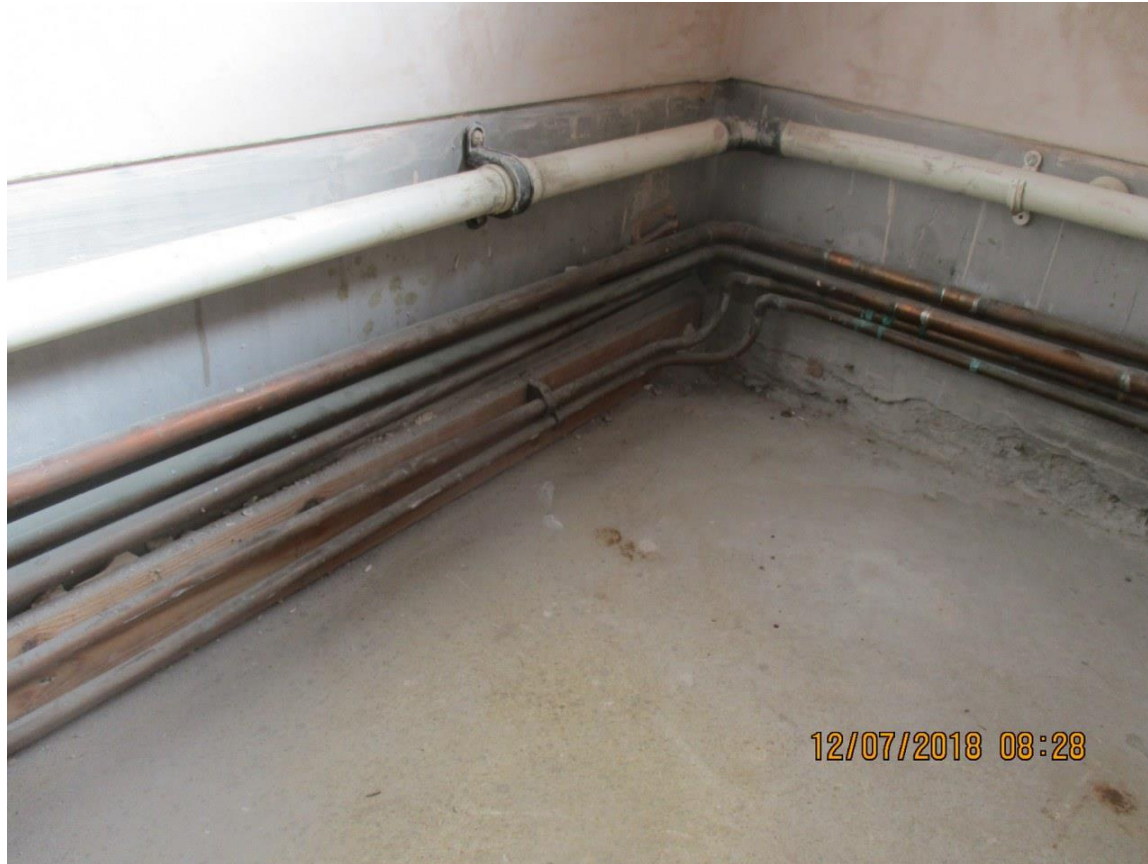
Domestic & Heating Pipe Work

The domestic water pipe work is running with heating pipe work in some areas; recommend this pipe work be insulated to help prevent possible heat gain.

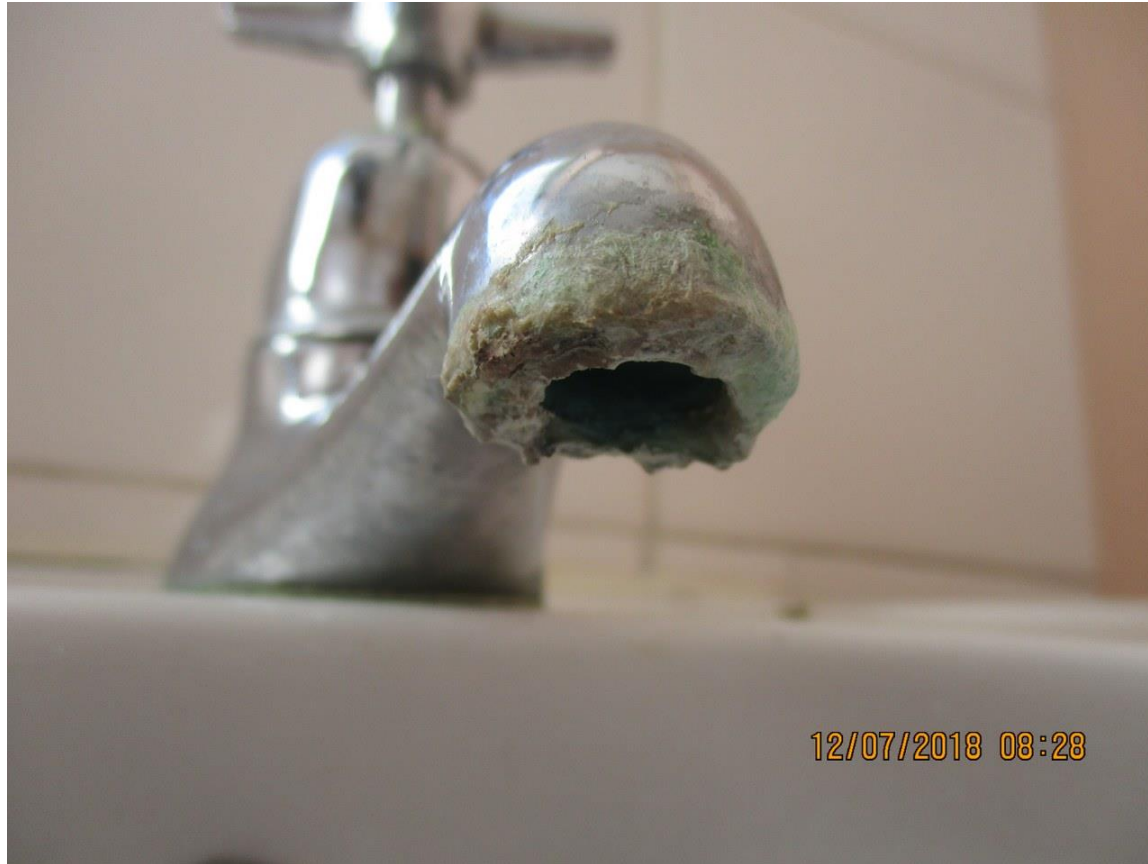
Tap Outlets

There was seen to be scale build up on tap outlets within 32A; recommend these are descaled on a regular basis as this can act as a nutrient for the proliferation of bacteria.
