32B Kentish Road
Review Photographs
12th July 2018

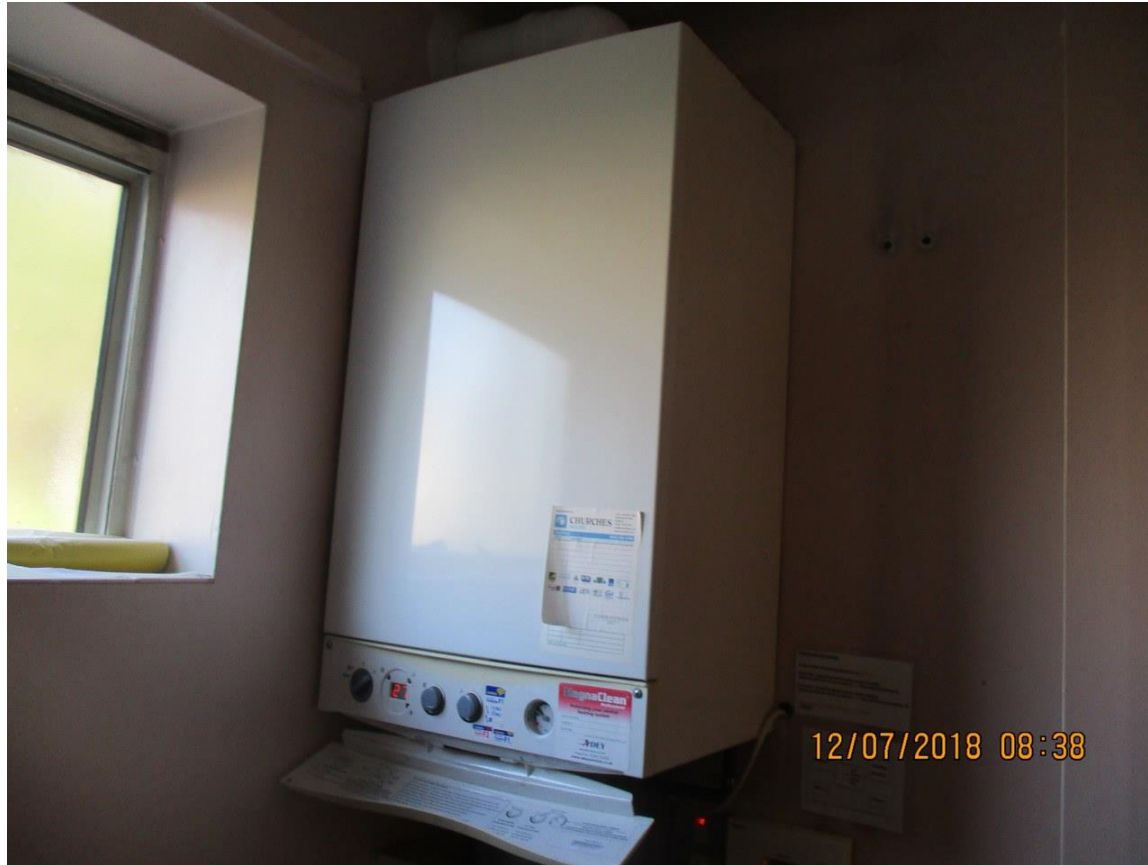
Combination Boiler

The combination boiler serving hot water to building 32B; good flow temperature recorded at the time of this 2018 review.

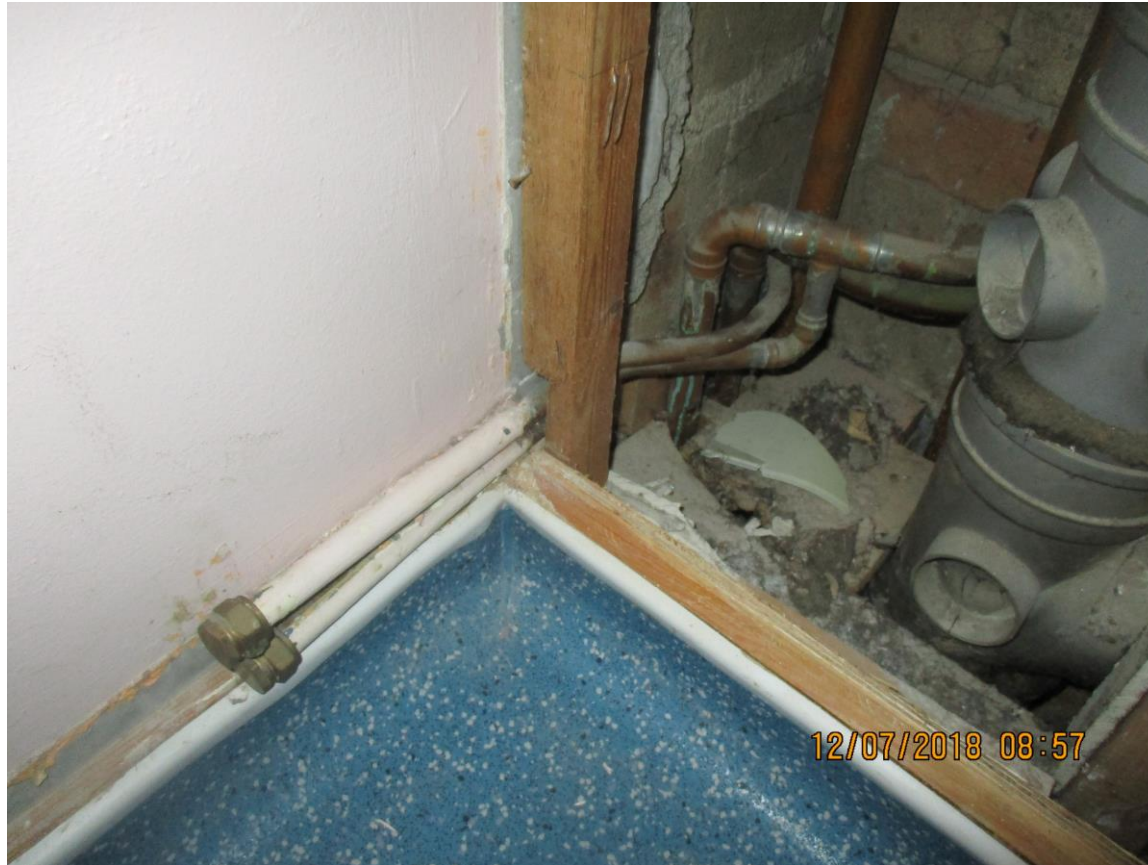
Deadleg Pipe Work

The deadleg pipe work in the first floor bathroom area is still in place at the time of this 2018 review; I would again recommend removal.

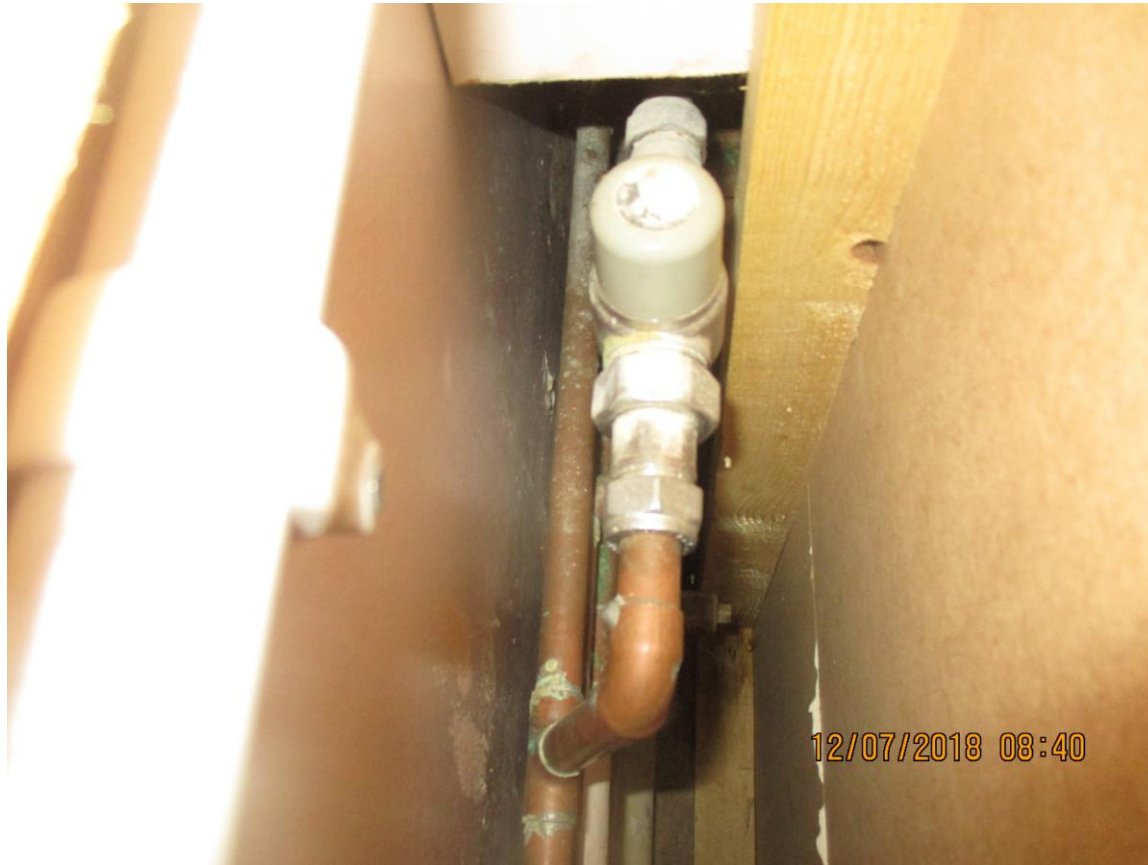
The TMV in the ground floor WC serves all outlets within the building which is not satisfactory; TMVs should be fitted as close to outlets as possible to prevent long pipe runs with reduced temperature water. I would again recommend removal. TMVs should be serviced and maintained as recommended by the manufacturers.

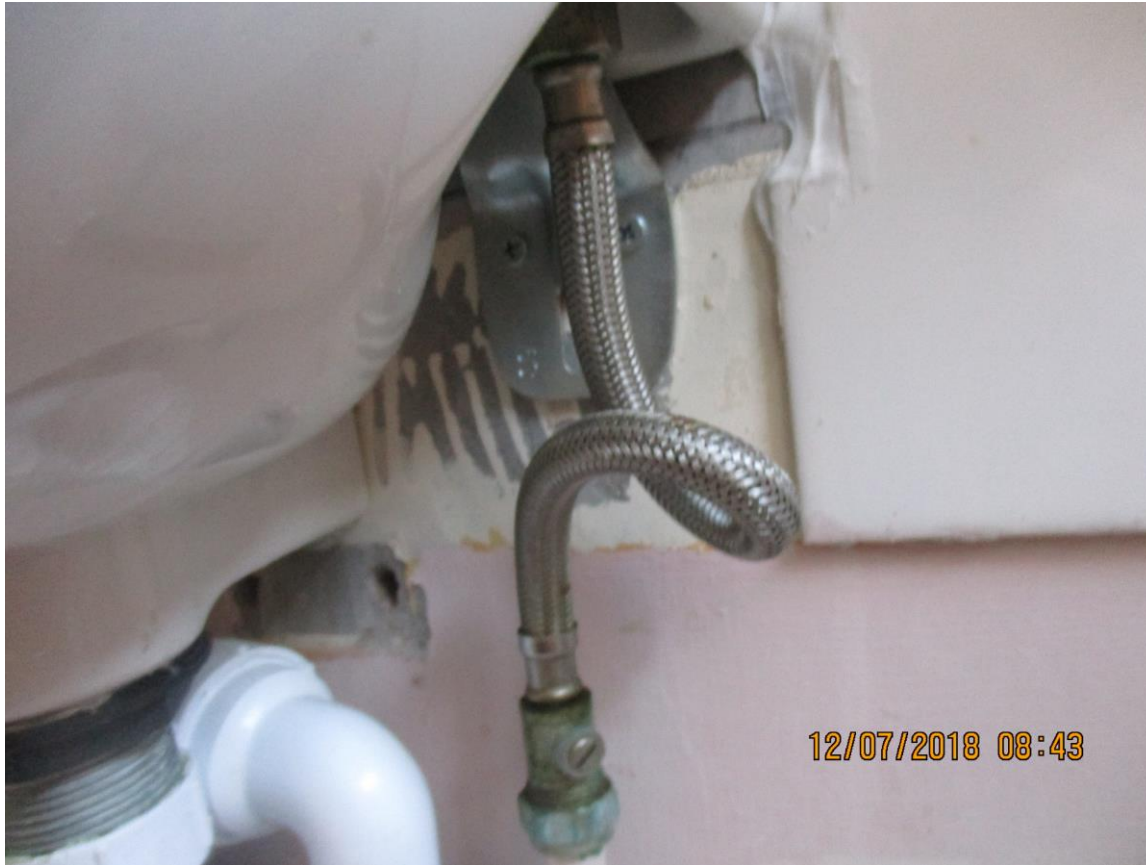
Kinked Flexible Hose

Kinked flexible hoses causes them to break down internally and create an ideal area for bacteria proliferation; recommend hard plumbed.

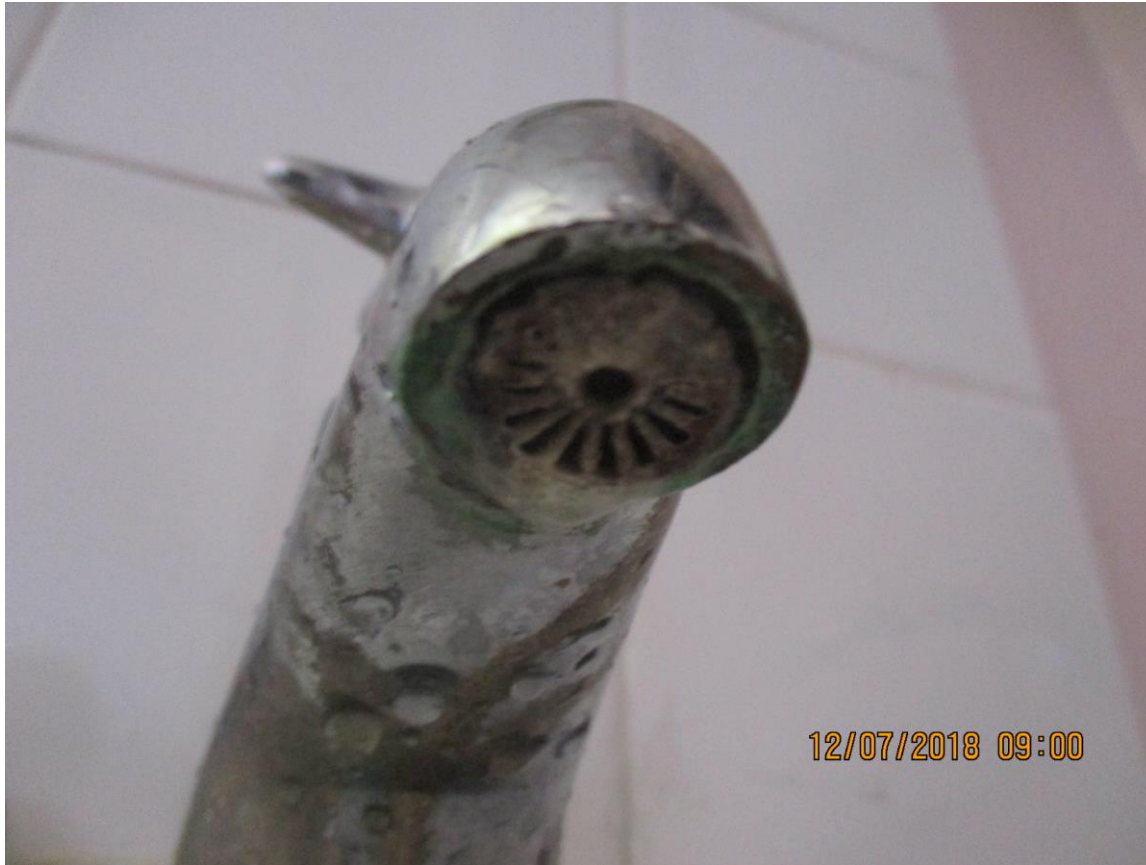
Scale Build Up

Ensure all tap outlets are cleaned of scale as this is an ideal nutrient for bacteria proliferation.
