Holly Lodge Cottage Review Photographs 5th March 2018

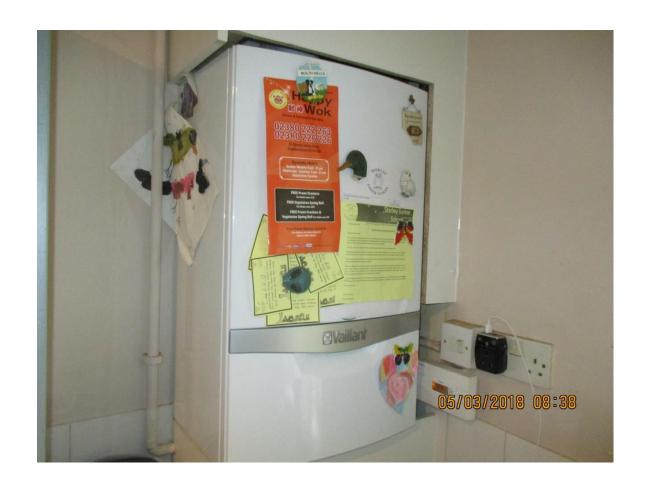
Combination Boiler

A new combination boiler has been fitted late 2017; serving all hot water in the lodge accommodation.

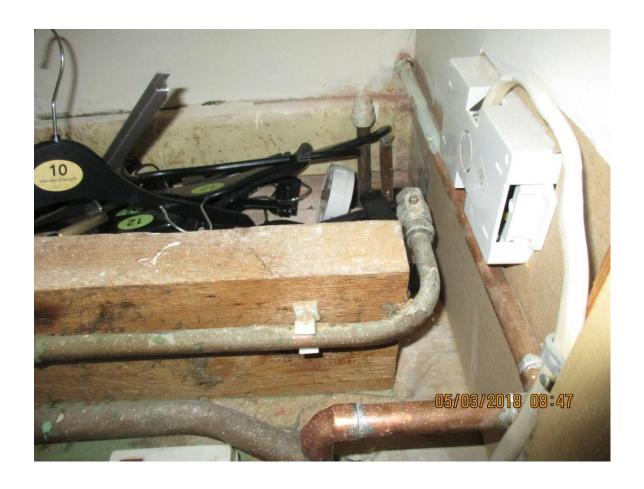
Deadleg Pipe Work

Deadleg pipe work was still seen on the mains water pipe work in the rear bedroom cupboard space; recommend removal. Capped off pipe work seen investigate and remove if found to be live.

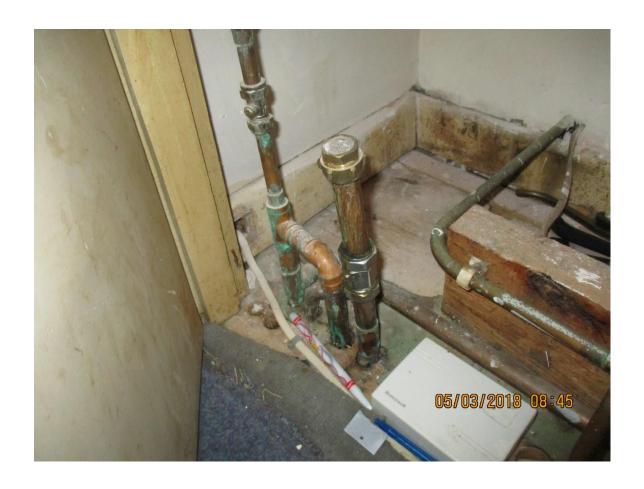
Possible Deadleg Pipe Work

Capped off pipe work was still seen in the rear bedroom cupboard space area; investigate and remove if found to be live.

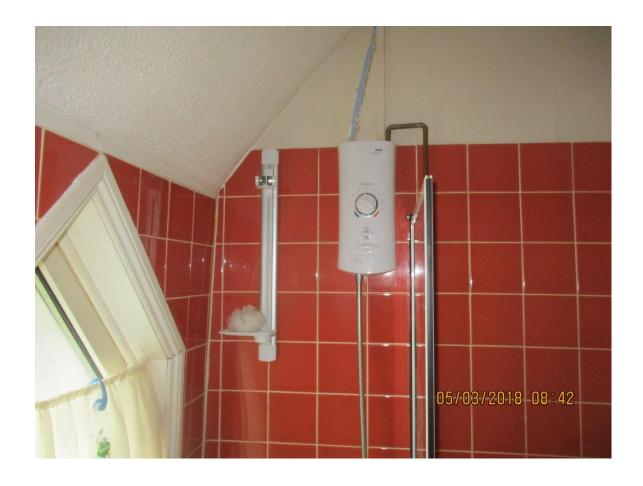
Electric Shower

A new electric shower has recently been installed; this shower gets regular usage.

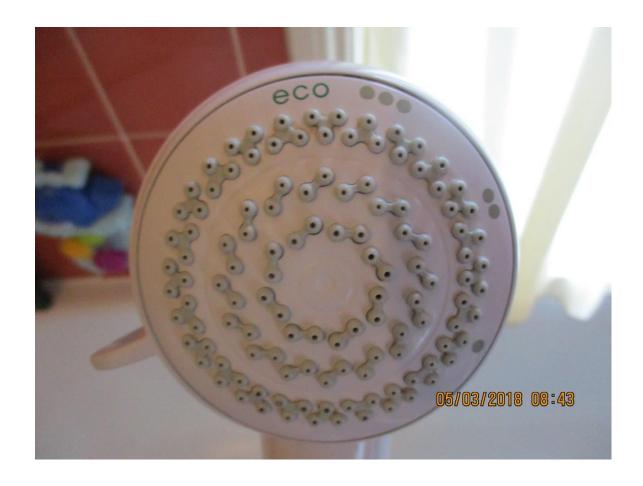
Showerhead

The showerhead is being cleaned and descaled at least on a quarterly basis; this was last carried out in January 2018 and was seen recorded in the logbook documentation.
