6 Out of Tolerance Result and Action Record

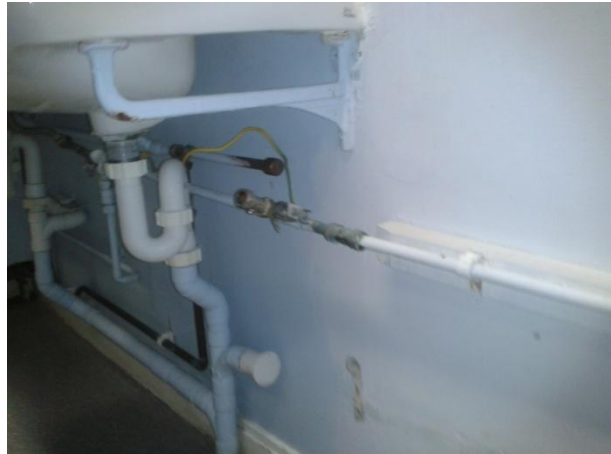
Deadleg pipe work is an ideal area for bacteria proliferation and should therefore be removed; some deadleg pipe work has been noticed at the time of monthly temperature monitoring; find attached photos of deadleg pipe work recently seen.

Deadleg pipe work seen in Scola building junior girls toilet area.

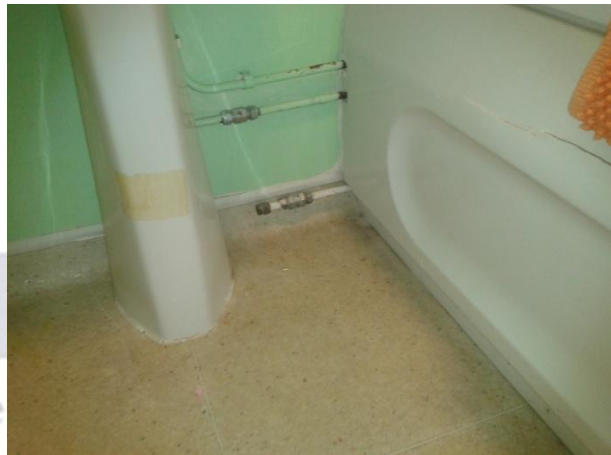
Deadleg pipe work seen in Rothely building shower room area.
