6 Out of Tolerance Result and Action Record

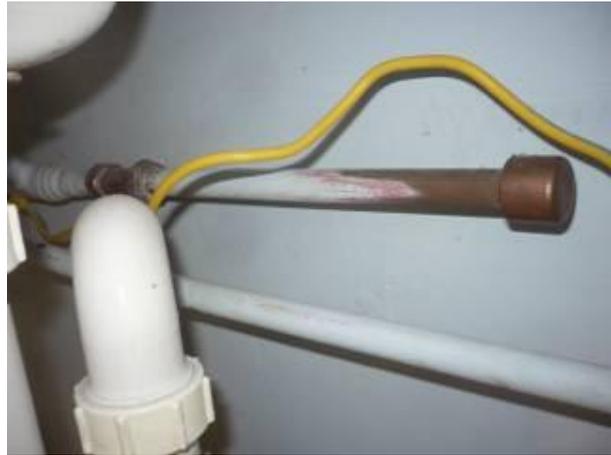
No.0062

Deadleg seen beneath wash basin in staff / visitors toilet should be taken back to the compression fitting.
